Facility Assessment
Fort Worth Botanic Garden
3220 Botanic Garden Boulevard
Fort Worth, Texas 76107

August 31, 2018
PROJECT NO. 16-1031.00

Assessment – Fort Worth Botanic Garden

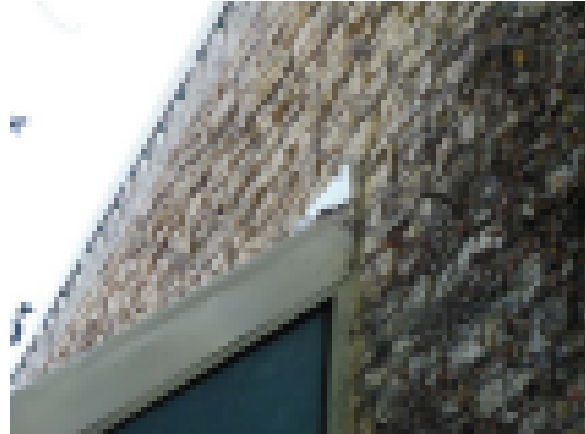
Flashing Damage

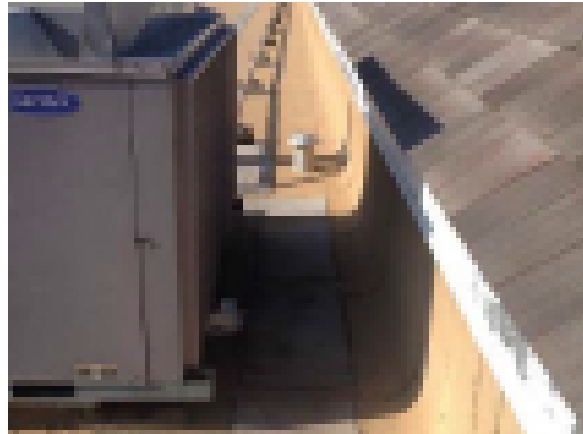
RTU Adjacent to Pitched Roof

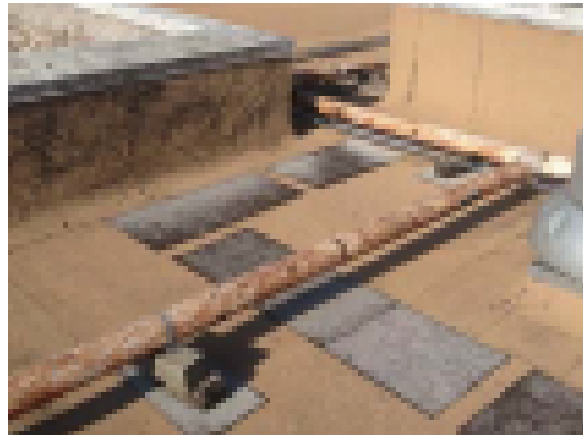
Rusted Natural Gas Piping on Roof

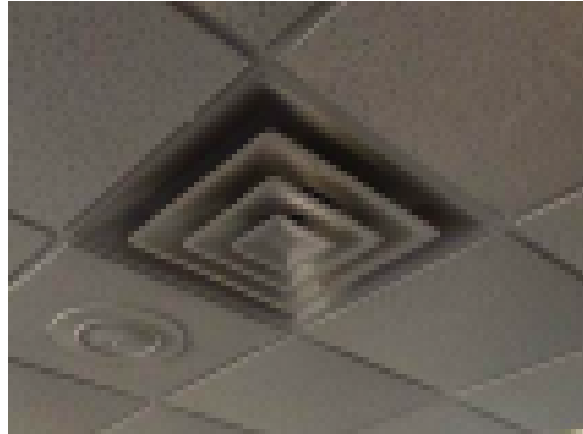
Rust on Ceiling Air Device

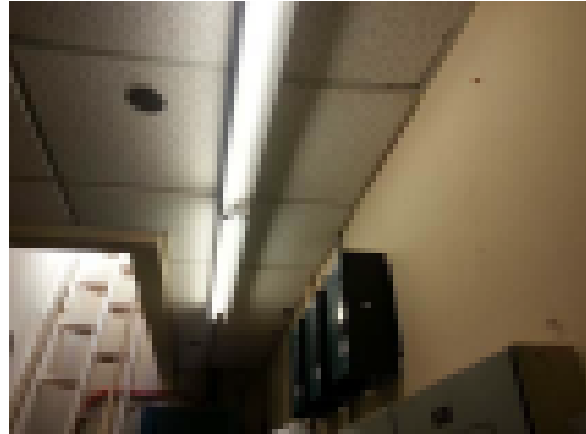
Lighting System in Need of Maintenance

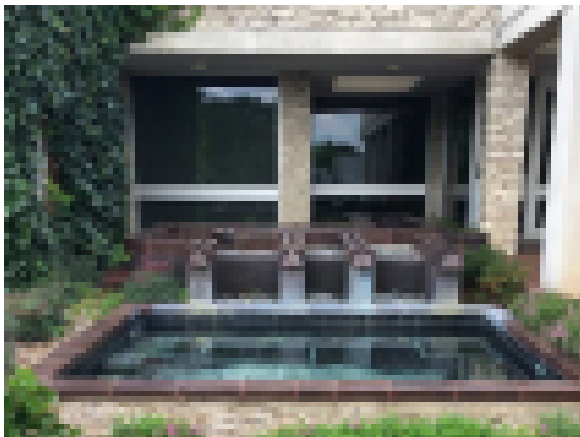
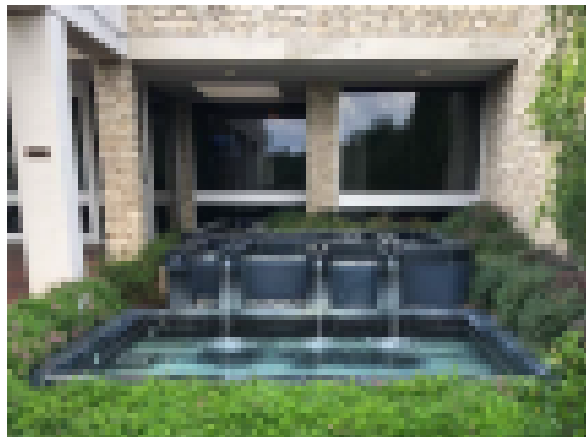
Each side of the Garden Center entrance walk includes a runnel type fountain feature with custom tile and stone work that weir into a lower basin. This fountain leaks and the electrical equipment is buried making it difficult to service. The leak in this fountain will need to be identified and repaired and the electrical equipment relocated so that the equipment is more serviceable and the junction boxes are out of view of the visitors.

Entrance Fountain (Left Side)

Entrance Fountain (Right Side)

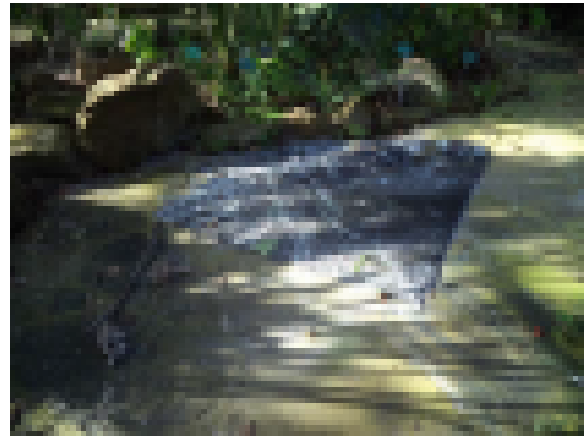
Fallen Glass

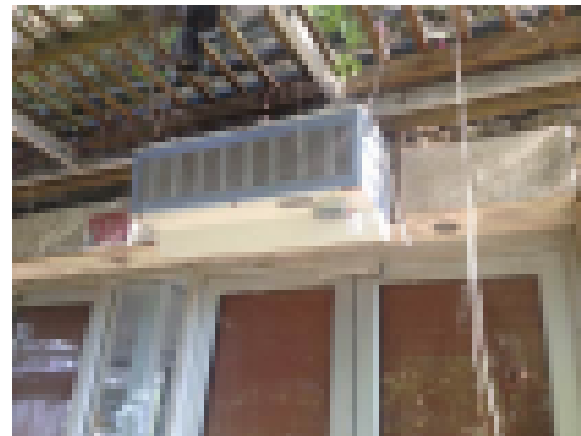
Rusted Air Curtain Over Doors

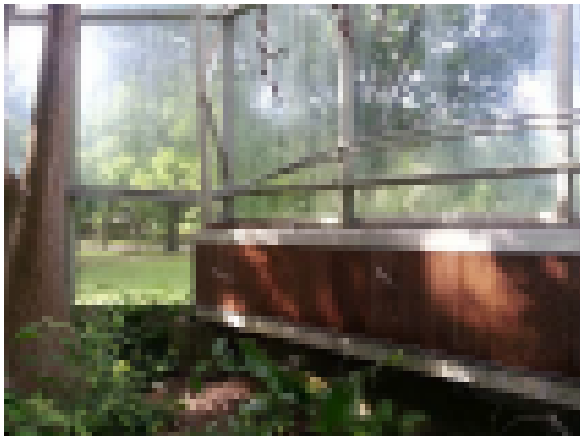
Unsupported Raceways

Replace corroded raceways and associated conductors inside the Conservatory with raceways suitable for the high humidity, high corrosion environment. Existing raceways are supported insufficiently. It is recommended to support the raceways per National Electric Code and secure firmly to structure.

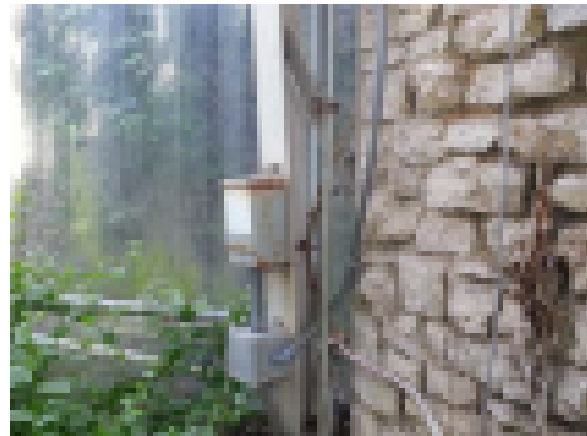
Corroded Devices and Raceways

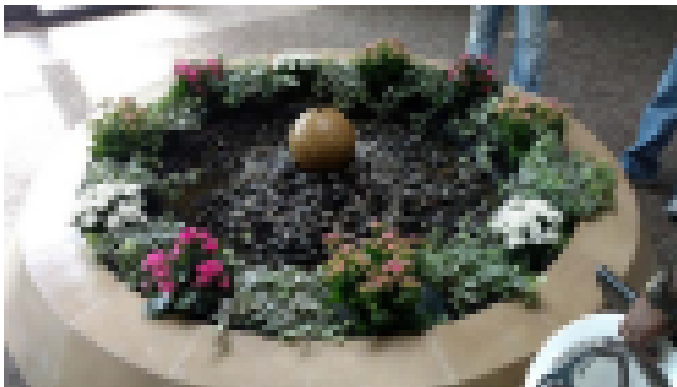
Leonhardt Lecture Fountain

The water feature in the Lecture Hall has a circular basin with a submersible sump and discharges a low flow of water from an orifice in a decorative stone sphere. The basin is filled with river rock. The nozzle for discharge should be replaced, the river rock should be removed, and grating should be installed for better pump function, ease of maintenance, and improved aesthetics.

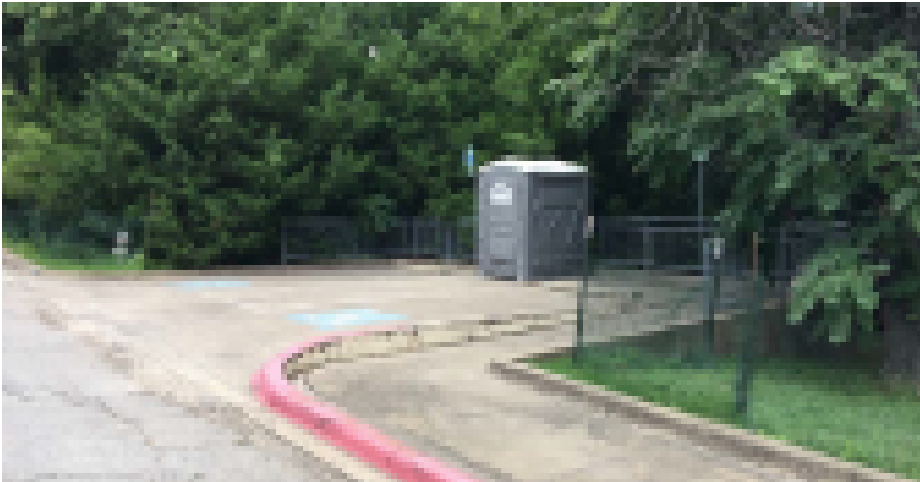
Handicap Parking

The accessible route from the handicap parking to the Texas Native Boardwalk area appears difficult to negotiate. This route needs to be reevaluated. Additionally, drainage is directed into street rather than into landscape behind the parking. Recommend storm/surface drainage to be re-evaluated with new construction of Old Garden Road.

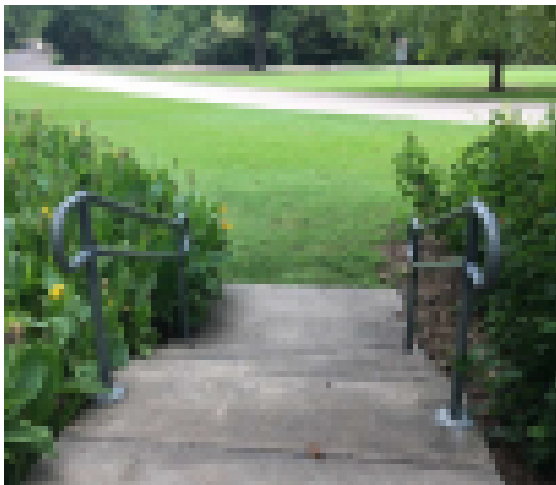
Concrete Stairs

Concrete stairs with handrails currently connect the Boardwalk area to the North Vista lawn. A connecting concrete pathway should be installed from the base of the stairs to Old Garden Road connecting the base of the stairs to the intersection of Old Garden Road and Rock Springs Road.

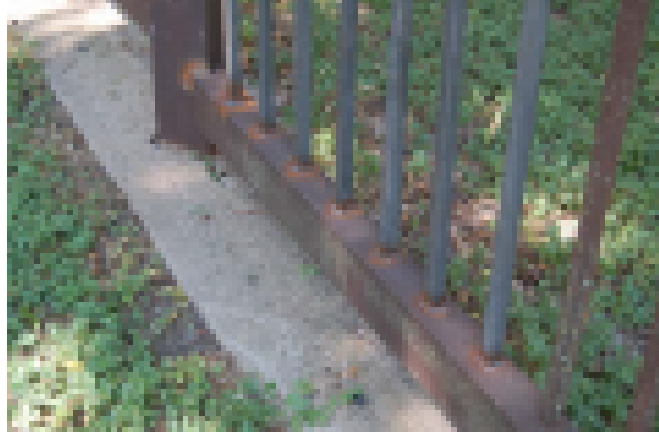
Perimeter Fence Rust

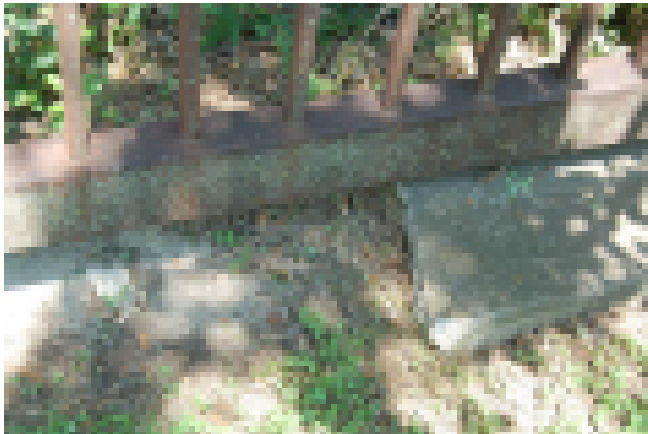
Concrete Mow Strip Damage

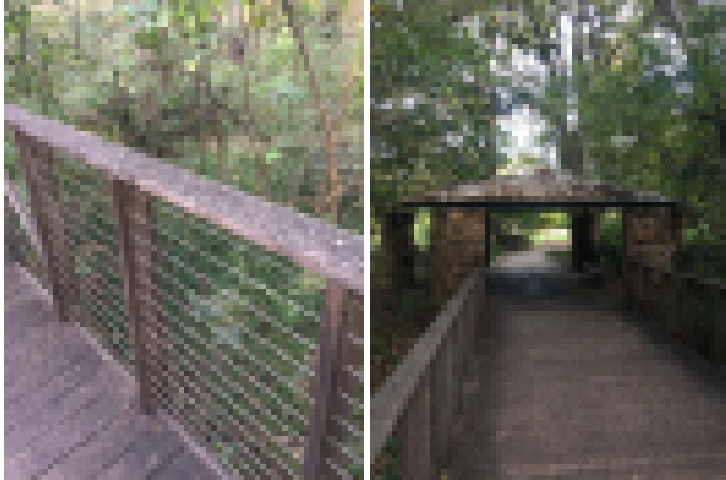
All exposed wood finishes of the elevated Boardwalk are worn due to weather exposure and natural debris. The entire exposed wood framing has faded to its natural patina and surfaces need to be cleaned to keep dirt, debris and natural substances such as sap and scaling from plant life from limiting the usefulness of the wood. The wood should be swept clean and lightly scrubbed with a mild hardwood cleaner and rinsed thoroughly with light water pressure. If retaining the original color and finish is desired, after cleaning the wood surfaces, a UV protectant should be applied.

Guardrail Weathering

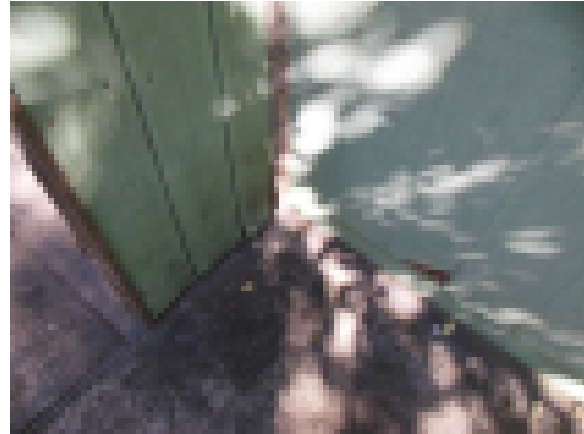
Siding in Disrepair

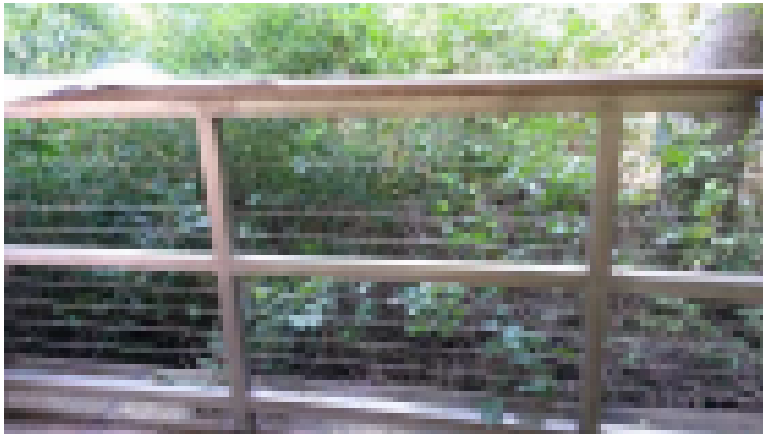
Boardwalk Guardrails

Many of the bolts and nuts connecting the diagonal braces to the vertical posts of the guard rail frame were loose. In addition to the loose nuts, one location was found where the nut for the bolt was missing and another location where the bolt was missing. All bolts should be tightened and nuts secured. Any missing bolts or nuts should be replaced.

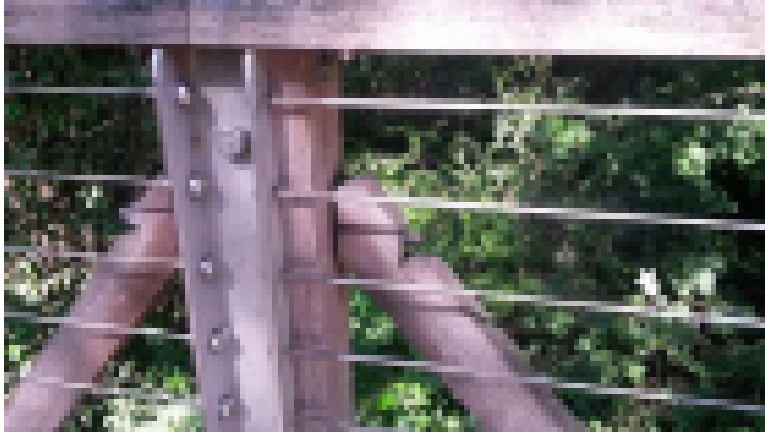
Loose Cross Bracing

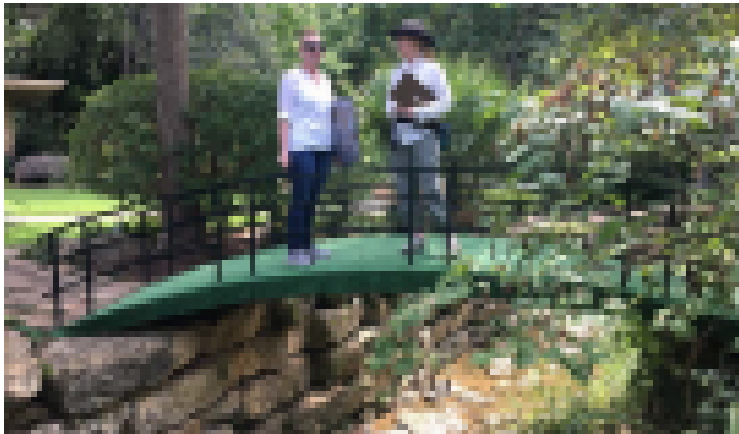
Existing Pedestrian Bridge

The small pedestrian bridge connecting the Texas Garden Clubs building with the grove should be replaced. The railing and slopes are not compliant with current building code / accessibility standards and the artificial turf is slippery when wet. This bridge should be replaced with a new bridge that meets current standards.

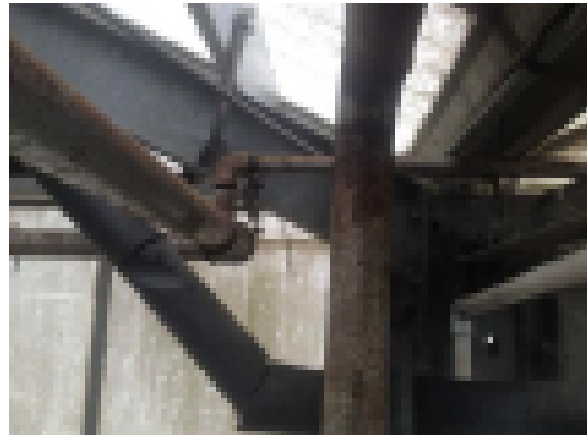
Two gas-fired units should have belt guards on the fans and unit heaters show signs of rust. Gas piping within the Greenhouse is rusted. It is recommended to replace unit heaters and to clean and paint the natural gas piping. Costs for replacement of these heaters are included in the Greenhouse Items.

Rusted Natural Gas Piping

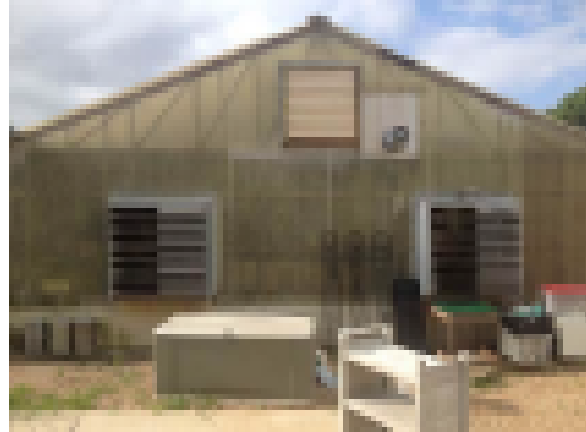
Flue Clearance to Intake

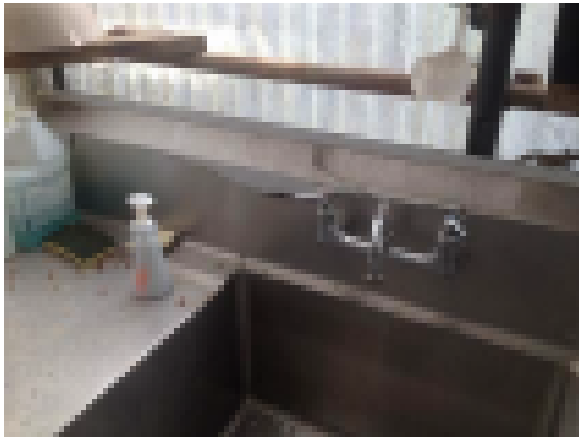
The sink's protective finish is peeling and shows deterioration. Pricing for replacement of this item has not been provided as the recommendation is for total facility replacement.

Peeling at Sink

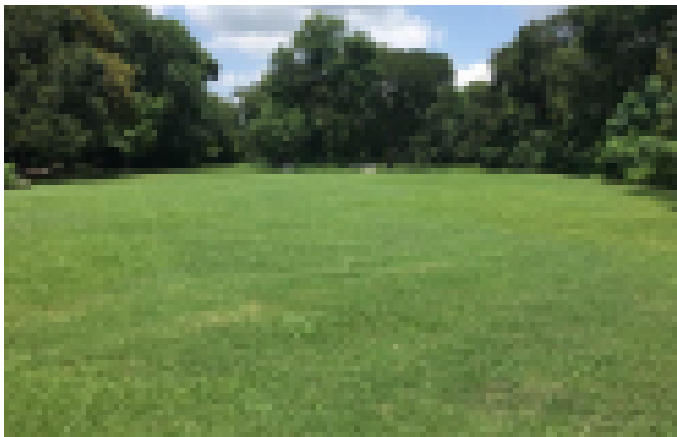
North View From Approximate Stage Location

The North Vista lawn is elevated above the adjacent grade impeding the drainage patterns from West to East. Over years, this lawn has become compacted and worn resulting in localized puddling. Over time, staff has installed area drains to alleviate localized drainage issues. However, after rain events or heavy use, the lawn in the North Vista still sustains visible wear such as rutting, standing water and muddy areas.

The entire lawn and soil beneath it should be excavated and reconstructed using a structural soil that is free draining and more capable of supporting the weight of heavy foot traffic and occasional service vehicle use without creating ruts or other damage. This construction would be similar to an athletic field, and would also include a subsurface drainage system to evacuate water. Additionally, surface runoff upstream of the lawn will need to be collected into area drain inlets and connected to a storm drainage system outfalling to the creek. Reconstruction would include installing new sod and irrigation system modifications (new heads, etc.).

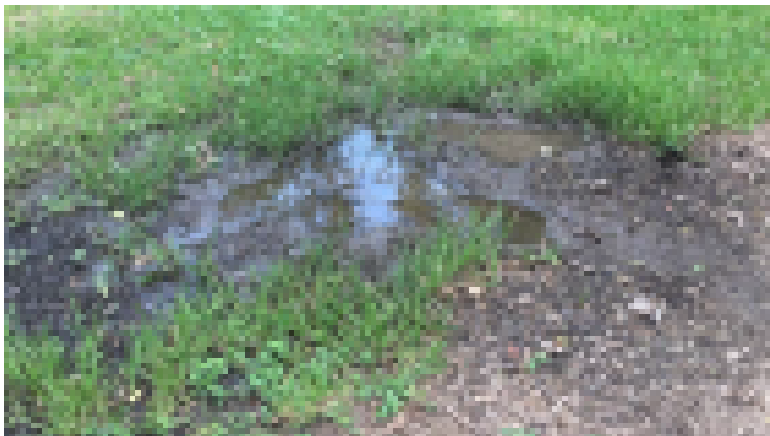
Standing Water / Muddy Areas Due to Wear and Lack of Positive Drainage

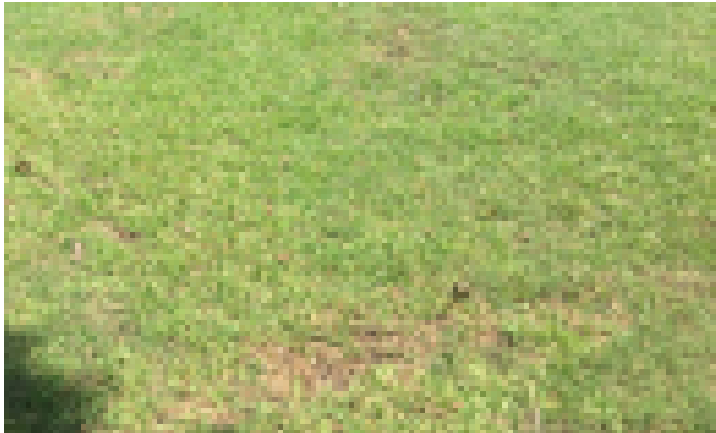
Worn Lawn Areas Due to Foot Traffic and Poor Drainage

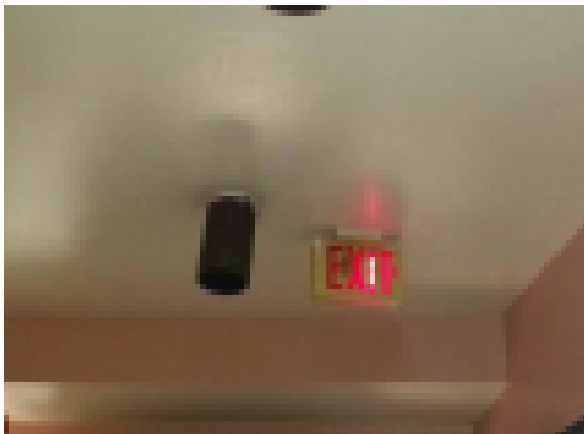
Exit Light Needs Replacement

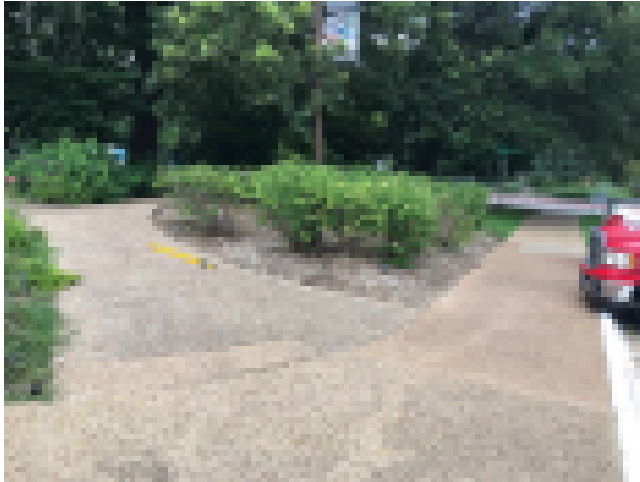
Slopes Exceed Allowable Maximums

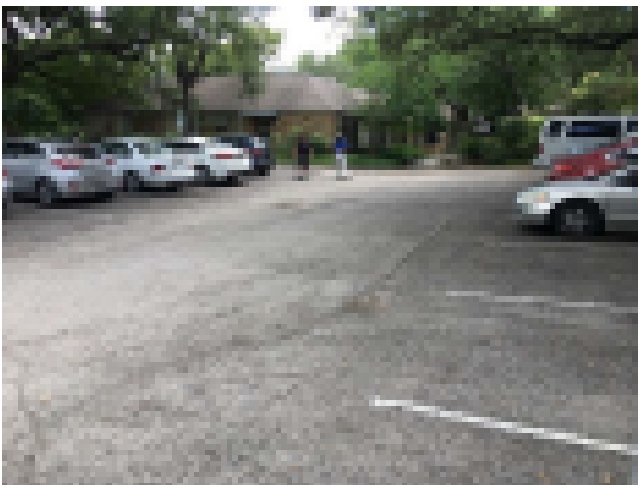
Asphalt Parking at Rear of Gardens Restaurant

The surface of the asphalt parking lot behind the restaurant is in disrepair. This lot should be replaced with a new concrete parking lot consistent with other new pavement in the Botanic Garden.

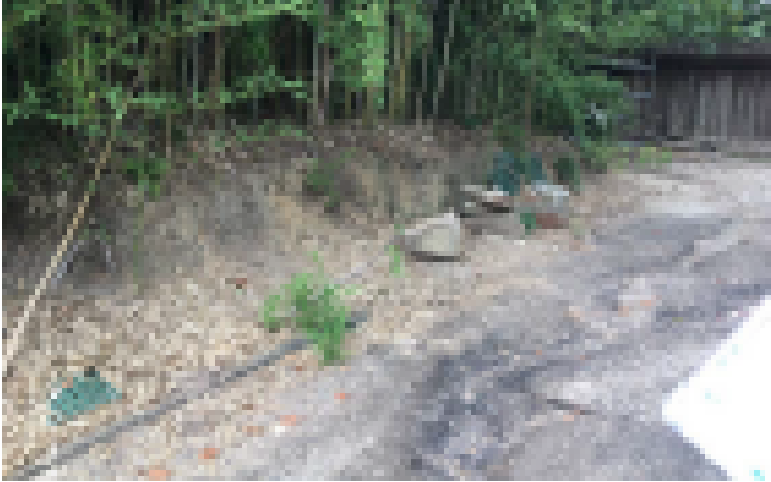
Slope Open to Erosion and Bamboo Growing with No Containment

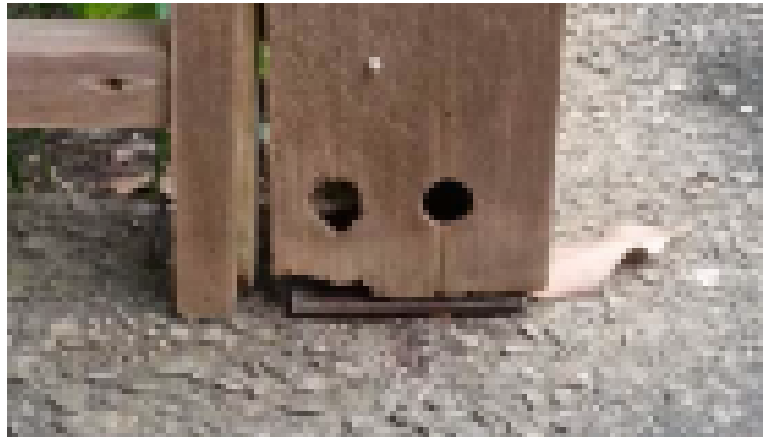
Deteriorated Post

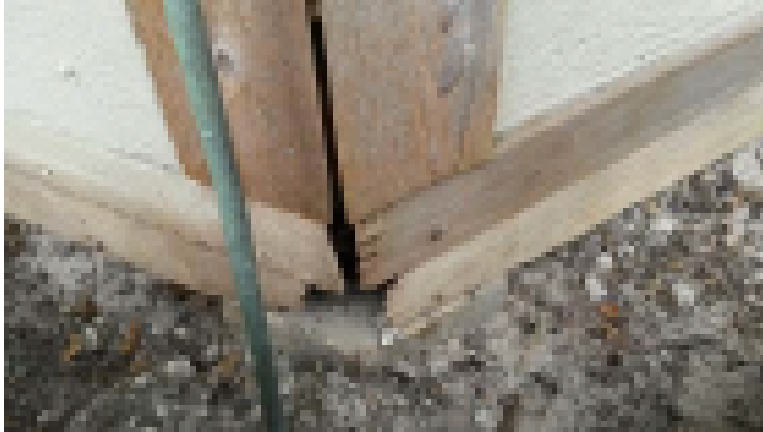
Trim in Disrepair

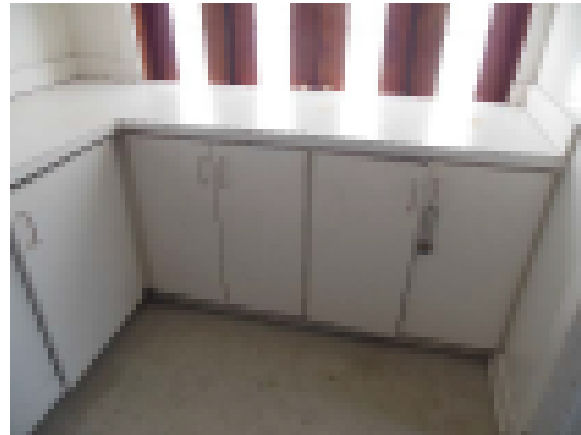
Damaged Millwork

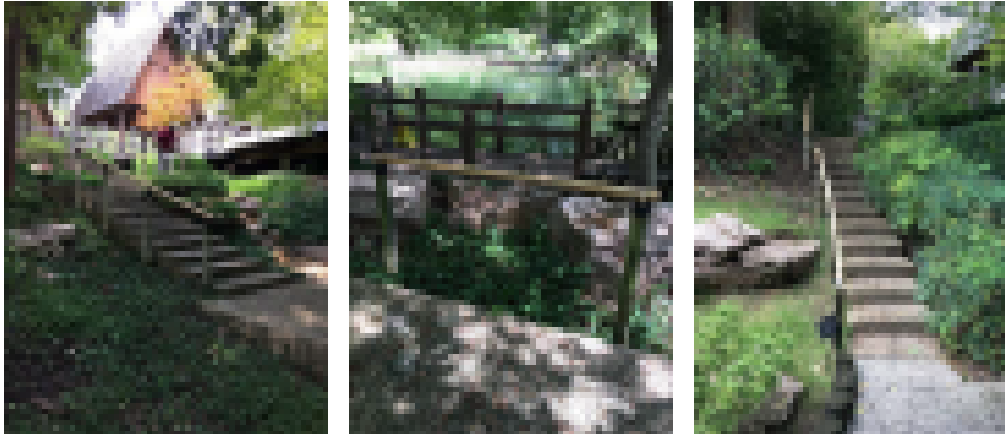
Visitors approaching the Pavilion area from the koi pond navigate a steep slope by using a series of exposed aggregate concrete steps and landings with decorative bamboo railing. These steps and landings do not have compliant handrails or guardrails. These should be installed in compliance with current standards.

Non-compliant step railings and landing guardrails

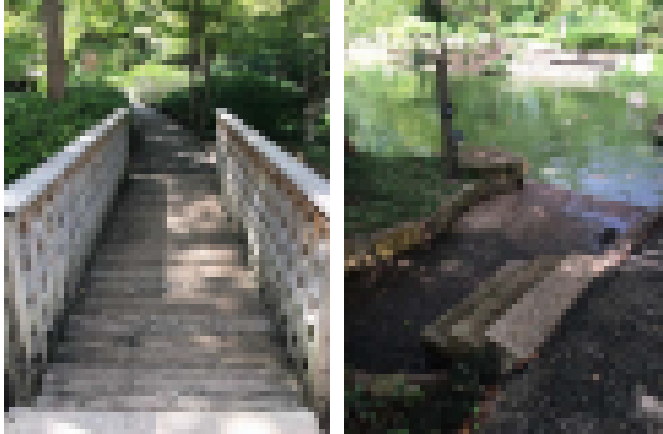
The koi feeding terrace is non-compliant and should be reconstructed with new handrails, steps, and a new landing.

Narrow bridge at koi pond Drop off and steps to feeding area

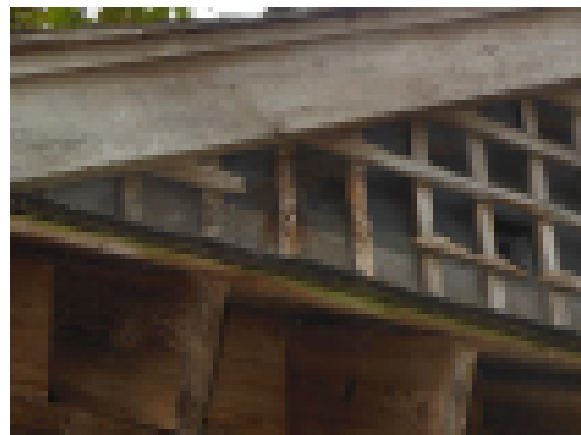
Damaged Trim

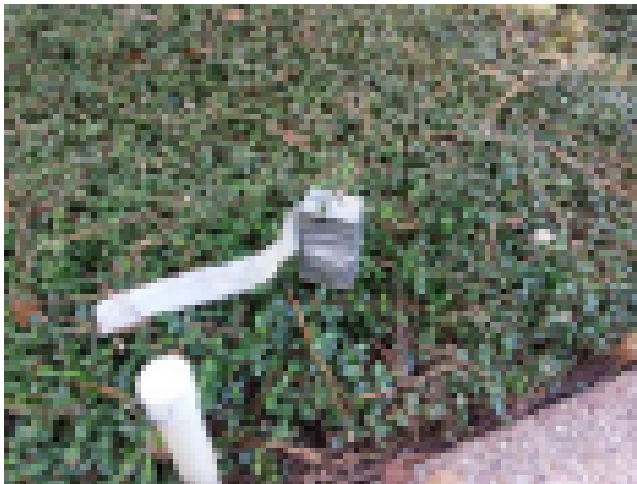
Damaged Receptacle

It is recommended that the convenience receptacles close to the Pagoda are replaced.

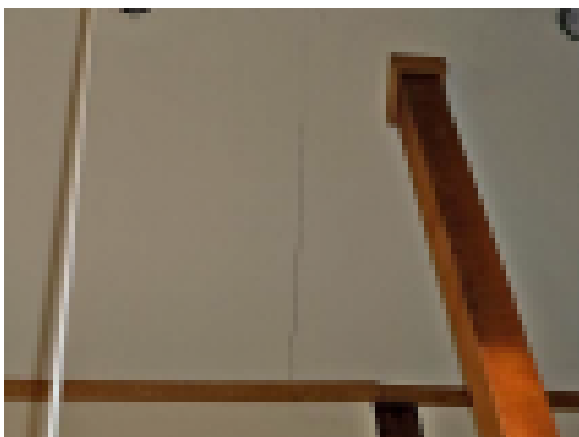
Minor cosmetic distress was observed on the interior finishes with a ceiling crack over the front sales counter and a drywall crack at the south exterior door. It is believed that the ceiling crack was the result of differential deflection of adjacent joists with the roof joists to the left of the crack having a much smaller span than the roof joists to the right of the crack. It is believed that the wall crack was caused by cutting in for the door into what was once a solid wall. This distress is not structurally significant. Costs for patching these items are included in the Architectural section.

Ceiling Crack Over Sales Counter

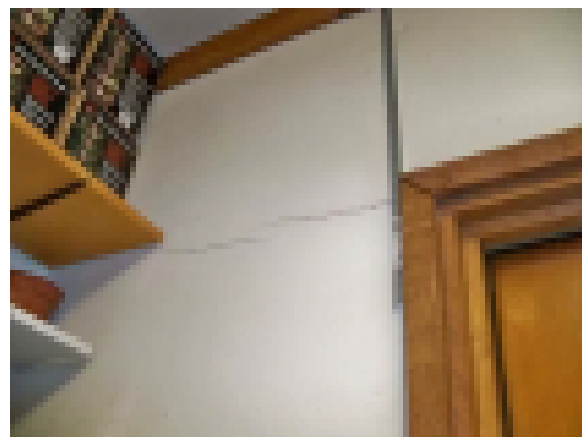
Drywall Crack at South Exterior Door

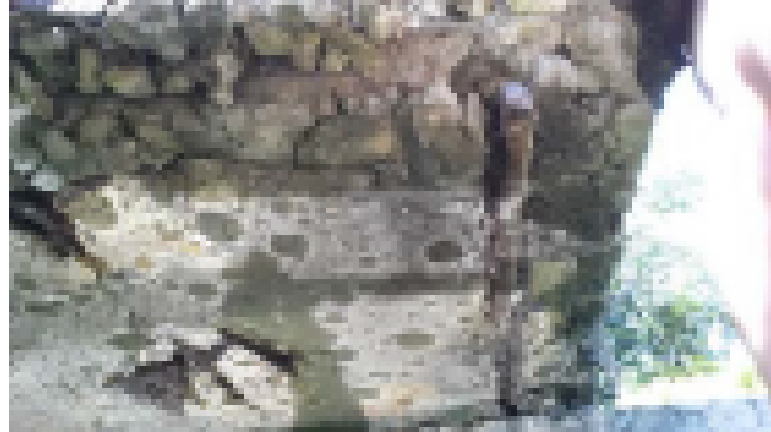
Concrete Spalling and Exposed Steel

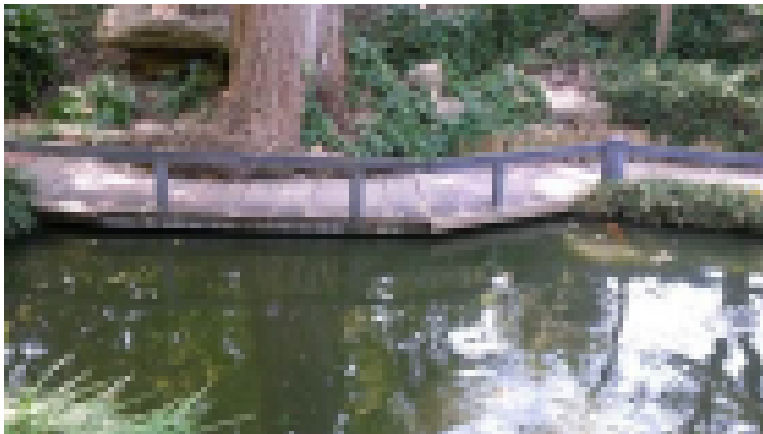
Wood Plank Bridge

Bridge (map location Grid J22): This wood plank bridge is supported along its outer edge (water side) by a steel beam. The inboard edge is most likely supported on a concrete retaining wall (although this element was not exposed to view). The bridge appears to be in relatively good condition, although we recommend cleaning and painting the steel structure to extend its useful life.

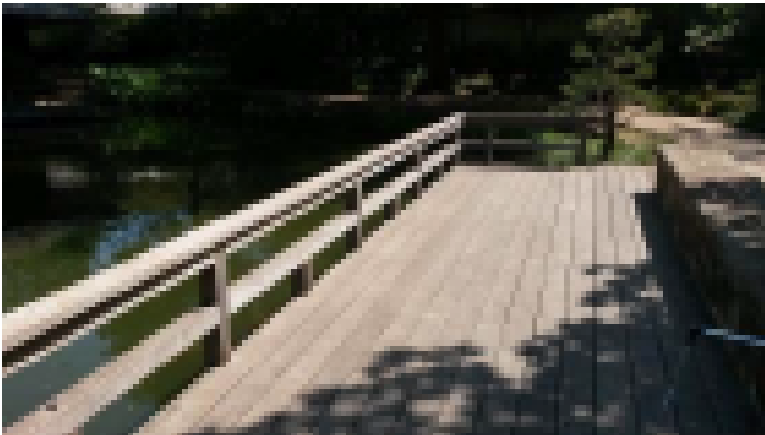
Wood Framed Overlook (map location Grid L21): This overlook is positioned across from the Teahouse. It is wood framed and supported on concrete piers at water side and concrete retaining walls at the earth side. The structure is in good condition.

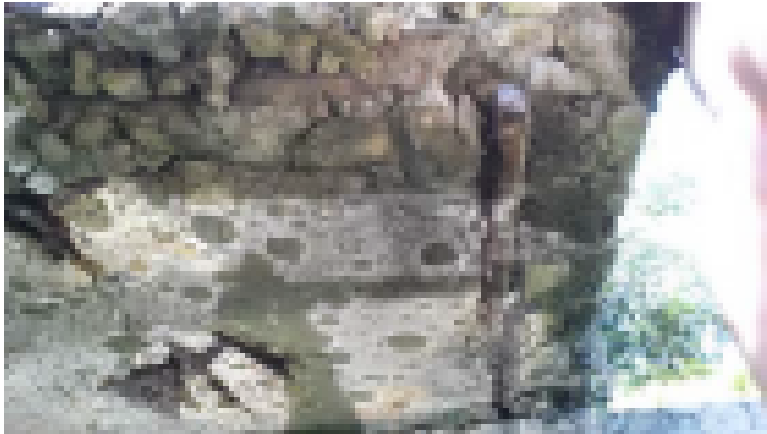
Concrete Spalling and Exposed Steel

Remove any loose, delaminated concrete and all concrete within $\frac{3}{4}$ " around an exposed reinforcing bar. Wire brush clean rebar to white condition. Coat exposed reinforcing bars and concrete surface to be patched with Sika Armatec 110. Patch concrete with Sikatop 123 Plus.

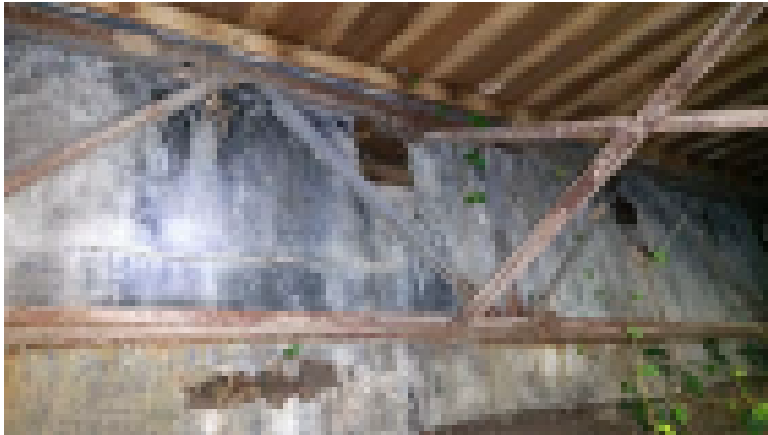
Bridge (map location Grid F24): Mild rusting of bar joints and bridging was noted. While this is not a current life safety issue, it is recommended that the steel structure be cleaned and painted to extend its useful life. We anticipate that the cleaning and painting will require removal and replacement of wood skirting.

Steel Requiring Painting

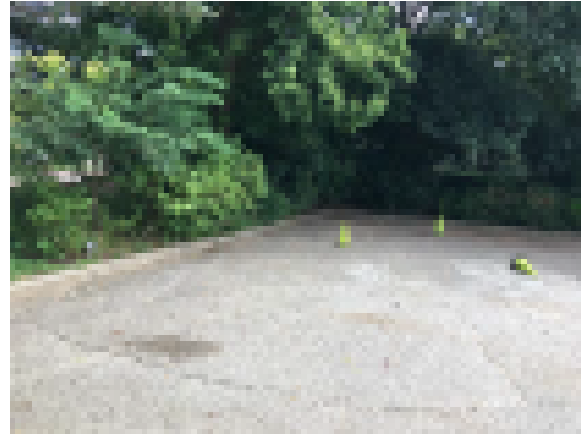
Drainage Ponding in Southeast Parking Lot

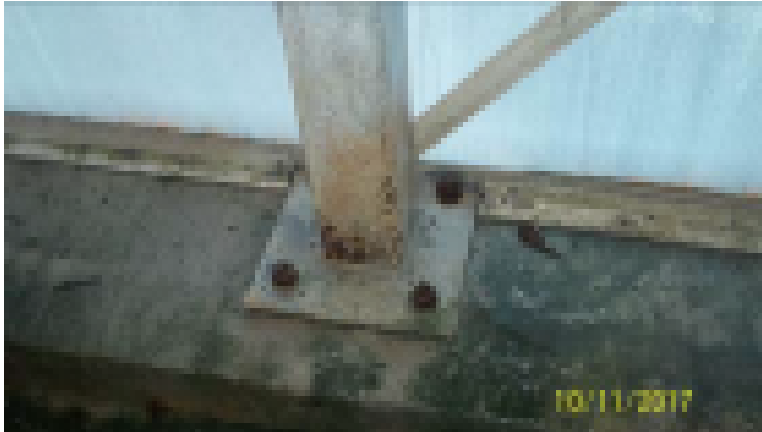
connecting the X-Braces to the columns were drilled in after the columns had been fabricated and galvanized, interrupting the columns' zinc protection layer and allowing a direct path for moisture to collect within the column, resulting in rapid deterioration of the steel at the column. It is recommended that new steel sleeves and baseplates be fabricated to replace the existing baseplates and rusted base of columns. The new baseplates should be bolted to the foundation with new stainless steel epoxied bolts. The X-brace plate should be welded to the new sleeve and re-painted with a zinc rich galvanizing paint.

Deterioration of Steel

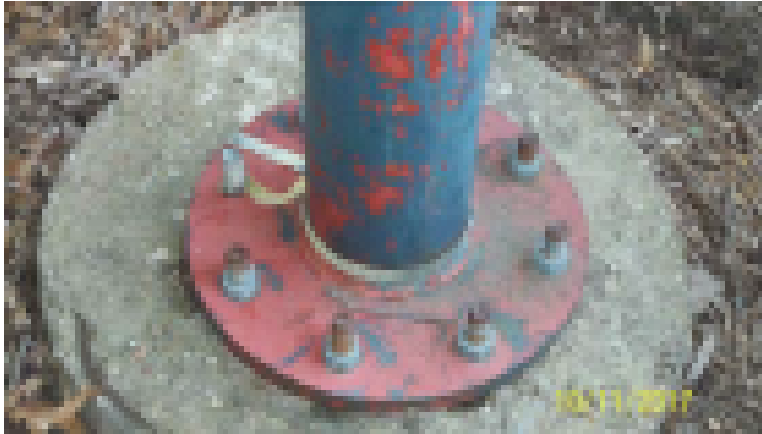
Missing Nut

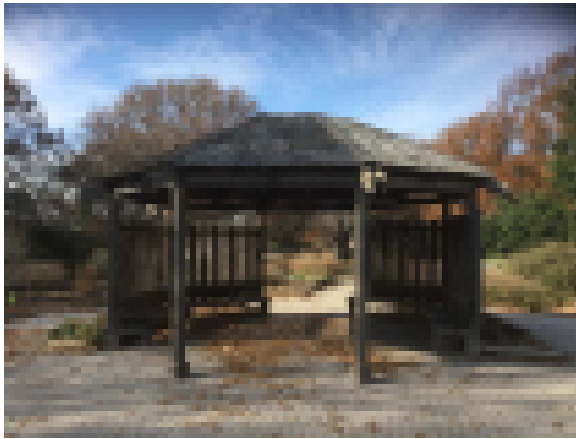
Trial Garden Gazebo

The wood pavilion structure at the center of the Trial Garden is in fair condition but is nearing the end of its useful life and should be replaced.

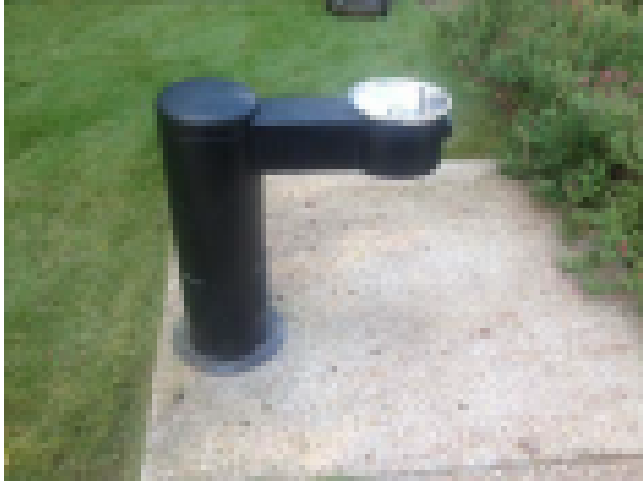
The drinking fountain in the Garden area was not working as there was no water flow at the bubbler. A service call is recommended to determine the reason for no water flow.

Drinking Fountain with No Water

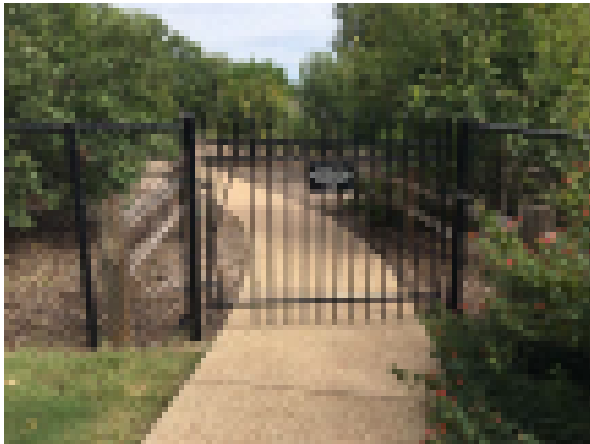
In addition, each of the two entry gates to the Backyard Vegetable Garden have damaged pickets. It is recommended to replace these gates.

Damaged South Entry Gate

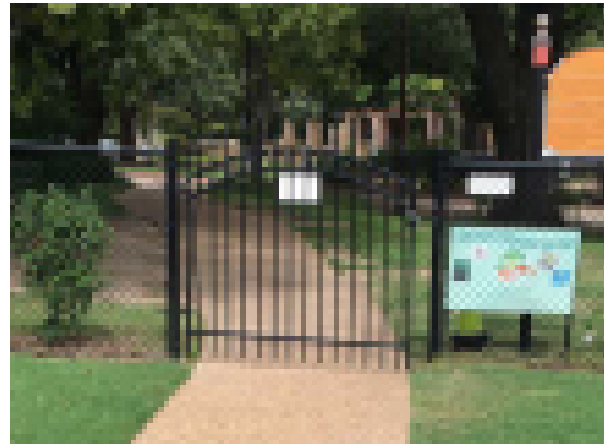
Damaged North Entry Gate

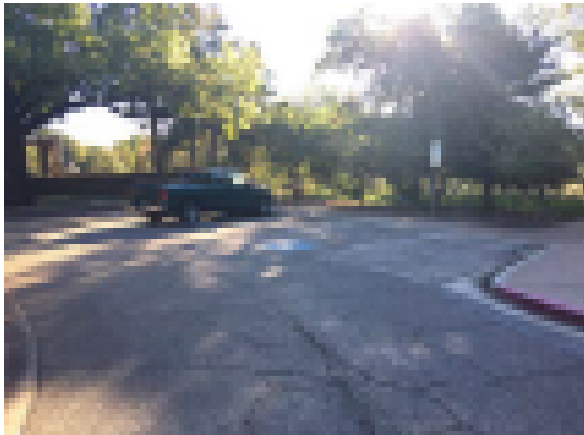
The asphalt parking lot is intended to slope toward the inlet in the southeast corner of the lot. The degraded asphalt surface and previous modifications have resulted in standing water after rain events. The asphalt should be resurfaced when Rock Springs Road is reconstructed. The new paving should be installed to promote proper drainage to the existing inlet and the parking spaces should be restriped. Additionally, all pedestrian curb ramps should be reconstructed to meet current accessibility standards.

Degraded Asphalt Paving

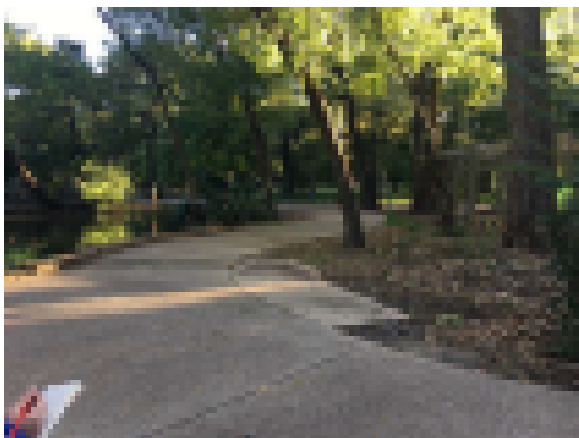
The Rock Springs Garden has recently undergone a significant renovation including new walks, walls, structures, water features, irrigation and plantings. These elements are in good condition; however, the low-lying area is prone to flooding and holding water (up to 6" or more) for several days after significant rain events.

Low Lying Area Prone to Flooding

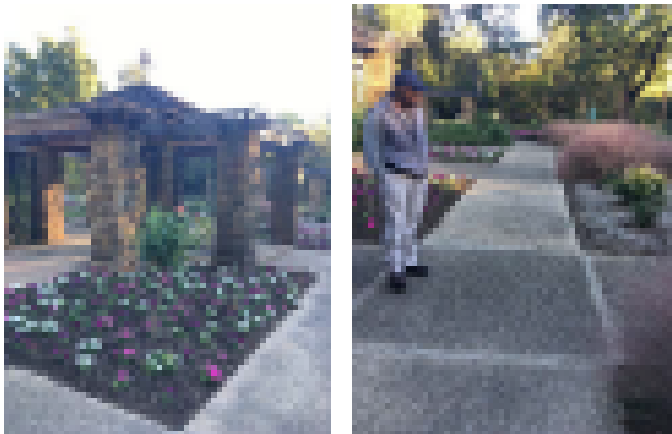
The Oval Rose Garden is situated in a low area of the garden and the planting areas include approximately 24” of prepared soil over the native material. This combination results in wet soil and nuisance water on paving that creates maintenance and plant health issues even in minor rain events. A landscape drainage system should be installed in all the beds so that they drain to the adjacent creek. When constructing the drainage system, fine grading will be needed in the planting areas to create swales that direct water away from garden structures.

Slow Draining Planting Area Low Walks Hold Water in Rain Events

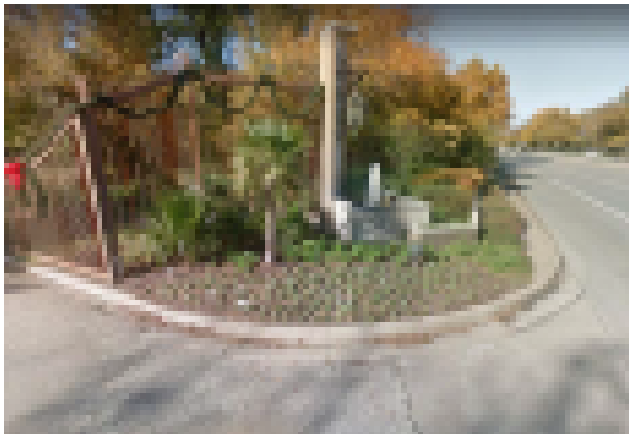
Fountain at South Entry

The fountain at the south entrance consists of two small basins with each with a submersible pump and a small spray that flank the entry road. Both basins leak, the leaks in this fountain will need to be identified and repaired with a combination of structural modifications and waterproofing measures. The basins shall be reconstructed to match the current appearance and the plumbing and electrical equipment upgraded to meet current requirements.
