Facility Assessment
Fort Worth Botanic Garden
3220 Botanic Garden Boulevard
Fort Worth, Texas 76107

August 31, 2018
PROJECT NO. 16-1031.00

Assessment – Fort Worth Botanic Garden

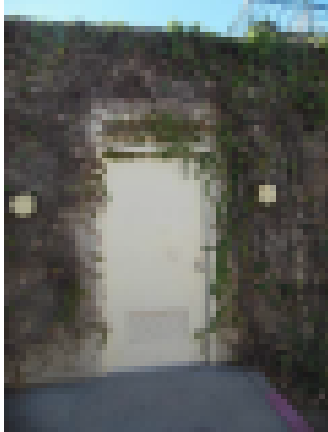
Most of the interior doors inside the Garden Center and a few exterior doors have knob type hardware which is no longer compliant with current accessibility codes. It is recommended to switch all existing knob type hardware to lever type hardware.

Exterior Knob Hardware

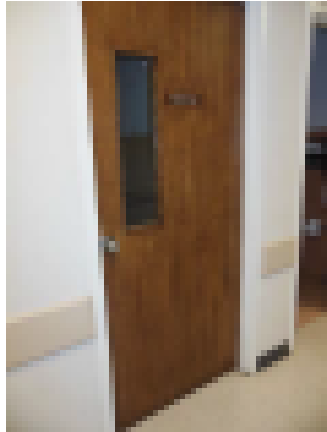
Interior Knob Hardware

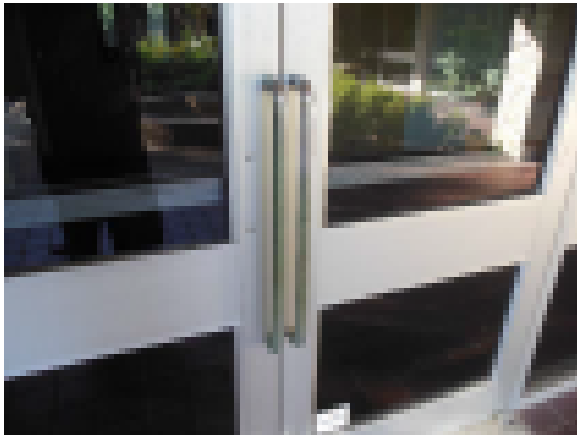
Exterior door pulls at just over half of the exterior doors have finishes that are beginning to deteriorate and should be replaced. A door at the adjacent maintenance building is in a state of severe disrepair and should be replaced.

Exterior Door Pulls

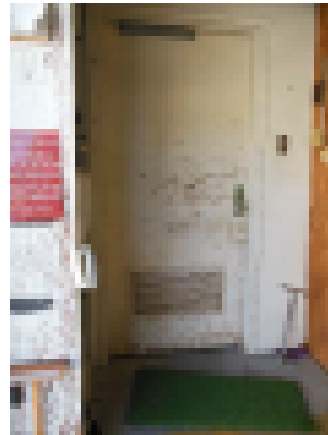
Damaged Door

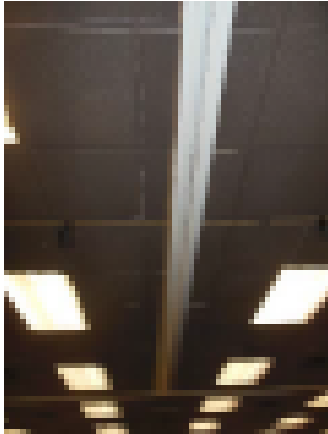
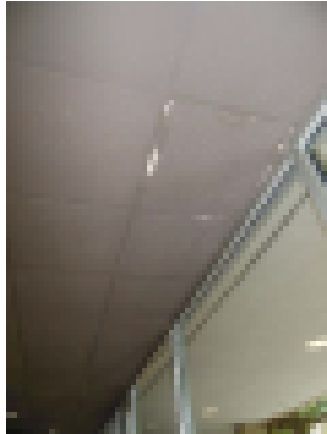
All of the meeting rooms inside the Garden Center currently have vinyl wall covering on the walls and some ceiling soffits. This vinyl wall covering is peeling off in many places and at the exterior walls it poses a risk of water entrapment due to the vapor impermeability. It is recommended to take off the vinyl wall covering and utilize a paint finish. The Oak Hall and the hallway adjacent to this room have ceiling tiles that were painted in place. This paint is becoming damaged and moving thus exposing the white tile beneath. It is recommended to replace these tiles with pre-finished thru color tiles that will not lose their color due to damage or movement shifts.

Damaged Ceiling Tiles

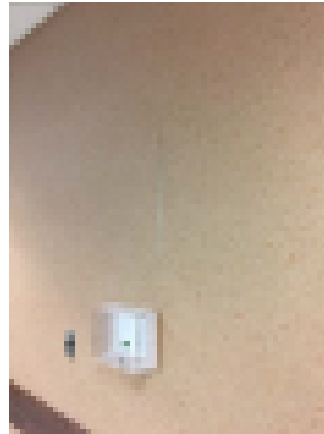
Peeling Vinyl Wall Covering

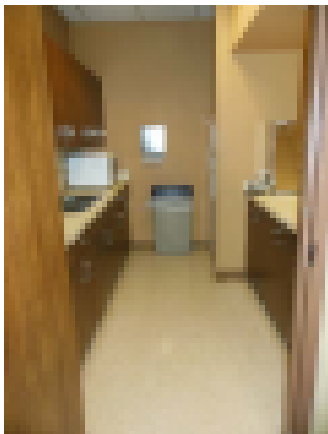
The two small serving areas that are adjacent to the Camellia and Azalea meeting rooms have millwork with finishes that are peeling and chipping away. The counter is too high to meet accessibility standards at both areas and the sink doesn't have the required skirt for knee and toe clearances. It is recommended to replace all of the millwork in these areas with new compliant casework.

Serving Area

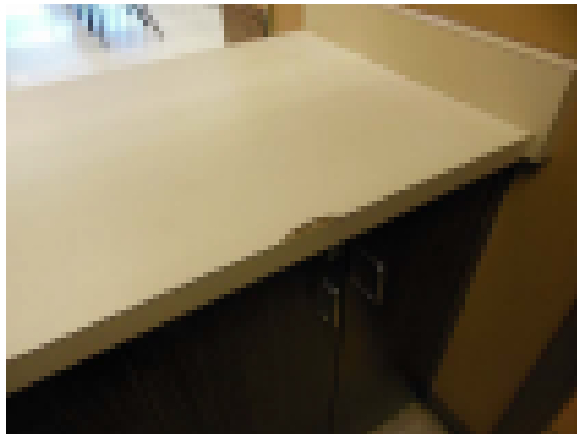
Serving Area Countertop Damage

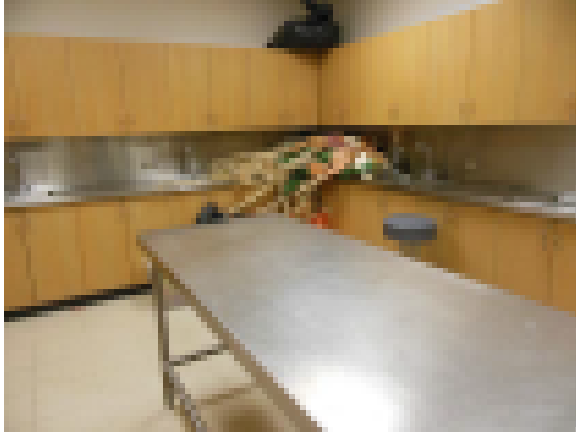
The cabinet face finish on the millwork in the Prep Room area is beginning to swell and roughen and should be sanded and re-finished. One section of the millwork should be replaced at an accessible height of 34". A skirt for knee and toe clearance should also be included at a sink in this area as none of the millwork in this area is accessible. The stainless-steel counters themselves are in good shape and could be re-used. The millwork in the Employee Breakroom is also too high for TAS compliance. The bottom cabinets should be replaced with an accessible countertop and a skirt should be added at the sink.

Prep Room Millwork

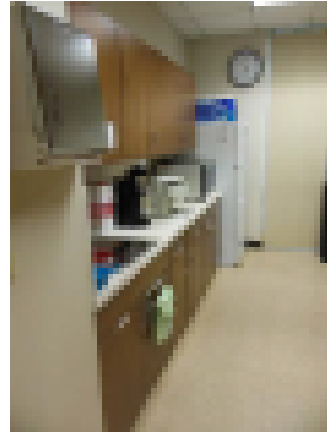
Break Room Millwork

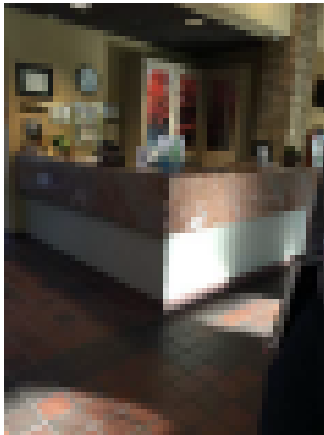
The two reception counters inside the Garden Center (one at the front entry and one at the booking area) are lacking a lower accessible service area and need to be modified to have an area at least 36" long that is 34" high.

Entry Reception Counter

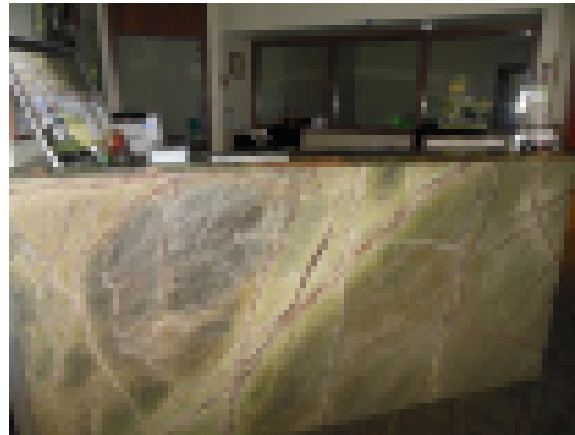
Booking Reception Counter

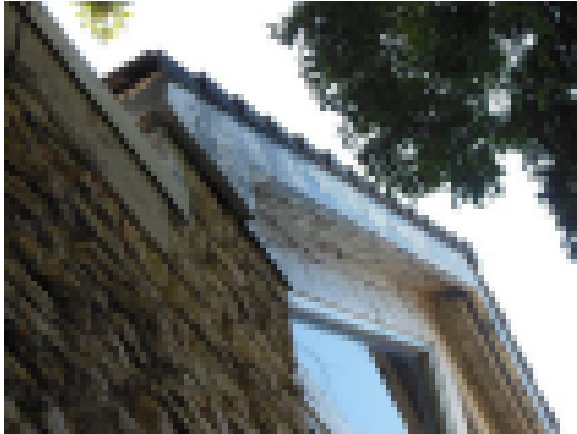
The exterior of the facility is in good condition. The clerestory area that runs north/south through the building has a paint finish over galvanized steel that is peeling off. This paint finish should be removed and repainted with a paint more appropriate for galvanized steel at an exterior condition. There are also a few pieces of trim at these soffit areas that are loose and need to be replaced. Many of the flashing conditions at transitions or capping storefront areas are damaged and should be repaired and/or replaced.

Peeling Clerestory Paint

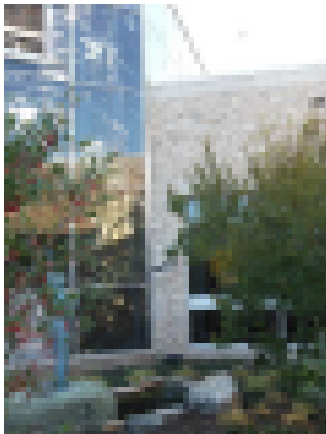
The expansion joints that separate the Garden Center from the Conservatory are in disrepair and should be replaced with new expansion joint filler and backer after removal of any existing jointing. There is a broken skylight at the front entry canopy area that should be replaced.

Expansion Joint

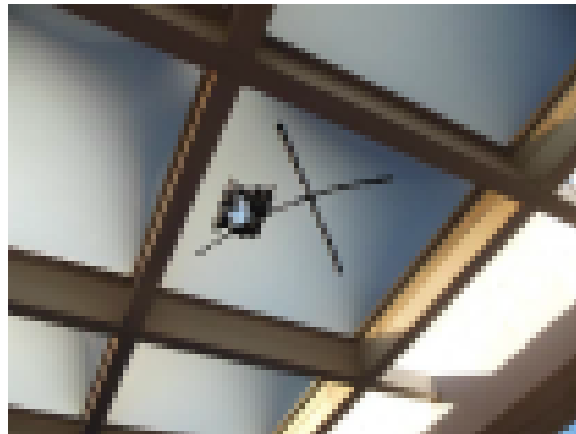
Broken Skylight

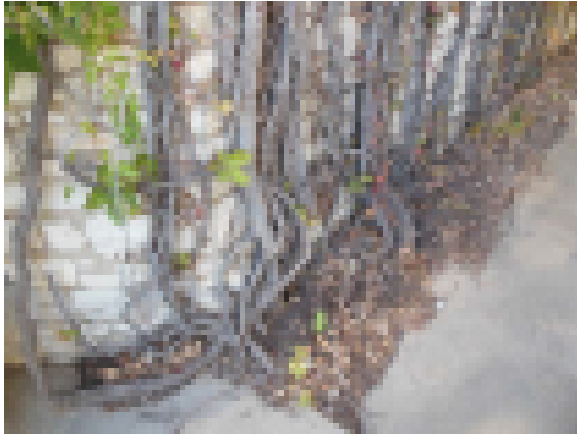
Vines are crawling up the walls at many areas around the facility. Care should be taken to maintain these vines so that they do not mature and break open mortar joints or crawl over parapets. As a maintenance issue, it is also important to note that these vines constitute displayed plant life and although our recommendation would typically be to remove these vines, we understand the desire to keep intact therefore no price for removal or remediation has been provided.

Wall Vines

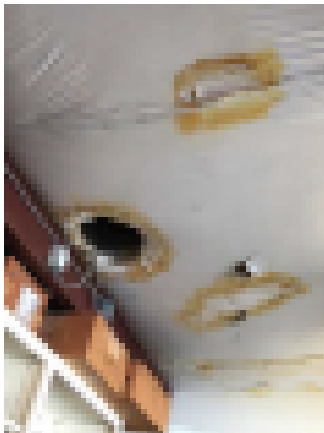
The maintenance building behind the Garden Center is in need of repair. The metal 'R' panel roof leaks and has damaged much of the exposed roof insulation on the inside. The roof has been damaged by multiple hail events and age. It is unknown when the last time the roof was replaced on this facility. This roof and the insulation should all be replaced. Care should also be taken that the vines growing on the walls of this facility do not overtake the parapet as this could exacerbate any roof leak issues.

Damaged Insulation

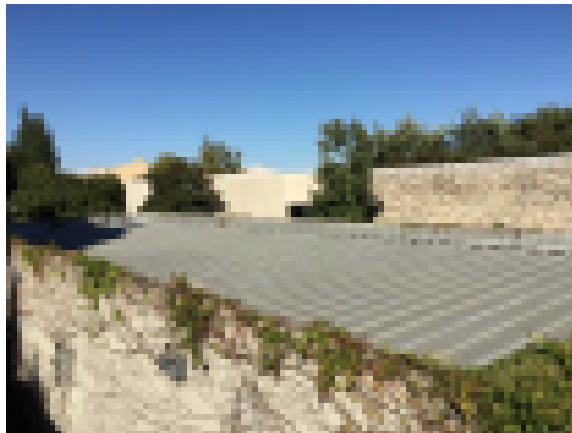
Damaged Roof and Parapet Vines

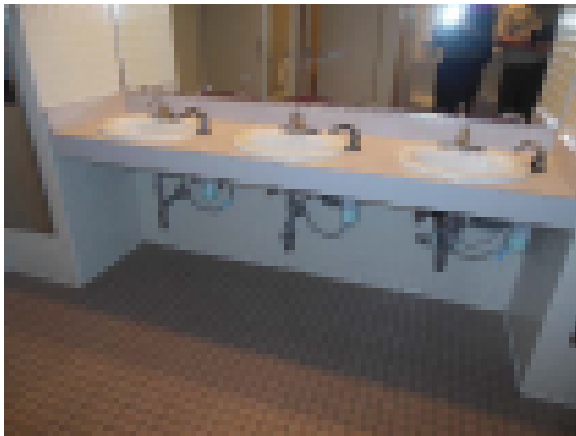
One set of restrooms inside the Garden Center next to the bride’s room are close to accessible compliance. All of the other restrooms in the facility need to point patrons to these accessible restrooms with signage. These nearly compliant restrooms require pipe insulation protection on the exposed pipes under the sink. Most of the drinking fountains in the facility are not accessible and do not meet the height or knee/toe clearance requirements. At least 50% of the fountains in the facility need to be compliant. It is recommended to replace the fountains outside of the accessible restrooms with compliant fixtures in order to meet this requirement.

Missing Pipe Insulation

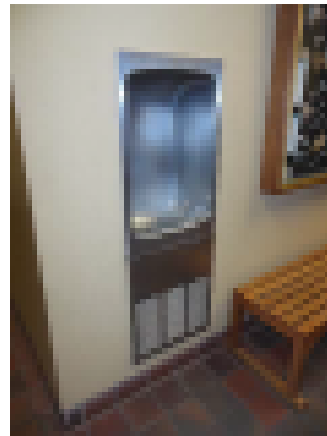
Non-Compliant Drinking Fountain

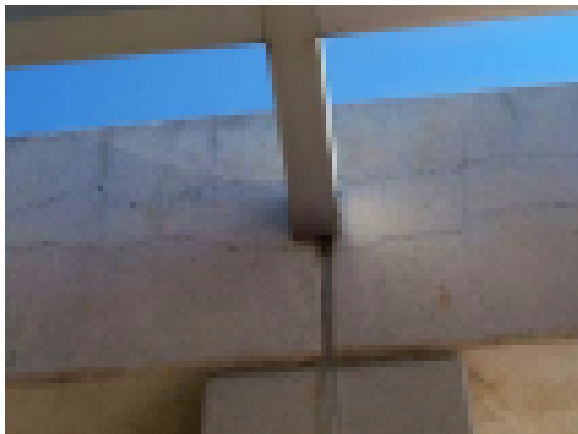
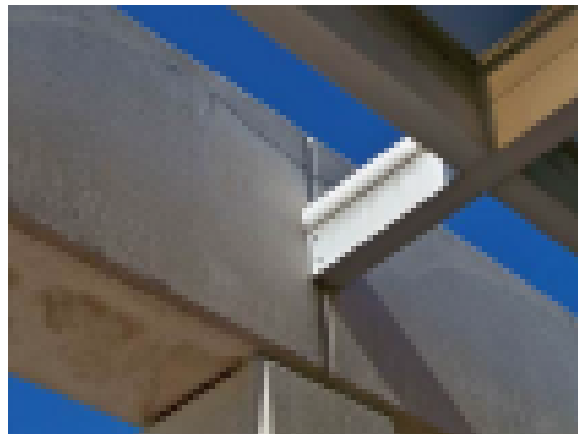
Cracking at Concrete Beams

9. Paint all beams to match existing (this will be required because the patching mortar will not match the existing beams).

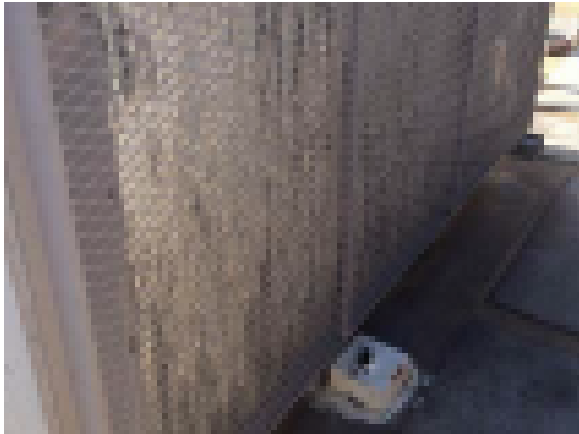
RTU Condenser Coil Damage

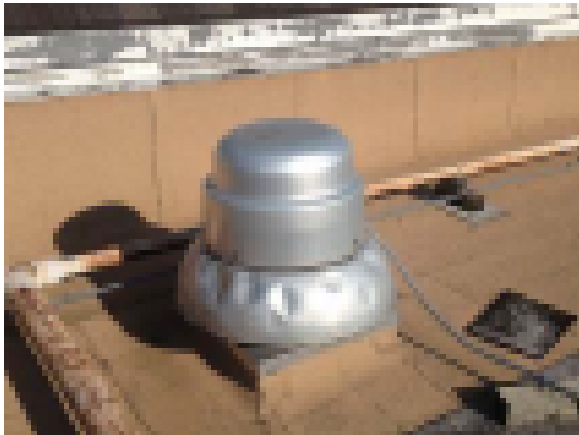
Exhaust Fan Damage

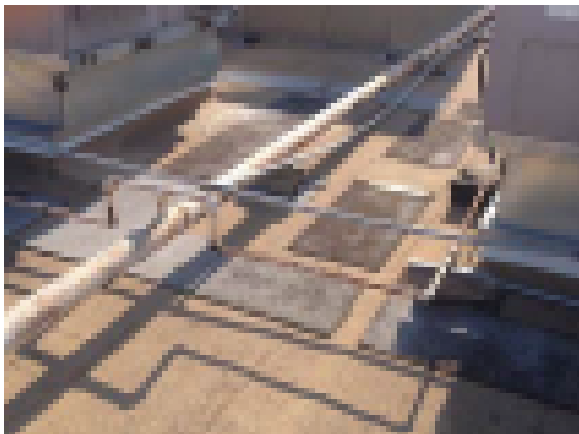
Sagging Condensate Piping

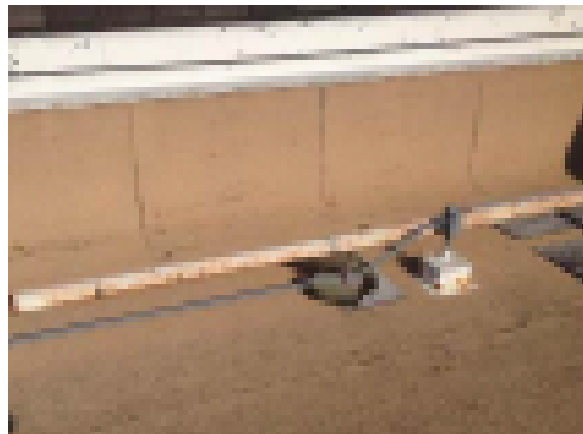
Misaligned Natural Gas Pipe Support

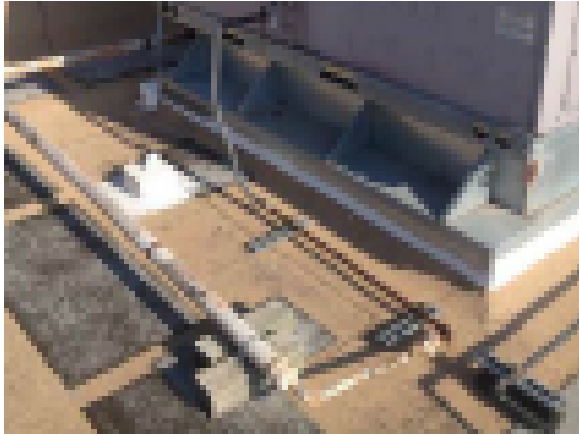
dirt leg installed on the natural gas piping prior to connection to each RTU. There are several locations throughout the facility where ceiling mounted supply air grilles are rusting, peeling paint and should be replaced.

No Natural Gas Pipe Dirt Leg

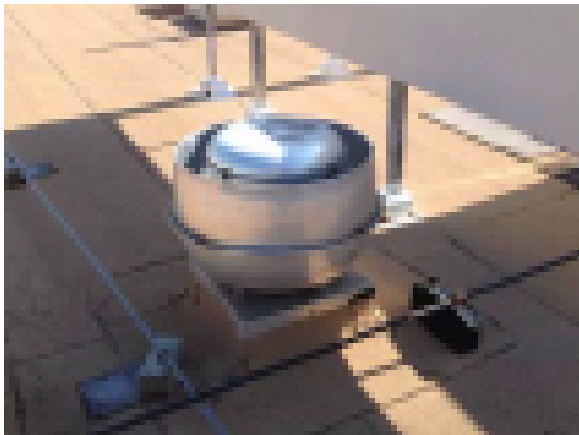
Kitchen Exhaust Fan Does Not Meet NFPA

It is recommended to replace the kitchen exhaust fan since installation does not meet NFPA requirements with exhaust fan discharge distance above the roof and vented curb.

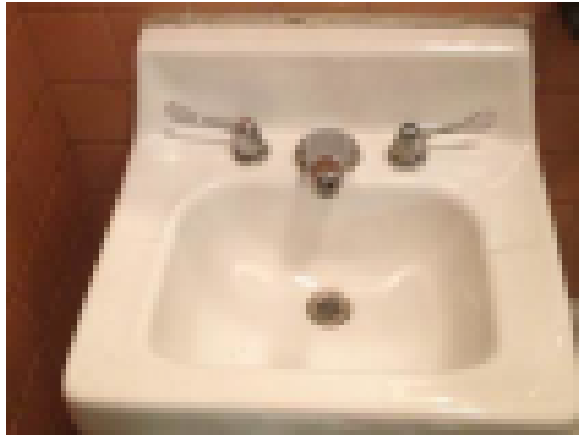
There are several instances in the facility where plumbing fixtures are not operating and faucets are dripping. The pantry area near the Meeting Room has a dripping faucet. Some wall mount lavatories need to be re-caulked and re-hung. Certain floor drains in the restrooms need to be replaced due to damaged covers. It is recommended to repair any damaged fixtures. Current installation does not provide any thermostatic mixing valves for the domestic hot water to provide tepid water to lavatories. It is recommended to install thermostatic valves for each domestic hot water system. These valves can either be point of use or a group type of mixing valve for the Main Restrooms.

Lavatory Caulk

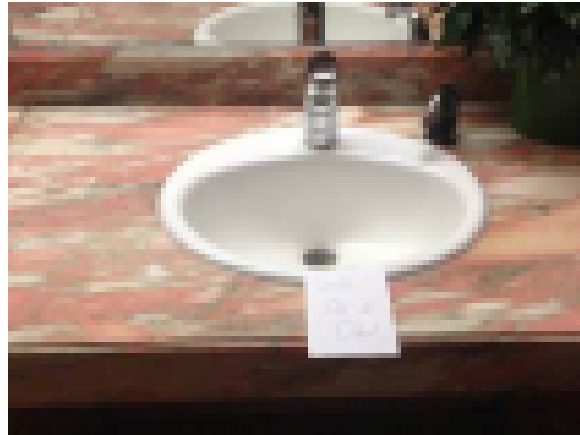
Non Operational Lavatory

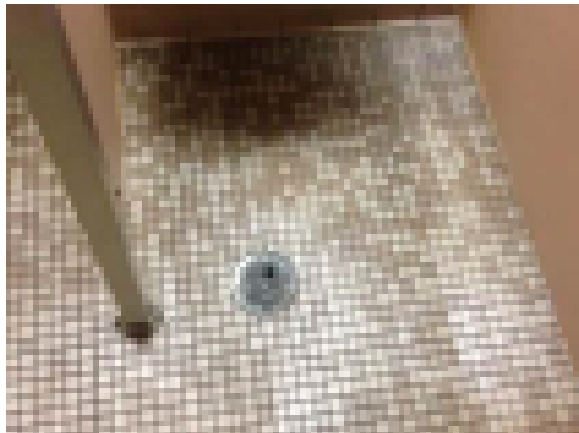
Damaged Floor Drain Cover

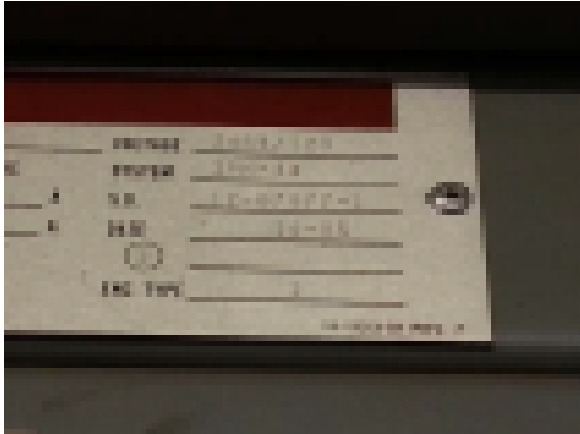
Original panelboards were manufactured in 1985. They are approaching the end of life and the recommendation is to replace them within the next 10 years.

Manufacturing Date of Equipment

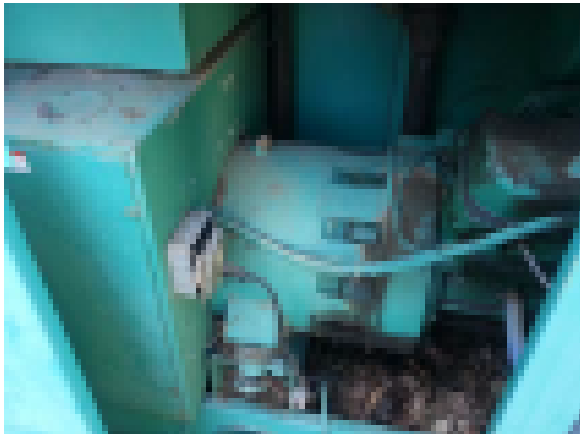
Emergency generator has not been maintained and with reliability unknown, requires replacement. Replace emergency generator and transfer switch.

Generator in Need of Replacement

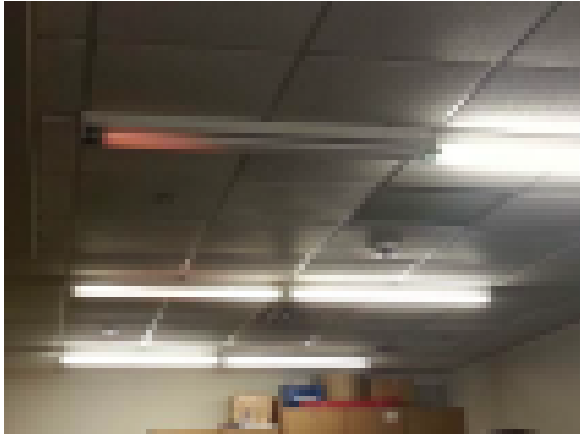
The lighting system requires minor repairs. Replace burnt out lamps, repair malfunctioning fixtures and replace incandescent lamps with LED light bulbs.

Lighting System in Need of Maintenance

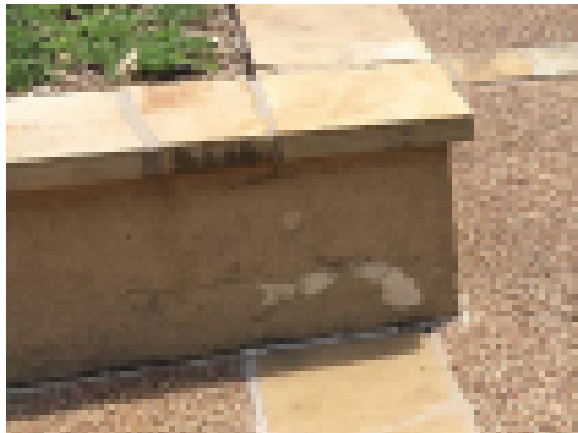
The low planter walls in the plaza have a stone cap and a stucco veneer. In several locations, the stucco is cracking and / or spalling. The concrete pavement around the raised planters in the courtyard has settled. This shift in pavement prevents proper drainage and has caused cracking of the mortar joints in flagstone paving, resulting in uneven walking surfaces, puddling, and rapid deterioration.

Stucco Veneer in Need of Repair

The courtyard paving needs to be removed, and new exposed aggregate concrete pavement with flagstone bands should be installed with appropriate slopes and deck drains that are connected to the adjacent storm drains in the Fuller Garden. The damaged wall areas should be removed / replaced, then the entire wall surface should be prepped, primed and painted.

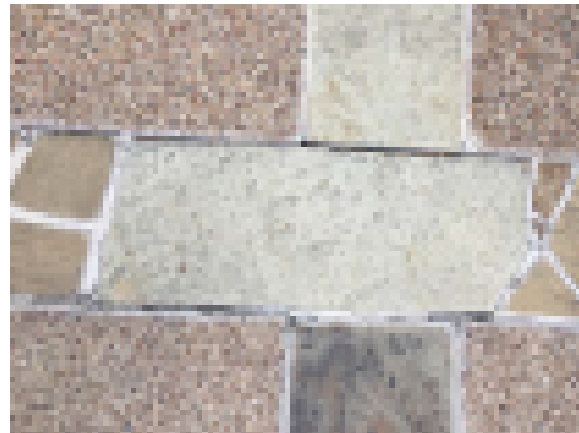
Flagstone Bands with Damaged Mortar Joints

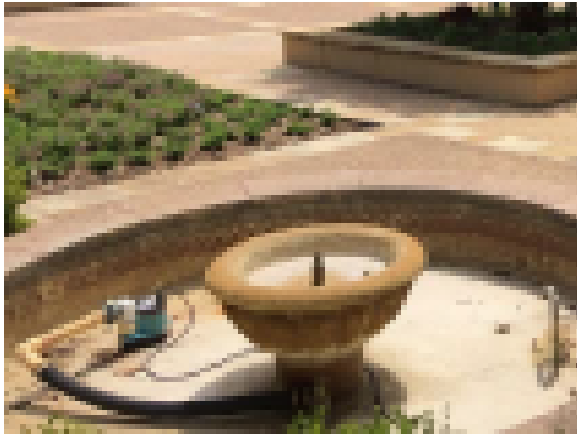
The existing fountain is a circular concrete basin with tile on the side vertical walls and a smaller stone bowl with one single display nozzle. The plumbing and electrical equipment are visible inside the lower basin. Fountain repairs should include replacement of the bubbler fountain nozzle and installation of basin uplighting. The plumbing should be rerouted inside the basin walls, and the electrical junction boxes should be relocated to a more discrete location in an adjacent planting area. At the completion of all the improvements, the basin should be cleaned, patched and resurfaced.

Water Feature in Disrepair

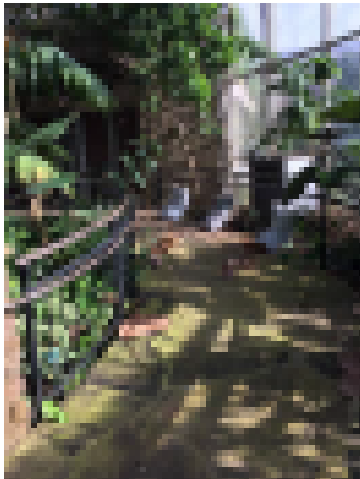
The running slope and cross-slope of the flagstone ramp just inside the Conservatory entrance are outside of TAS limitations. In addition, elevational variations within the flagstone paving and its setting mortar are a potential trip hazard. It is recommended that the 25' flagstone ramp be reconstructed to meet TAS guidelines for running slope and cross slope. It is also recommended that the ramp hand rail be replaced entirely due to rust and corrosion being beyond repair. It is recommended to replace the entire railing system in the facility with either galvanized or stainless steel but to reuse the brass handrail.

Flagstone Ramp

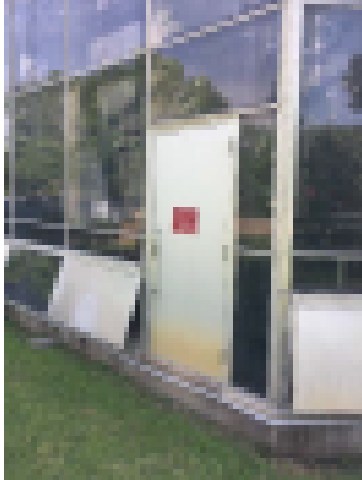
The secondary emergency exit in the southeast corner is non-accessible as one must travel into the sloped planting exhibit with a 2' grade difference between the sidewalk paving inside and the raised threshold of the exit door. There is no exit sign over the door, but a sign is located on the door face and crash bar is installed as required for exiting. A stair should be built with handrails to access this door and a new exit sign should be placed above the door. A landing with a step should be placed at the exterior of this door.

Emergency Exit (Exterior)

Emergency Exit (Interior)

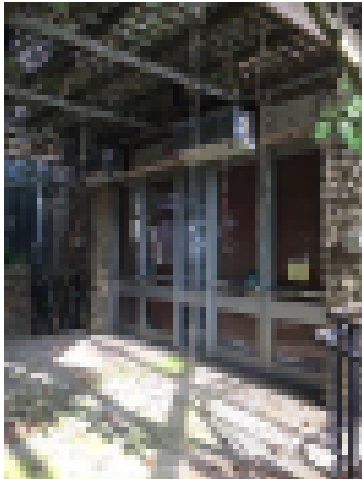
It is recommended that the trellis canopy mounted directly above the vestibule doors be removed. This wood trellis has issues with rotting wood and was not intended to support maintenance personnel when pruning the wall area above the trellis. A new wood canopy should be installed and designed to support maintenance personnel with safe access. This canopy should also incorporate light fixtures designed for the corrosive environment.

Entry Canopy

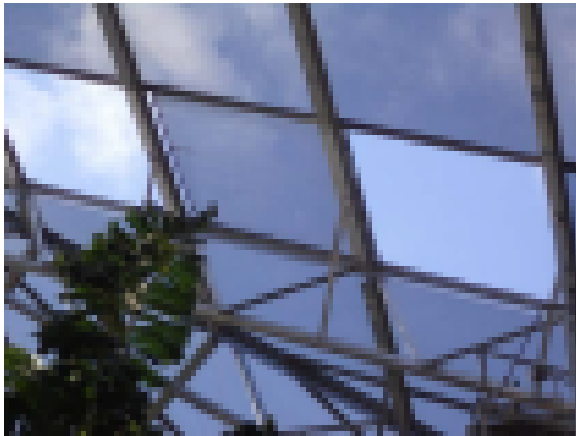
At the time of our observations, the Conservatory was closed to the public due to falling glass panels within the greenhouse structure. Over time, individual glass panels have been replaced due to storm damage. Upon repairing, the correct hardware and proper cleaning/reinstallation of the zipper gasket was not performed correctly causing the glass panels to become loose and slide out of its frame.

Roof Glass Slippage and Failing Glazing

It is recommended that the existing glazing system (including framing members) be replaced. The glazing bar spacing shall be no more than 24 3/4" centers with new aluminum glazing bars and bar caps. It is recommended to install 1/4" laminated glass with tinted inner layer for roof & 1/8" lapped tempered glass for sidewalls.

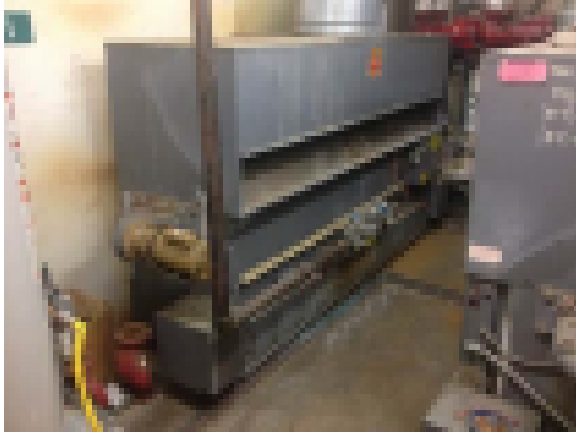
The Botanic Garden Conservatory is heated by two water tube boilers installed about 18 years ago. Each boiler is rated at 1,825,000 Btu/hr input and 1,496,000 Btu/hr output. One of the boilers started a fire in 2014. There have been issues of meeting Conservatory (60°F) temperature requirements when outdoor temperatures are less than 40°F. Boiler and main circulating pumps have had seals replaced numerous times. There has been issues of getting parts for boiler repairs. The two boilers and associated in-line circulating pumps provide heating water to eight (8) hot water unit heaters in the Conservatory. Hot water unit heaters show signs of rust damage; and as such some have been recently replaced.

Boilers to be Replaced

It is recommended to replace boilers and eight unit heaters. The boilers are 18 years old and associated with a fire several years ago. It is also recommended to upsize boilers to maintain desired temperature within the Conservatory since there are issues with maintaining temperature in winter time operation.

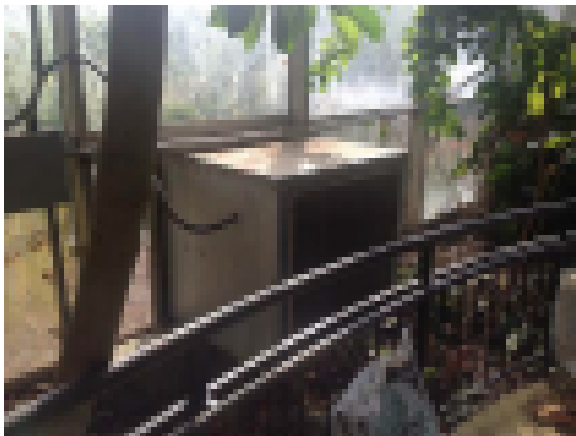
Box Ventilation Fan

It is recommended to replace the eighteen general ventilation box fans. There have been many issues with motor replacements for these fans. Since these units are mounted to and connected to the Conservatory envelope that is recommended to be replaced, it would make sense to replace these at the same time. It is recommended to replace the two air curtains since they are rusting.

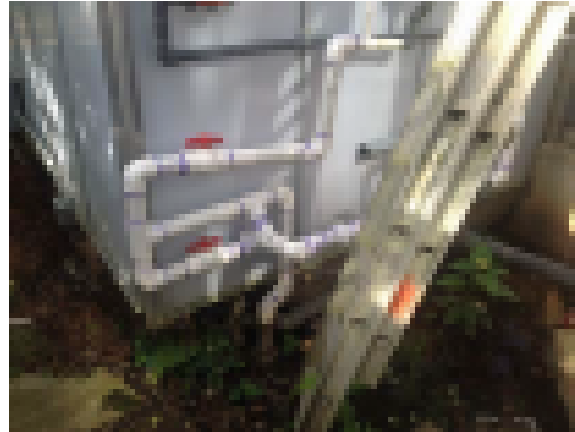
Set of Leaking Valves

It is recommended to replace the mister system since the existing system has become an issue to repair and find parts. Numerous emitter heads need to be replaced along with high pressure piping. It is recommended to repair the underground water leaks or replace the piping, including repairing leaks in the above ground shut-off valves. The underground domestic water and reverse osmosis piping has leaks, although exact locations are unknown. Domestic water and reverse osmosis is configured in a switch-over valve arrangement. One of these valves is leaking. It is recommended to replace the water feature pump with a grinder pump in order to minimize the clogging issues that have occurred.

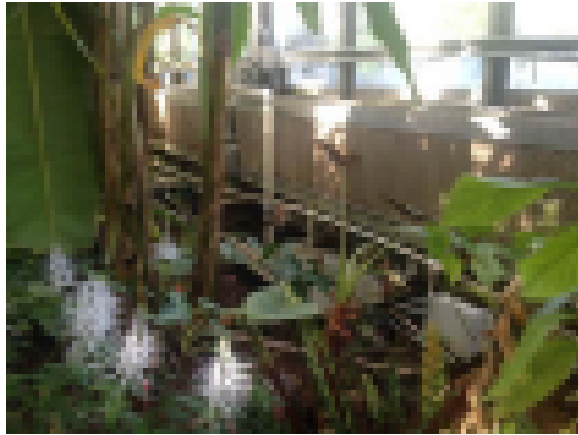
Sagging PVC Water Pipes

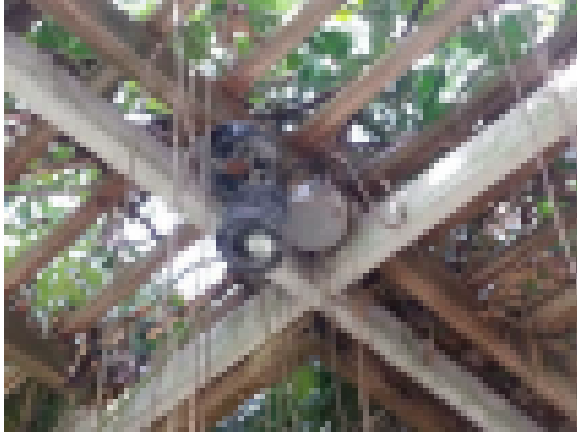
Lighting Fixture to be Replaced

It is recommended to replace lighting fixtures in the Conservatory entrance and other locations with lighting fixtures suitable for the high humidity, high corrosion Conservatory environment.

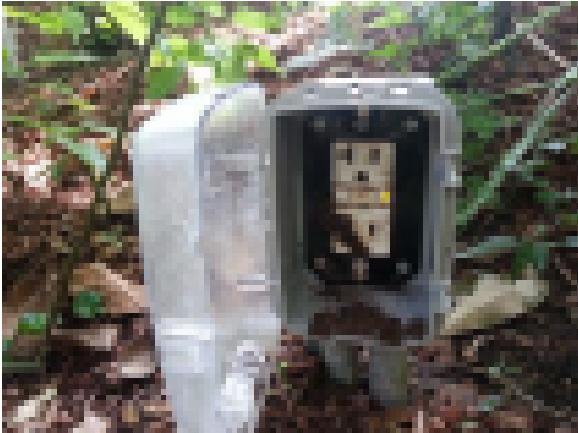
Damaged Receptacle

It is recommended to replace damaged receptacles throughout the Conservatory.

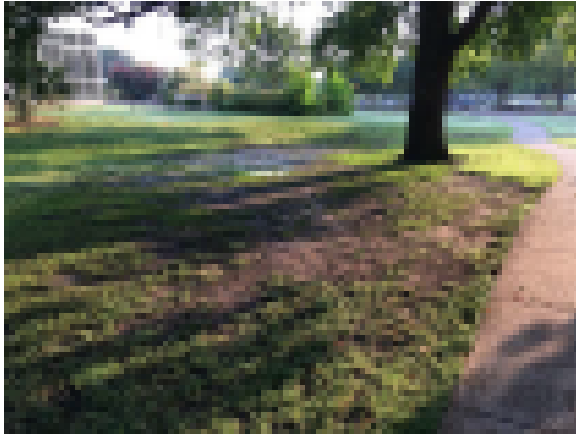
The grass lawn area between the visitor parking lot and conservatory building does not drain adequately. Current drainage system appears to be undersized and should be upgraded to reduce ponding in grass areas.

Inadequate Drainage

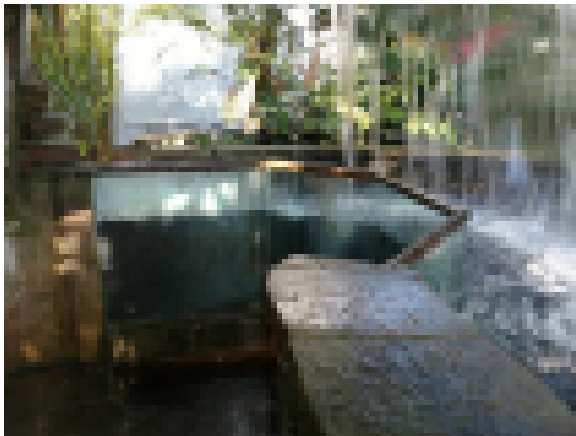
Initial observations of the waterfall feature include severe calcium deposits on the glass. The weir edge where the water falls from the top basin to the bottom basin needs cleaning, possible repairs, and/or potential replacement. The fill line has an issue that needs to be further diagnosed, the current floats could be updated with electronic probes, and water is collecting on the ground.

Waterfall Feature

The glass has heavy calcium deposits, and it will need consistent cleaning to remove and reduce calcium deposits. Current maintenance does not appear to be enough. Also, the debris load in the feature is excessive. This debris load is not only an eyesore to visitors, but it can also lead to equipment failure.

The overflow pipes currently have no caps. Installation of copper domes on top of the piping is recommended to reduce large debris from entering the overflow and to hide the suction pipe from view. A deep cleaning of all features is also recommended and will provide fountain technicians an opportunity to inspect for structural and/or waterproofing issues in each fountain.

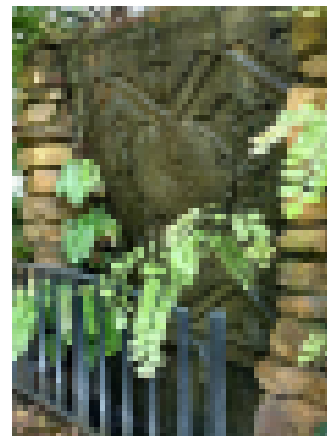
Decorative Stone Wall

The decorative stone wall on the back of the waterfall feature is starting to fall/lean, and water is collecting on the surrounding floor. Whether the water is coming from the stonework or splash from the water weir into the lower basin could not be determined. This leaning stone wall is cause for concern, as it could present danger to patrons/employees and lead to further damage to the feature itself. It is recommended that a further structural study be performed on this wall and make a determination for resolution.

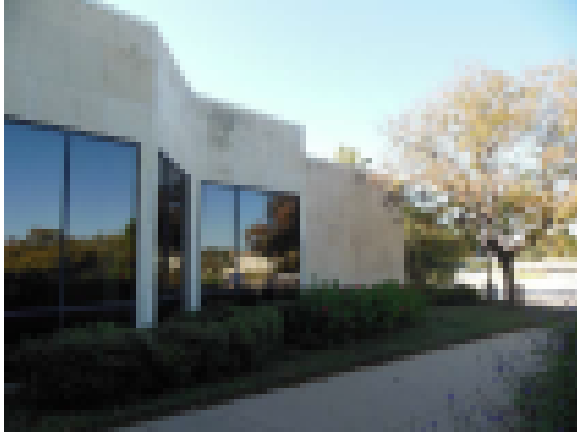
The exterior of the Lecture Hall is in good condition. The stone veneer needs to be cleaned with equipment under strict American Masonry Institute guidelines. After the veneer is cleaned it should be sealed to maintain visual aesthetics. Care should be taken to protect the plant life around the building during this process. Most of the joint sealants on the façade are starting to fail. It is recommended to replace all joint sealants on the exterior.

Stone Veneer Requires Cleaning

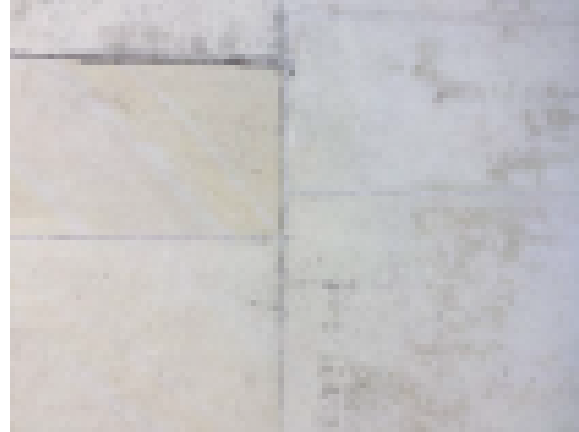
Worn Sealants

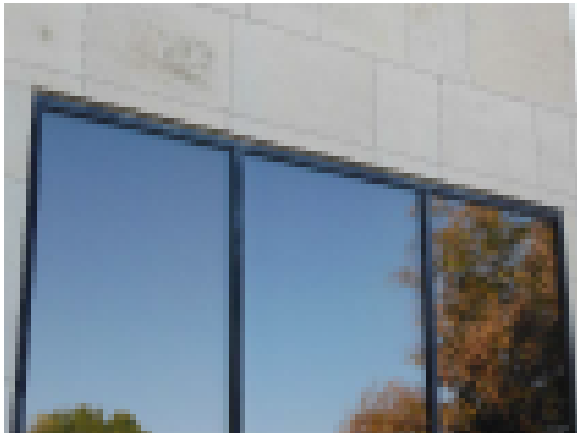
The storefront at the front of the building is missing the metal trim piece at the head detail. These trim pieces should be repaired/replaced.

Missing Head Trim

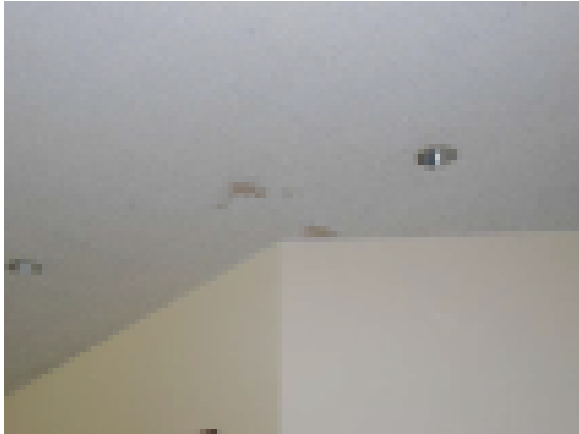
The ceilings inside of the lobby area outside of the Lecture Hall and the ceilings inside of the two restrooms are in disrepair. Tiles have been removed or have fallen off and the finish is nearing its lifespan and should be replaced.

Chipped Ceilings Tiles

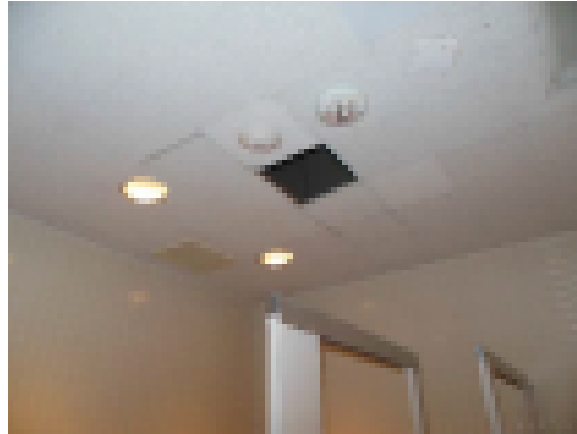
Missing and Damaged Ceiling Tiles

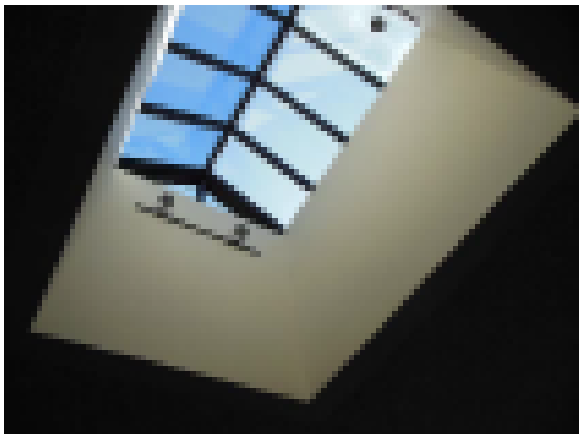
The sealants on the skylight in the lobby area are starting to peel away and should be replaced.

Peeling Skylight Sealant

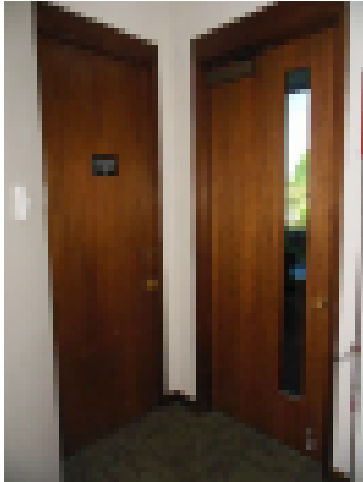
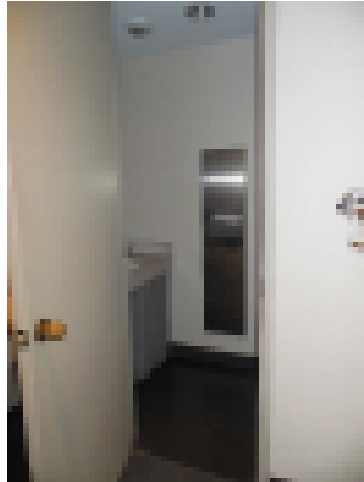
Most of the interior doors inside the Lecture Hall and a few exterior doors have knob type hardware which is no longer compliant with current accessibility codes. It is recommended to switch all existing knob type hardware to lever type hardware.

Knob Hardware

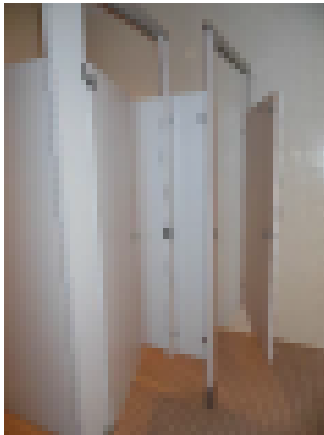
Restrooms in the facility do not meet current accessibility codes. However, because there are restrooms in the Garden Center that are accessible, these restrooms simply need signage pointing to the accessible restrooms. The drinking fountains outside the restrooms are not accessible. These fountains should be replaced with an accessible hi/low configuration.

Non-Compliant Stall

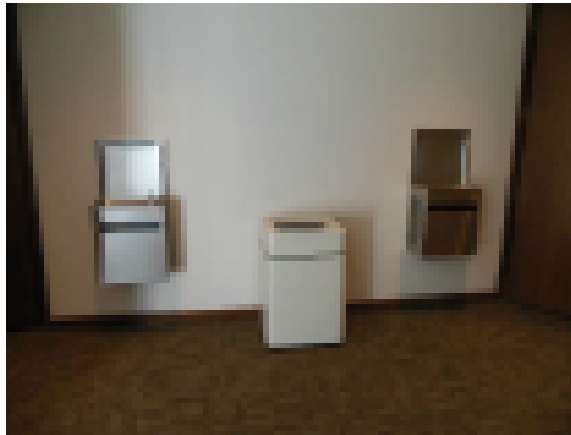
Non-Compliant Drinking Fountains

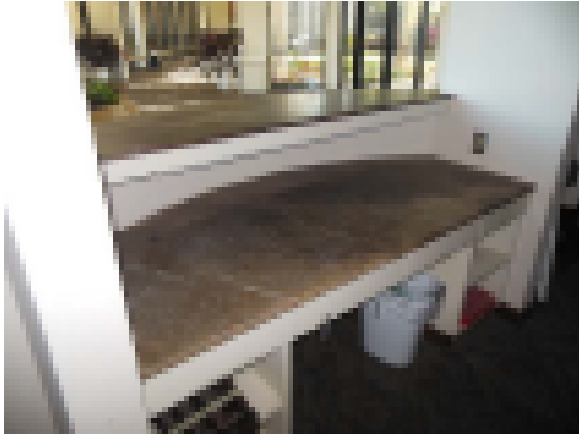
The coat check counter does not meet required reach ranges. This high counter should be modified keeping the low counter in place. The auditorium itself has several accessibility issues. A few seats have been designated with the handicap symbol presumably as assistance to an adjacent wheelchair space, but inadequate wheelchair space and cross slope is provided. There needs to be at least 5 wheelchair spaces in this auditorium and only 4 are provided. Seats should be modified and/or removed and areas should be designated for these spaces.

Coat Check Counter

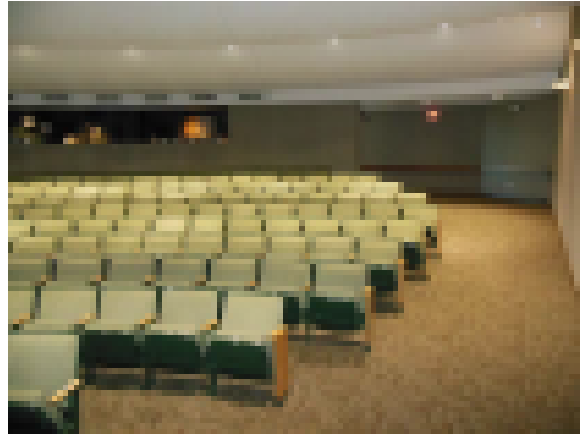
Auditorium Seating

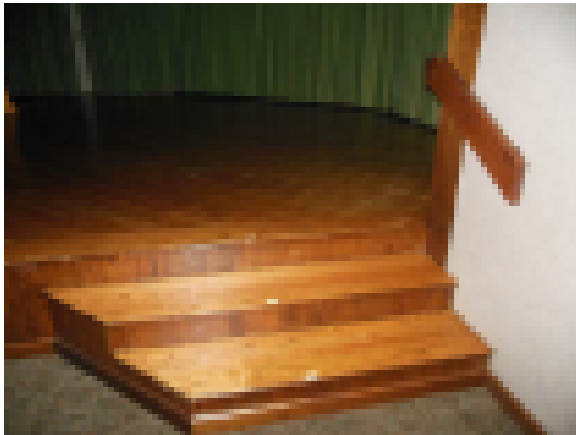
Considering the extremely steep slope of the aisles, handrails should be added both at the wall and at the seating (single loop rails at each seat). The stairs that serve the stage and the stairs that serve the lecture hall have non-compliant railings that should be replaced.

Stage Stairs and Handrails

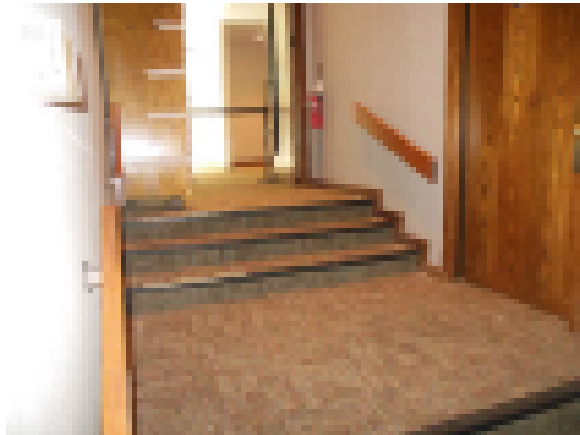
Handrails at Stairs

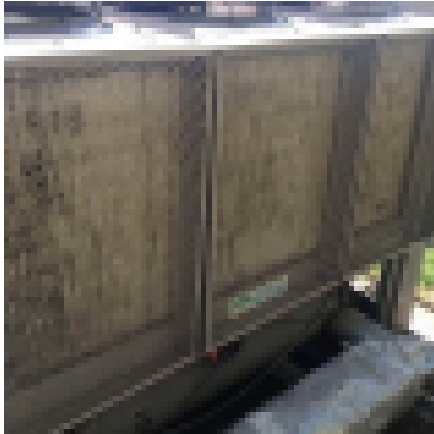
The air-cooled chiller is 15 years old and has reached its life expectancy. There are signs of age, including deteriorated piping insulation. The AHUs and hydronic accessories are all 30 years old and have reached their life expectancies. HVAC and piping insulation inside the mechanical room shows signs of damage

Chiller Coil Damage

and missing insulation. There are signs of rust damage throughout the Mechanical Room. There is a musty odor for the entire Lecture Hall facility and becomes apparent when entering the Link from the adjacent Garden Center building. The musty odor could possibly be attributed to under floor ducts and water entrance into ducts. The musty odor for this entire facility should be addressed and further investigation as to the specific cause. It is recommended to replace entire HVAC system including equipment and insulation with new.

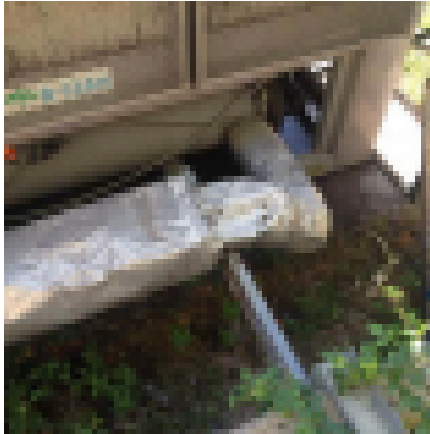
Insulation Damage Near Chiller

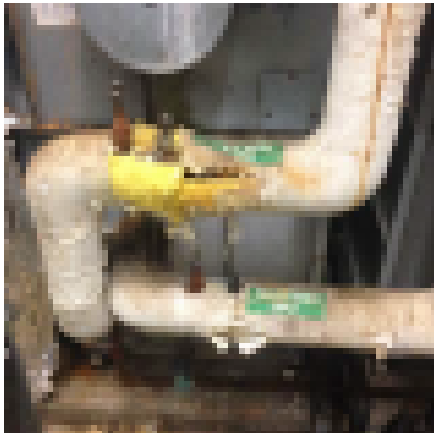
Insulation Damage

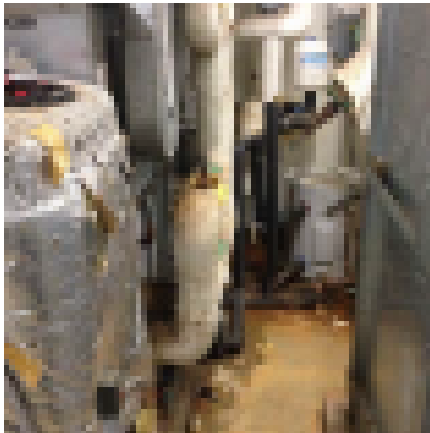
Insulation Damage

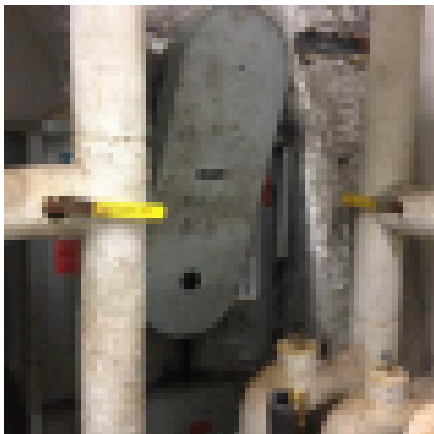
Rusted Ball Valve Handles / Tight Clearances

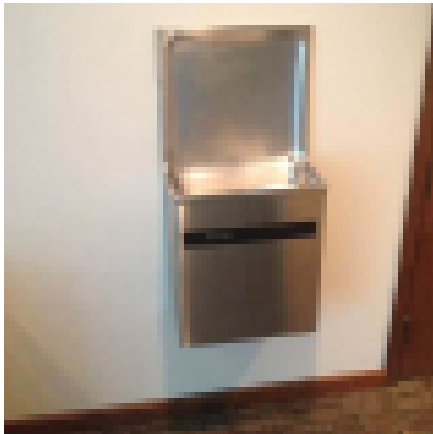
The north-most electric water cooler is not operating. It is recommended to replace this water cooler. Pricing for this is included in the accessibility portion of this report. The janitor sink has reached its lifespan and should be replaced. It is recommended to unclog the floor drain in the mechanical room.

Water cooler not Functioning

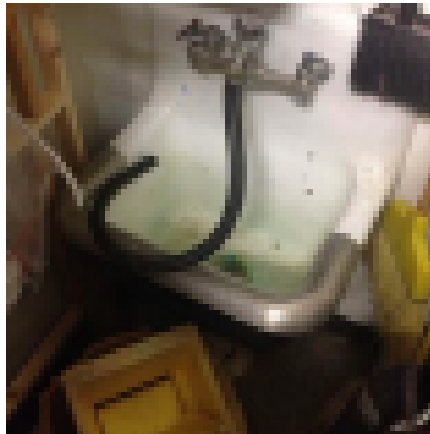
Utility Sink Stained

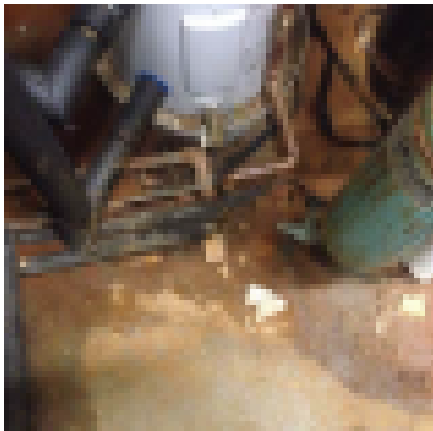
Floor Drain Clogged

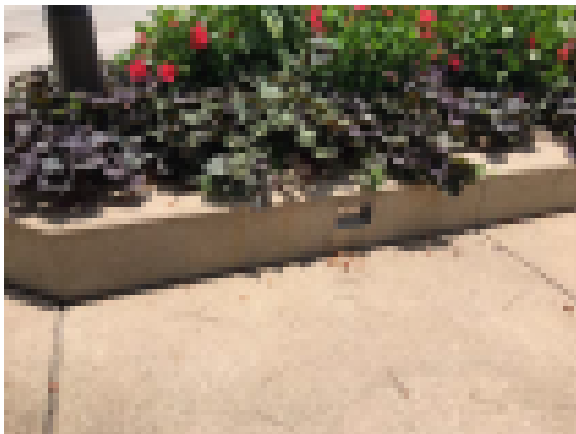
Low walls along the walk ways have louvered lights imbedded in them. Some of the lights and louvres are missing and need to be replaced. Some joints between pavement and concrete walls are missing or need to be sealed. Also, some walkway joints need to be sealed.

Damaged Wall Lighting

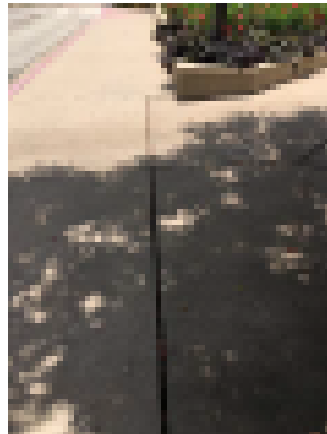
Non-Sealed Paving Joints

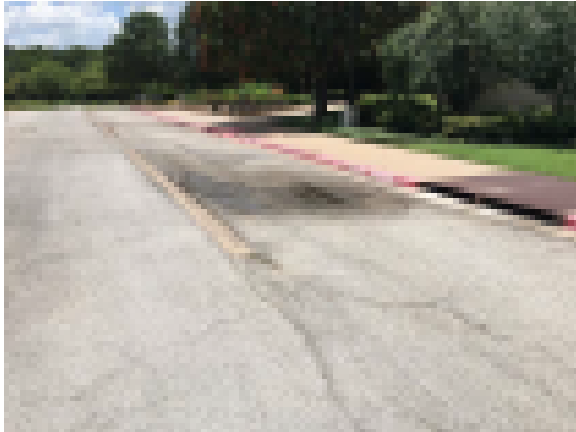
A bus drop-off is in front of the building and is part of the asphalt drive. It has been patched and repaired in the past and will need to be replaced with concrete paving to match the adjacent parking lot. Costs for this item are included elsewhere in this report.

Leonhardt Lecture Hall Drop Off

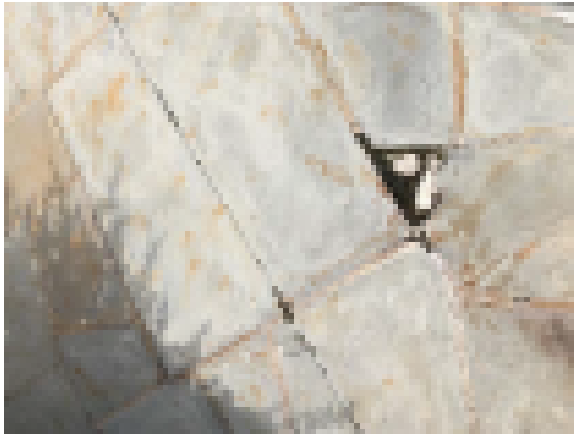
The general condition of the flagstone paving is good, however in several locations the stones are either cracked or broken and the grout joints appear to be damaged or missing. The damaged stones should be removed and replaced and new grout joints installed.

Chipped Flagstone Paving and Mortar
