Facility Assessment
Fort Worth Botanic Garden
3220 Botanic Garden Boulevard
Fort Worth, Texas 76107

August 31, 2018
PROJECT NO. 16-1031.00

Assessment – Fort Worth Botanic Garden

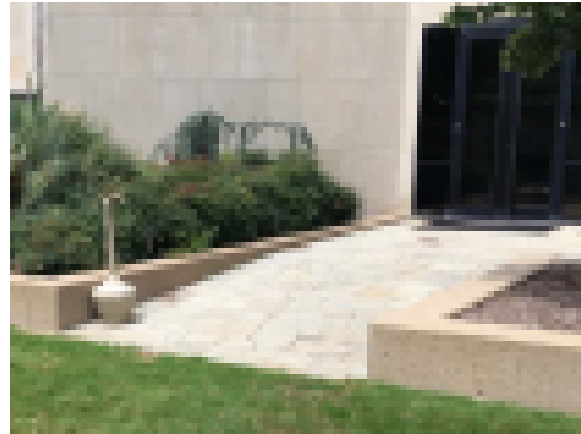
The courtyard includes two levels, the building entry level and the lower fountain level. A paved sloped visitor access route connecting the upper level to the fountain area is greater than 5%. Additionally, the landing at the base of this route is grass requiring visitors to walk over grass to view the fountain and hard surface required for accessibility. Handrails and a paved flagstone landing should be installed in this area as required for ADA compliance.

Ramp in Need of Handrails

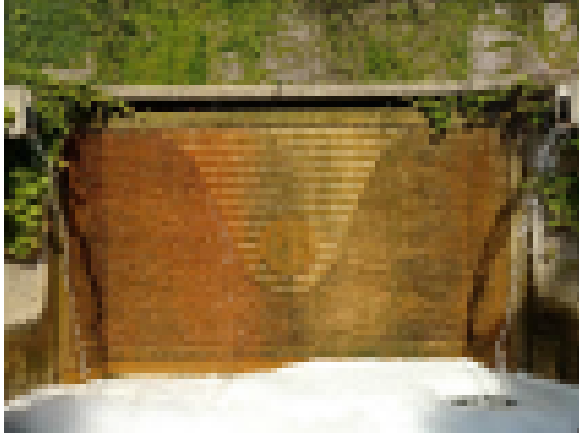
At the far end of the garden is a focal point water wall with a small lower basin. Underground equipment is housed in a vault behind the back wall. The current float mechanism is an eyesore, and is recommended

Wall Fountain

for replacement with an outside probe in a small well. Additionally, the fountain lighting should be upgraded to increase visibility and enhance the visitor experience.

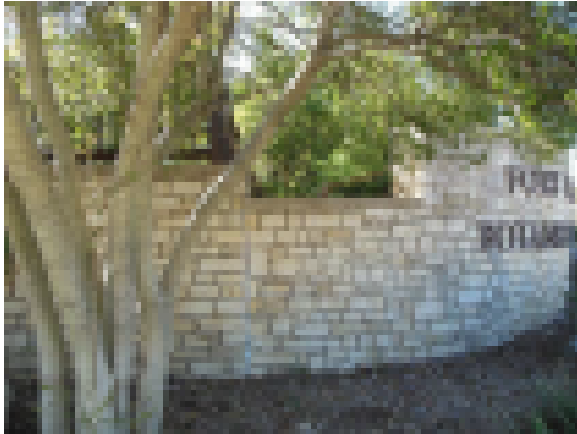
The retaining wall for the Will Rogers Complex behind the garden area is damaged in a few places and should be repaired. There is also an expansion joint at this area that has deteriorated and requires replacement.

Wall Expansion Joint

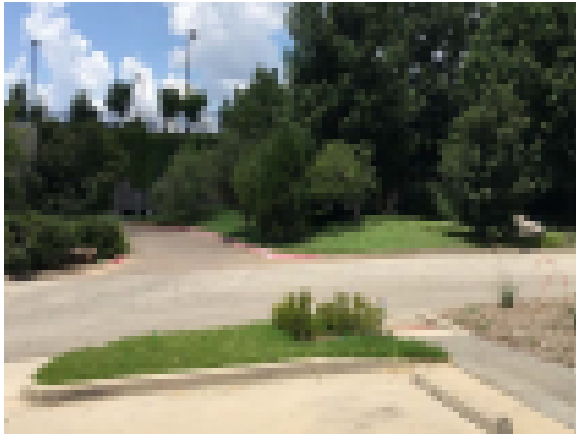
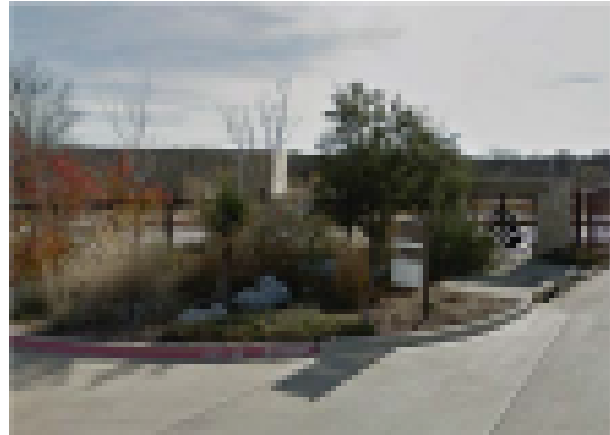
At the north entry, the sidewalk leading to the pedestrian gate does not connect to the accessible pathway at Trail Drive. Install 75 lf of 5' wide concrete pathway and (2) curb ramps where the pathway crosses the service drive.

Pedestrian Crossing needs Ramps / Crosswalks *North Entry Pedestrian Gate Pathway*

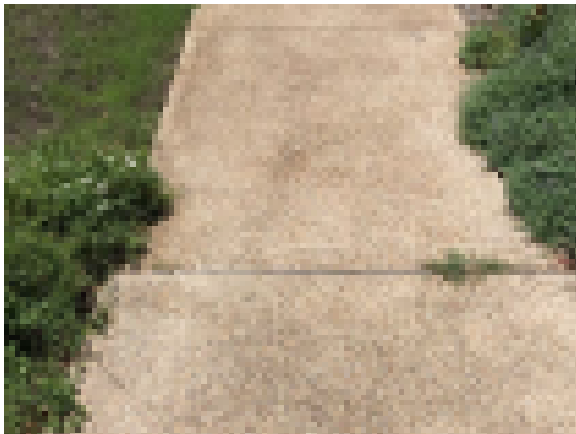
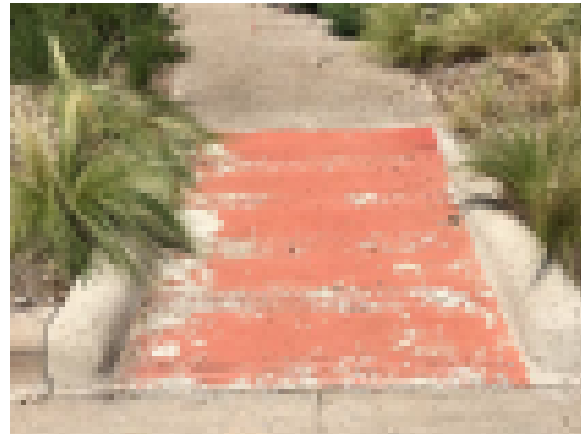
In the garden, the pavement appears to be in good condition; however, the redwood expansion joints are not flush with the pavement. Also, gaps exist between the pavement and joints, which allow weed growth. The redwood should be removed and the joints sealed.

The ramp is cracked and has peeling paint. It should be replaced.

Pavement with Redwood Expansion Joints *Ramp with Cracks and Peeling Paint*

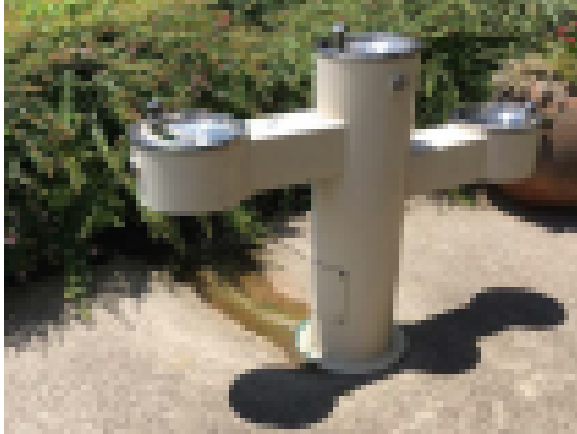
The drinking fountain has a significant leak. It should be repaired to stop the leak and prevent discoloration of the pavement.

Leaky Drinking Fountain

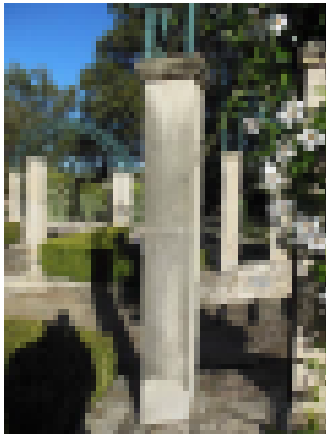
The steel trellises have stone pilasters that have become dirty from constant interaction with people as well as general wear over time. These pilasters should be cleaned and sealed to protect their aesthetic value.

Pilasters Require Cleaning

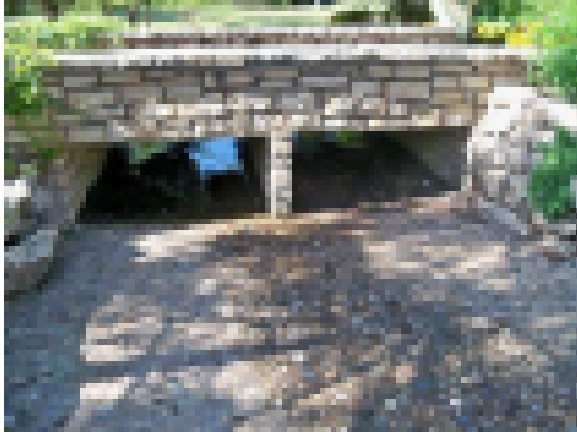
The pedestrian bridge located between the Leonard Courtyard and the Fuller Garden (see photograph below, left) has steel beams along the two sides of the bridge. These beams have surface rust on the exposed bottom face of beam (see photograph below, right). We recommend that the exposed surfaces be painted with a rust-inhibitive paint to extend the useful life of the bridge.

Pedestrian Bridge

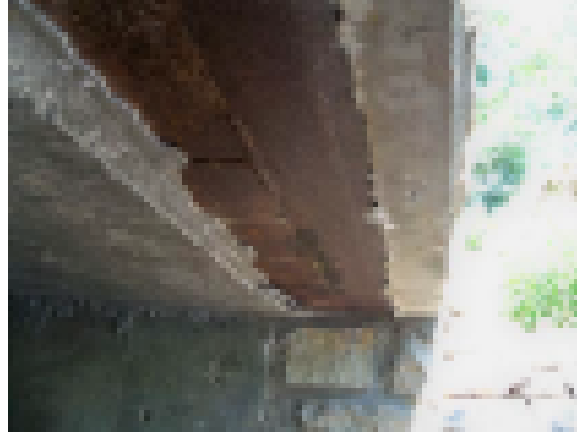
Steel Bridge Support Beam

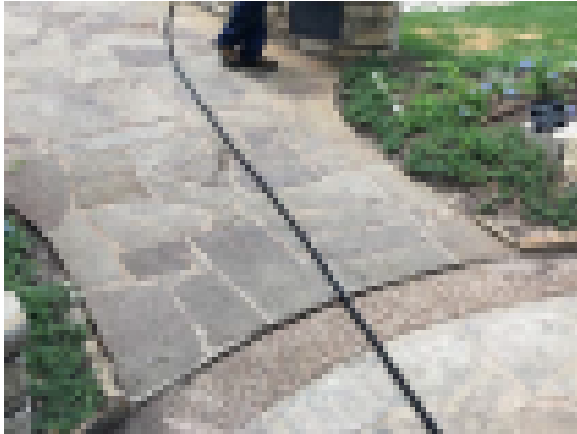
At the 'round sunken garden' are steps and what appears to be an access maintenance ramp, which are often used by visitors. These steps and ramp need to be reconstructed to have appropriate handrails, surfaces, and slopes.

Ramp at 'Round Sunken Garden'

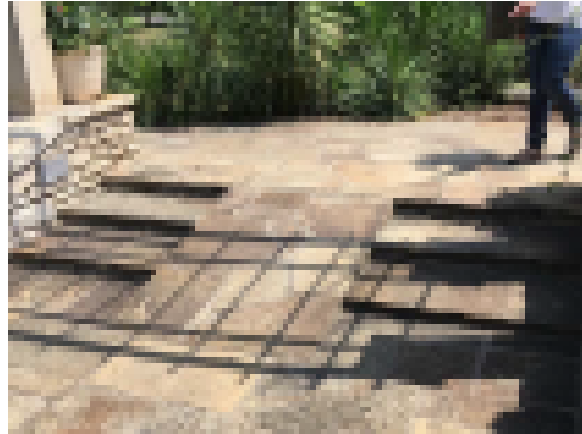
Steps and Maintenance Ramp

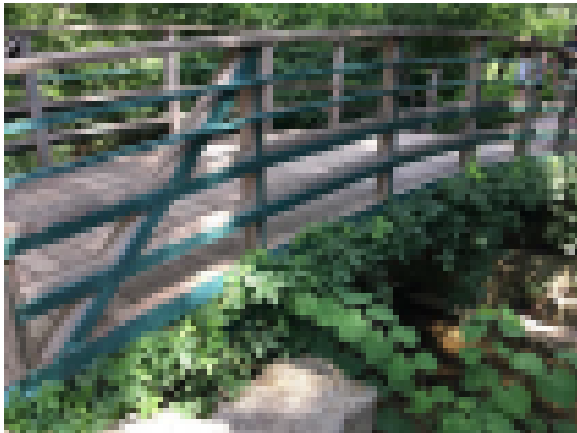
The bridge crossing the creek has a wooden railing that has been added to the steel structure, but additional railing modifications are needed to make openings less than 4" as required by code. After crossing the creek, visitors arrive at a round pool water feature surrounded by flagstone pavement. Visitors are then encouraged to continue walking on a mulch path that links the 'round water feature' to the roadway crossing near the Nature Boardwalk entrance. This mulch path should be removed and replaced with an 8' wide flagstone-on-concrete path to match the paving in the rest of the garden and as required for accessibility.

Bridge Crossing the Creek

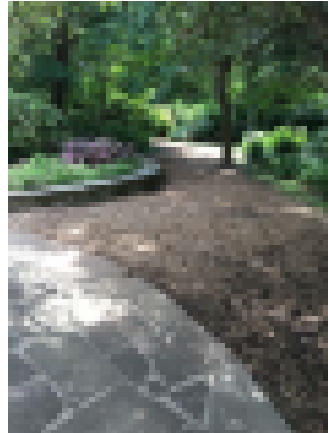
Path Linking 'Round Water Feature' to Old Garden Rd

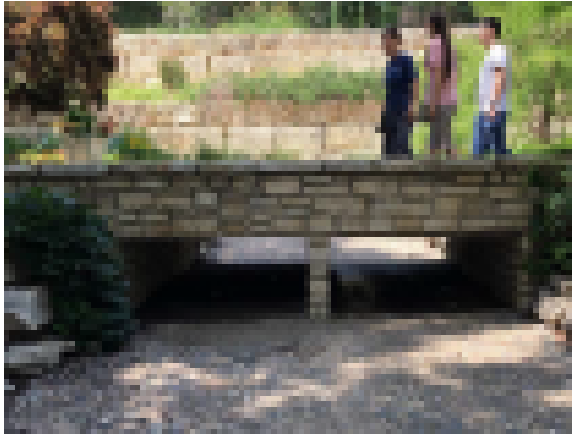
River Rock Swale Under Main Pathway

The concrete-lined swale should be removed and replaced with an appropriate permeable natural surface to promote infiltration of rainwater. The swale should be graded so that the surface elevation is less the 30” below the walking surface of the adjacent walk so handrails will not need be required by code.

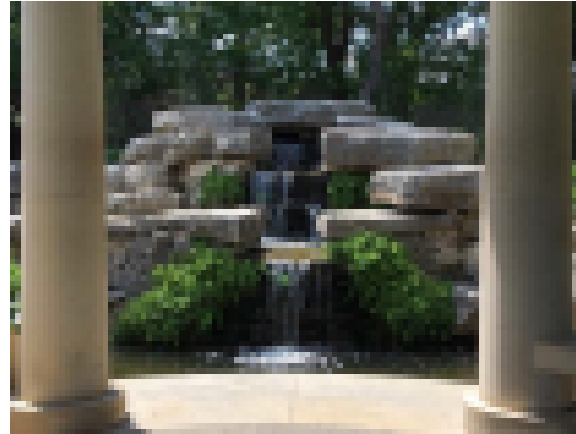
The Botanic Garden staff have identified that the naturalistic waterfall and creek feature has a damaged shell/liner. The pool should be drained, the leak identified, and the pool liner repaired. The extent of repair is difficult to determine without additional investigation, but for the sake of this report, we anticipate that the gunite repair will be significant.

Waterfall with Damaged Shell / Liner

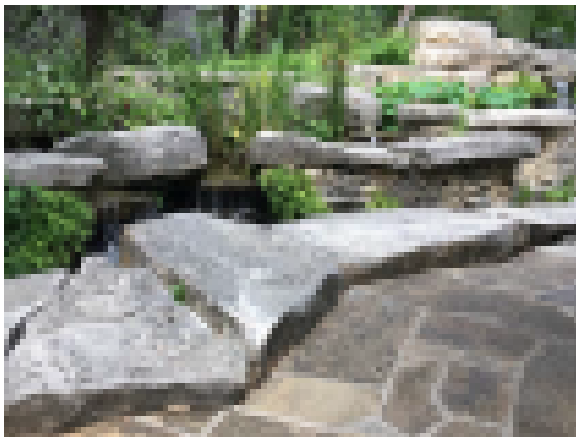
Creek with Damaged Shell / Liner

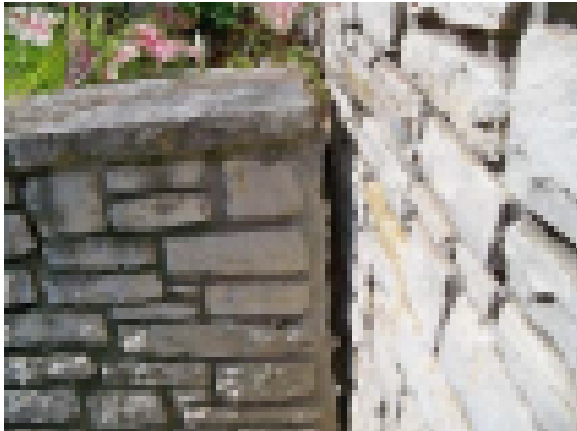
The planter walls on the south side of the boulevard were constructed taller than shown on the construction drawings and have suffered distress. This wall has dropped and rotated outward relative to the taller pier-supported walls and has significant movement related cracking. We recommend that this wall be replaced with a properly designed and reinforced wall and footing.

Structural Wall Movement

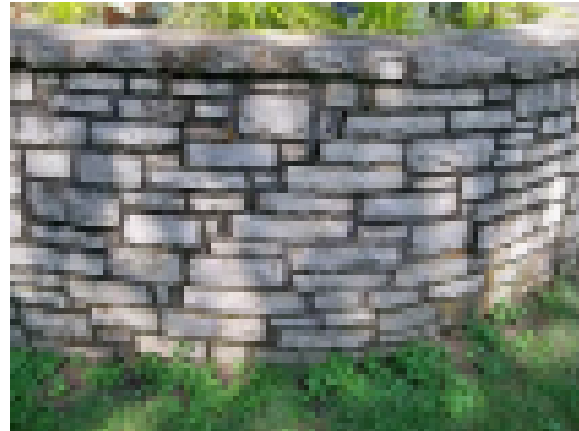
Retaining Wall Cracking

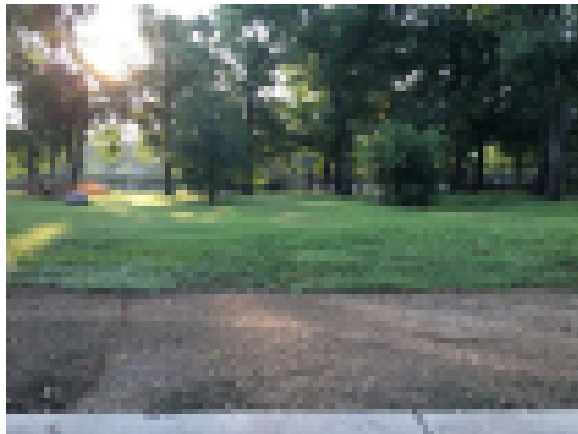
Runoff from the parking lot north of Botanic Garden Drive is intended to surface drain to an existing inlet in the heavily vegetated area north of the Main Entrance. This drainage pattern has been obstructed by a TXU access road and existing mature trees creating a standing water problem. Additionally, runoff from the garden entrance road collects along the stone wall parallel to University. This area should be re-graded with grass swales to promote proper drainage to the existing inlet.

Grass Access Drive

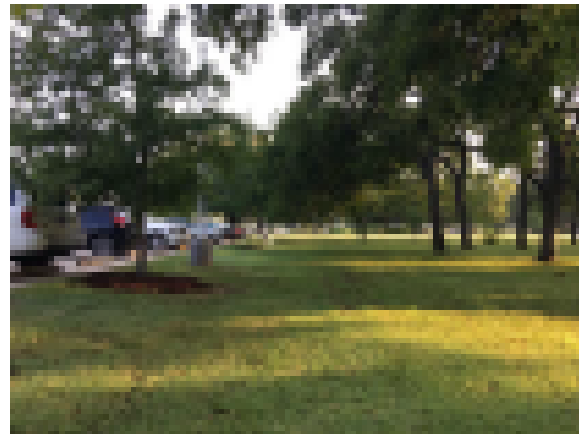
The concrete parking lot south of Botanic Garden Boulevard was constructed without curbs to promote rainwater infiltration in the planting areas. However, after a rain event runoff collects in the landscape areas east of the lot creating standing water. A drain inlet should be installed in this area to alleviate the ponding and transfer the water to a new inlet constructed with future roadway improvements for Old Garden Road.

Slow Draining Area Adjacent to the Parking Lot.

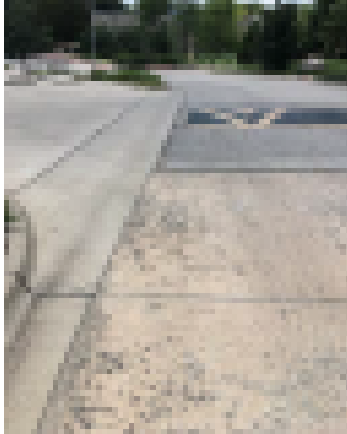
Portions of the pavement of Conservatory Drive north of the Botanic Garden Boulevard are asphalt that show signs of damage and wear. These portions of the drive should be replaced to match the adjacent concrete pavement in the parking areas.

Transition of Asphalt/Concrete Paving

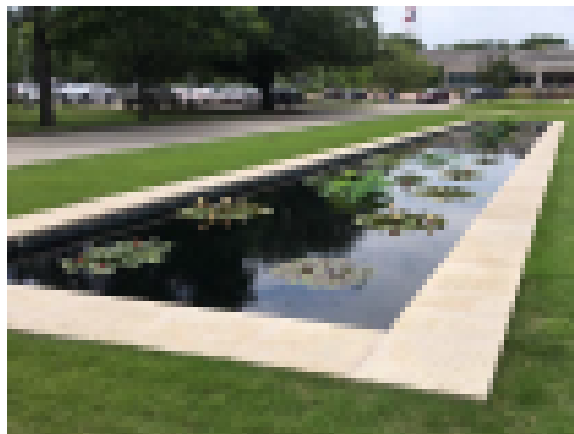
The 'Frog Fountain' in the boulevard consists of two large rectangular basins with dyed water planted with aquatic plants. One pool features two frog sculptures; the other does not. The pools include 24 nozzles on the top basin and 38 nozzles on the lower basin. The existing PVC nozzles have been broken repeatedly by patrons stepping on them. These nozzles should be replaced with new brass nozzles in niches to reduce the likelihood of patrons stepping on them and disrupting the fountains' performance in the future.

Frog Fountain (Nozzles Are Turned Off)

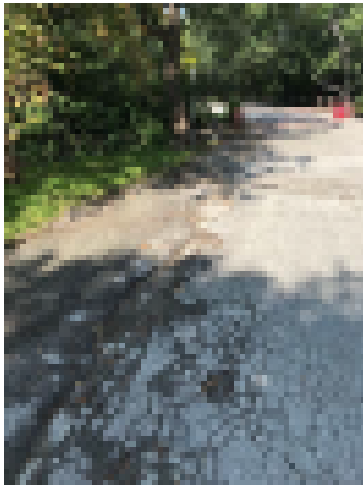
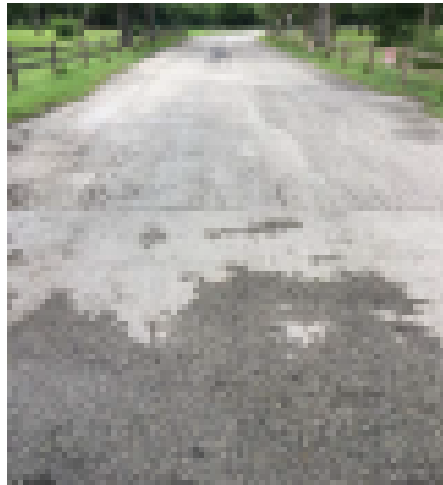
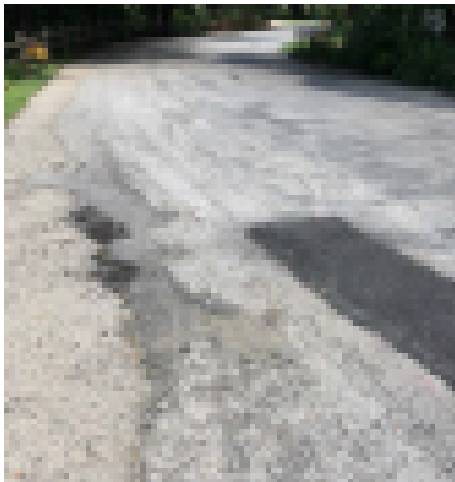
Roadway surface experiences heavy traffic volumes at times and is deteriorating faster than repairs can be made. Recommend replacement of entire roadway with new concrete roadway to match new concrete roadways in Zone 1. Subsurface storm drain system should be incorporated into new roadway improvements.

Road Deterioration

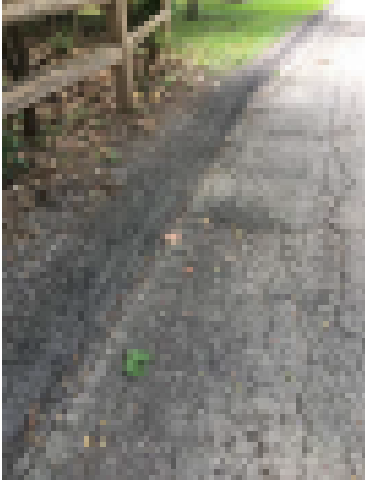
An asphalt curb appears to have been scabbed on to the roadway to direct or control surface drainage flow. These should be replaced with concrete integral curb and gutter when roadway is reconstructed.

Asphalt Curb

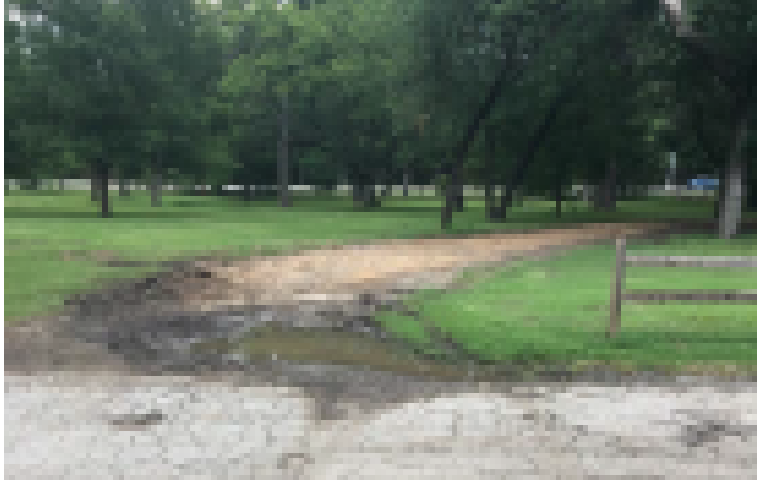
A temporary mulch access path between Botanic Garden Boulevard and Conservatory Drive intersects Old Garden Road. This appears to be used by maintenance vehicles to access the Clock Grove area. Recommend installation of concrete drive apron to prevent drainage ponding, mud and standing water.

Maintenance Drive Entrance

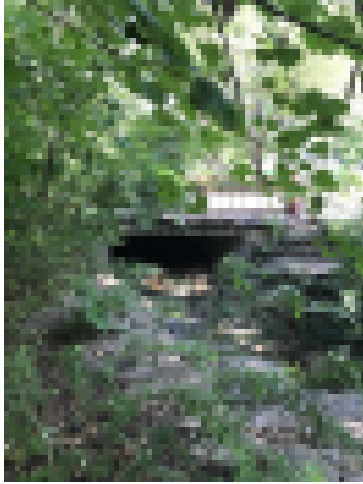
The drainage channel/creek that runs from the Fuller Garden south to the Sister Cities International Grove crosses underneath Old Garden Road. This stone lined drainageway is partially collapsing near the road intersection and is in need of repair. Recommend removal of approximately 50 lf of collapsing stone edges

Drainage Channel

both upstream and downstream of roadway. Replace with installation of reinforced decorative stone to match existing.

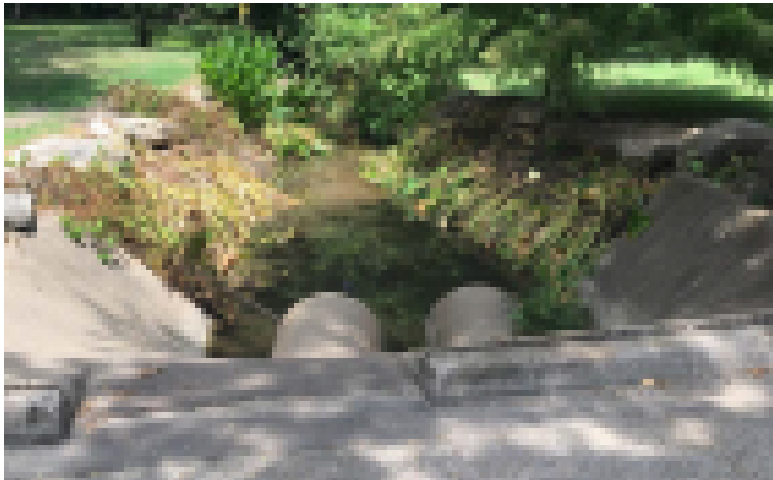
The culvert at Rock Springs Road daylights into a channel then flows north through the site. The garden staff has planted this channel with a variety of riparian vegetation including aquatic plants and trees. As they have matured, the trees and larger vegetation now limit the capacity of the channel. The obstructions in the channel should be removed and the sides of the channel should be regraded to increase capacity. A drainage study will need to be performed to determine the required extent of the improvements

Channel with Vegetation

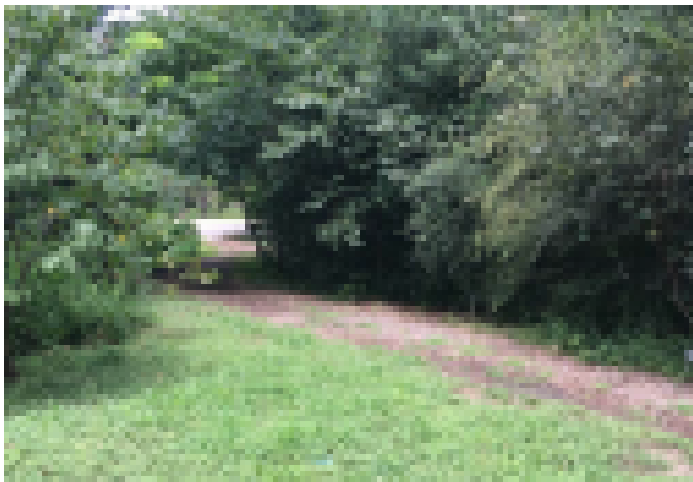
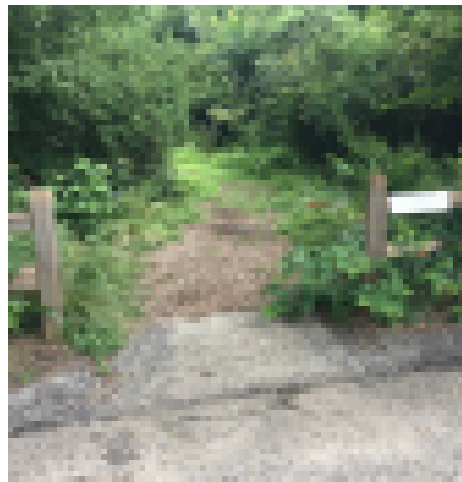
Mulch Path

Mulch Path Connection

The Wildscape area is an interpretive educational garden that highlights the native vegetation and sustainable garden techniques. Visitors access the site by using a mulch path connection from Old Garden Road. A portion of this pathway should be replaced with a 5' wide concrete pathway to provide access to the main interpretive elements.

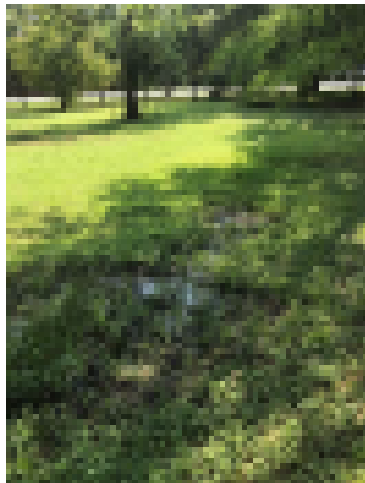
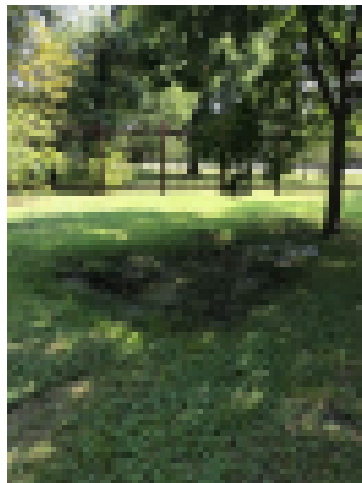
The large area adjacent to University Drive is informally described as the Clock Woods. This low-lying area consists of lawn grasses beneath mature trees and includes several grass swales to promote runoff toward the culvert that crosses University Drive. However, not all of this area drains well and a nuisance water problem exists in some areas. The surface drainage swales that exist in this zone should be regraded to promote positive drainage and eliminate standing water.

Standing Water

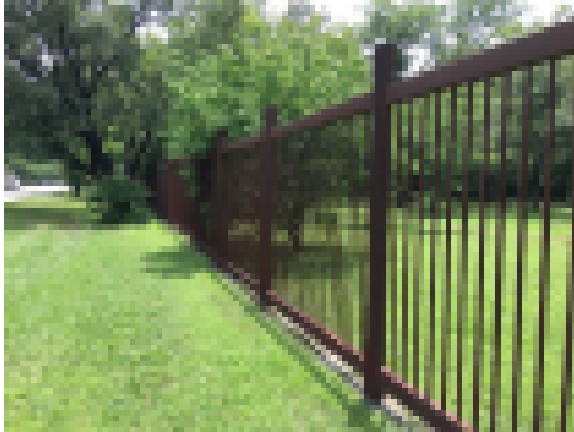
The Botanic Garden is bordered on University Drive and the IH30 Service Road by a custom ornamental metal picket fence with a weathered steel finish. At the base of the fence is a continuous concrete mow strip/maintenance edge. With busy traffic along University Drive, this fence has been impacted by vehicular accidents on multiple occasions with staff providing spot repairs as needed. In addition, several pickets are either missing or have rusted through, and the mow strip is deteriorating or missing in several locations. It is recommended to replace the fence and mow strip in its entirety.

Perimeter Fence Rust

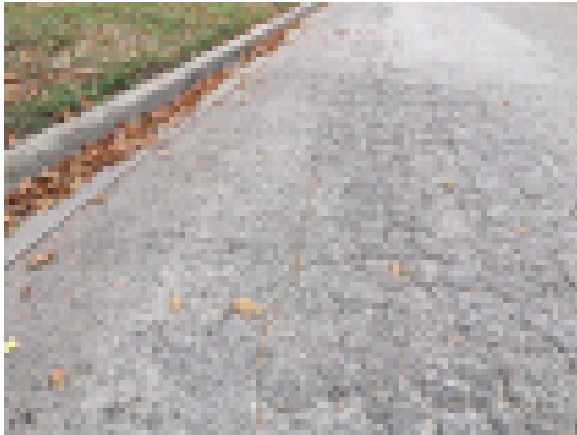
The asphalt roadway surface is deteriorating and has many cracks and potholes. The roadway conveys runoff in the gutter then continues through a curb cut to the creek. The area directly adjacent to the roadway shows signs of wear from pedestrian traffic.

Deteriorating Asphalt Surface

It is recommended to replace the entire road with a new concrete roadway to match the recommendations in Zone 1. Included in this construction, a 5' wide sidewalk should be added to the north side of the road

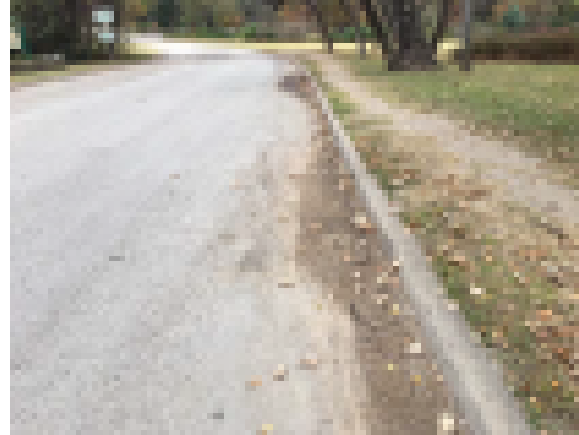
Sediment in Gutter and Worn Pedestrian Path

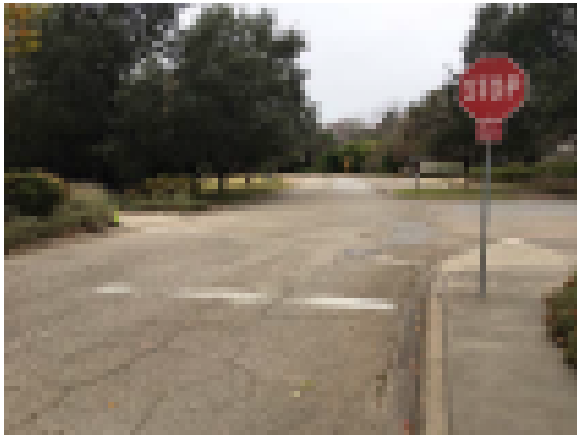
Worn Markings and Intersection Ramps

from the steps at the North Vista leading to the garden entrance. Additionally, all parking spaces and pavement markings should be repainted and pedestrian access ramps should be reconstructed to meet current standards.

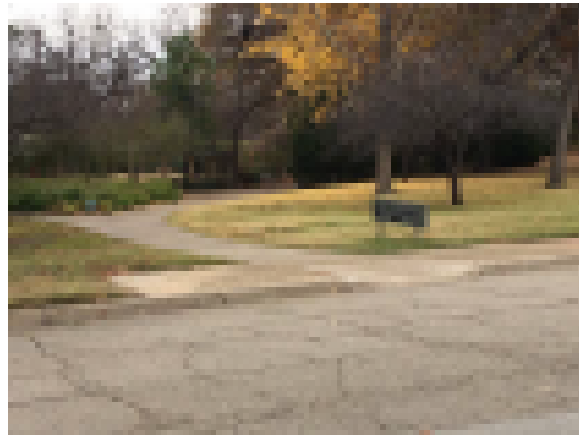
Non-Compliant Curb Ramp.

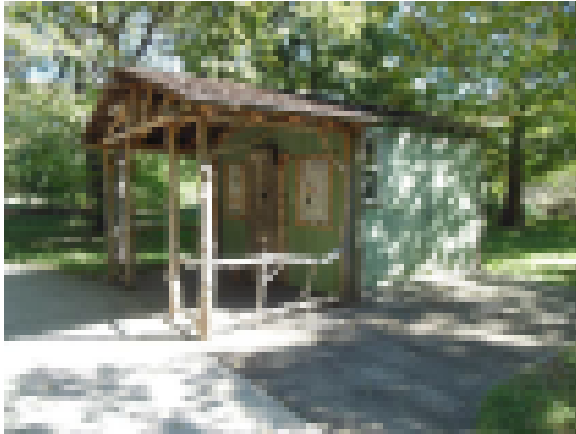
The Log Hotel needs a new cedar shake shingle roof and decking, as well as minor wood trim and siding repair.

Log Hotel

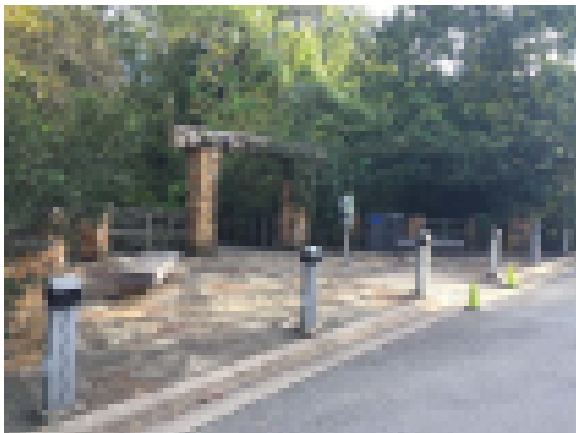
At the north entrance, there are a few accessible issues with the curb ramp and access to the trash receptacles (Reference Site description). However, the surface texture of the flagstone paving at the trail head varies more than the 1/2" maximum allowed for accessibility. This problem also exists at the pavilion area.

North Entrance

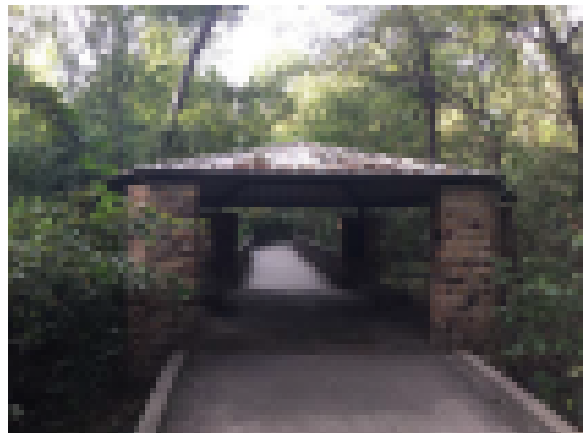
Pavilion

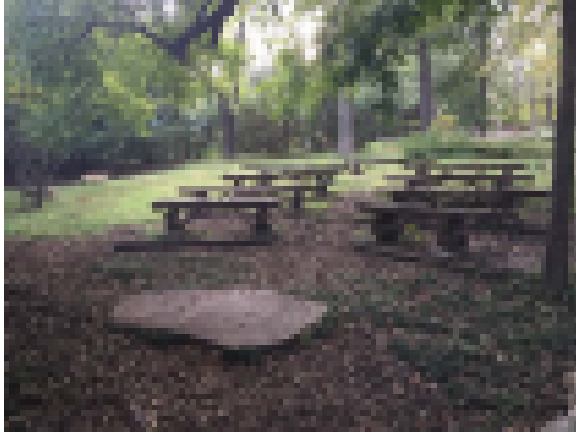
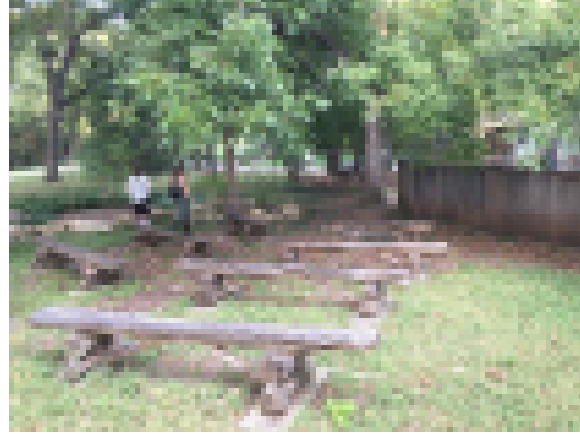
At the Amphitheater Area, there is no accessible route to the seating space. A paved route from the existing paved path and a pad near the seating area should be provided so a person in a wheelchair could participate in demonstrations at this area.

Amphitheater Area

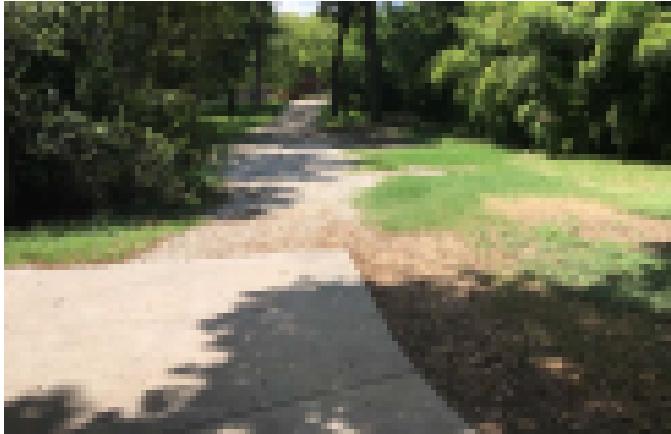
A gravel path is currently utilized as a service access from Old Garden Road to the North Vista. This area is also the location where portable restrooms are placed for the Concerts in the Garden. This drive should be paved with concrete to provide an accessible path and level pad for the restrooms.

Service Drive Area at Portable Restrooms for Events

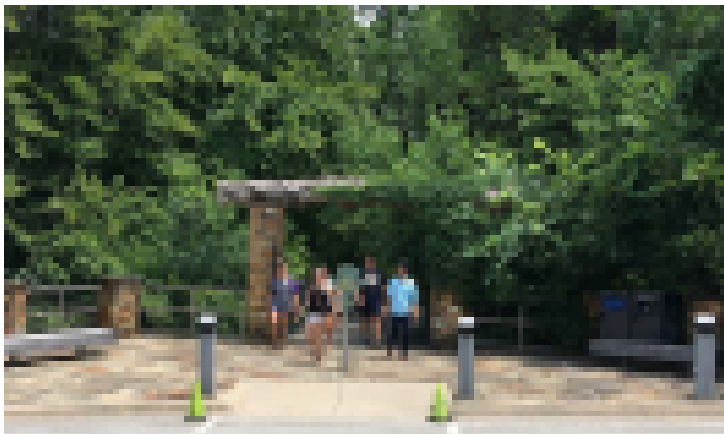
The northern Boardwalk entrance intersects Old Garden Road where pedestrian/vehicle conflicts may be a concern. The accessible ramp should be modified to include a truncated dome warning surface. This may be constructed in conjunction with the future renovation of Old Garden Road. Trash receptacles should be relocated from behind the existing benches to allow an ADA compliant clear floor area and access to receptacle openings.

North Entrance to the Boardwalk

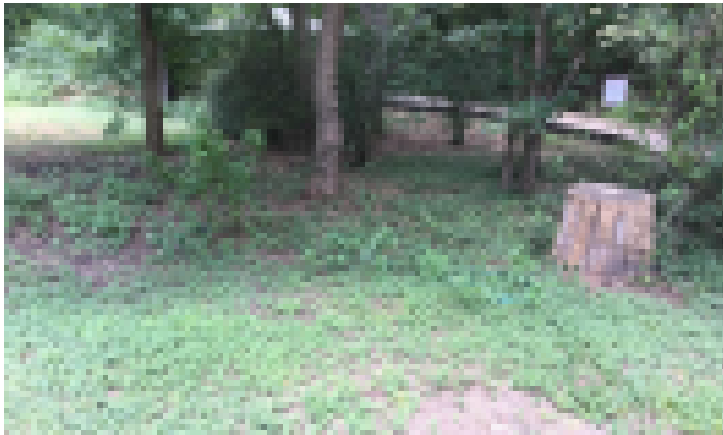
The approach walkway on the south side of the boardwalk was constructed so that it is elevated slightly above the adjacent grade, which obstructs the natural drainage pattern from west to east and creates nuisance water. These low-lying areas should be regraded and area drains installed to reduce the amount of standing water.

Low Lying Area Adjacent to Elevated Concrete Walk

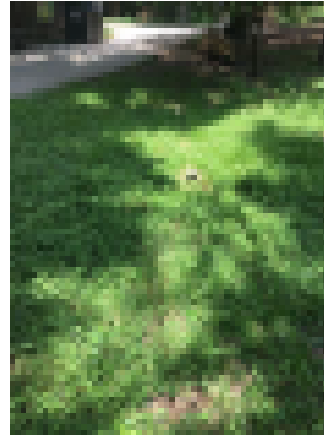
Low Lying Area

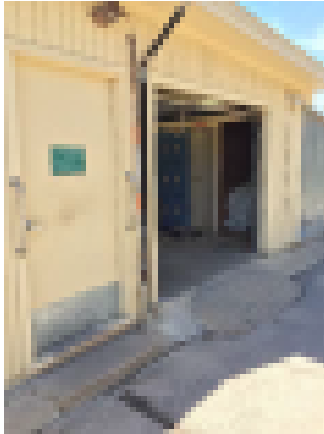
The entrances at the Production Glass Greenhouse and the Potting Shed are not considered with the threshold height between the outside grade and the interior concrete paving. Pavement should be modified outside to gradually slope up to the existing stoop. The door hardware at the Production Glass Greenhouse does not meet current accessibility standards with its knob hardware. The door hardware should be replaced with lever type hardware to meet accessible requirements.

Non-Compliant Entrance

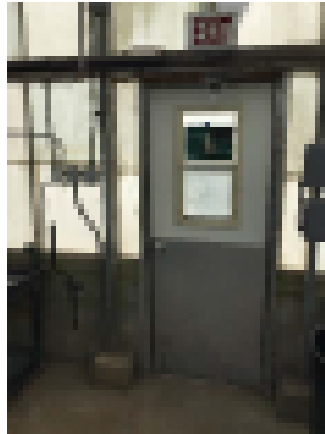
Knob Hardware

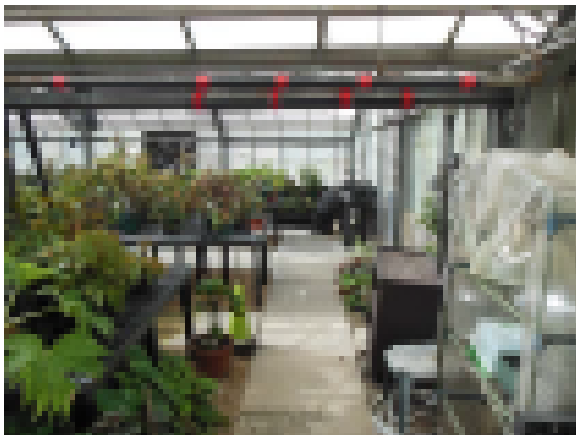
The head clearance of the galvanized steel structure does not meet accessibility compliance. The structure between the two bays and the unit equipment is hung approximately 70" a.f.f. As this issue cannot be resolved without rendering the greenhouse non-functional it is recommended to indicate the lower clearance with clear signage. The exit signs above the egress doors are reflective and non-illuminated. For compliance, replacement with illuminated exit signs is required.

Low Structure Clearance

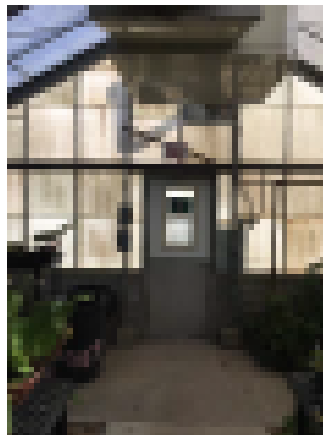
Non-Illuminated Exit Signs

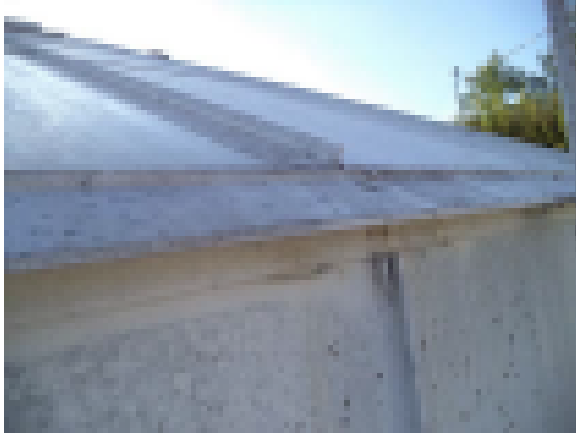
The existing glazing & glazing system are in need of replacement. It is recommended to replace with a new mill finish aluminum TECHLITE glazing system and 16mm clear Impact Modified acrylic glazing panels. Currently, there is a manual ridge vent that for all intents and purposes is non-functional. It is recommended

Outdated Glazing System

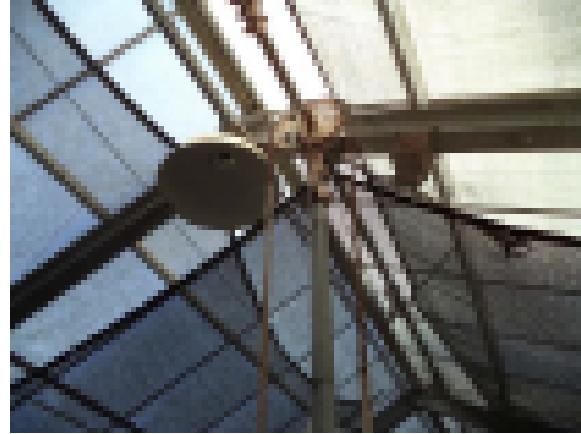
Corroded Ridge Vent Drive

to install an automatic ridge vent drive system for tighter temperature control including new rack and pinion vent operators, drive shaft, and drive motor(s).

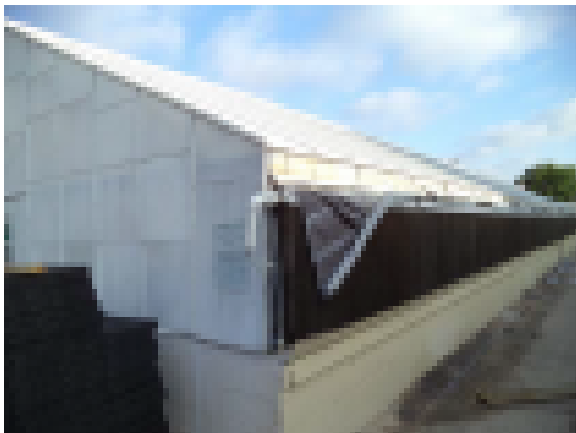
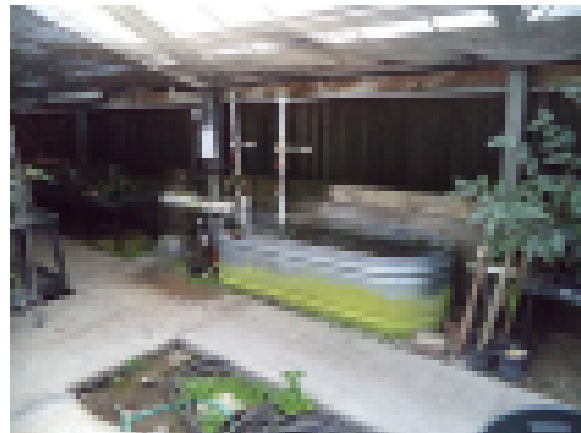
The existing evaporative pad cooling system has wood framing and open water collection system. It is recommended to replace the existing evaporative cooling system and all wood supports with a new efficient evaporative pad cooling system using new aluminum stringers, framing, and flashing. Furnish and install new outside vent operator system supported by 2.5" galvanized steel posts.

Vulnerable Evaporative Cooling System

Weathered Pads

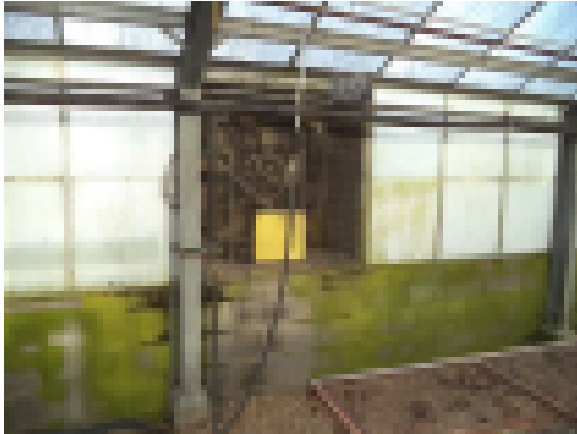
The existing exhaust fans, although very old, seem to be operational. It is recommended that if a new evaporative pad cooling system is installed, that replacement of the exhaust fans with new high efficiency models happen simultaneously. The existing system consists of unit heaters that 'blow' warm air through a fan jet tube that restricts space in the greenhouse. The fan jet model of heat distribution is outdated and a more efficient and 'plant growth friendly' means is to relocate the unit heaters to allow room for new shade system and utilize HAF fans to distribute and de-stratify warm air. It is suggested to remove the jet tube system and relocate the existing unit heaters.

Outdated Exhaust Fans

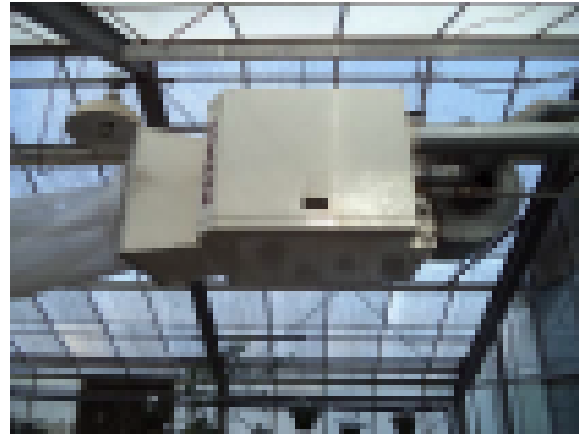
Unit Heaters and Fan Jet Tube

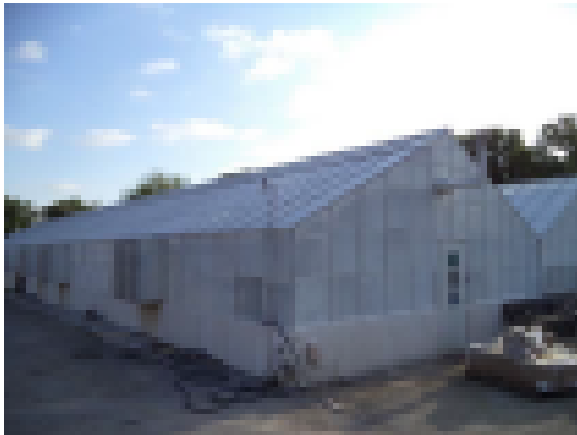
The existing shade cloth is an exterior type spray on shade. It is recommended to install a new automated interior shade cloth/heat retention system. The existing controls are a series of individual single stage thermostats. It is recommended to upgrade to a Wadsworth environmental control system.

Spray on Shading

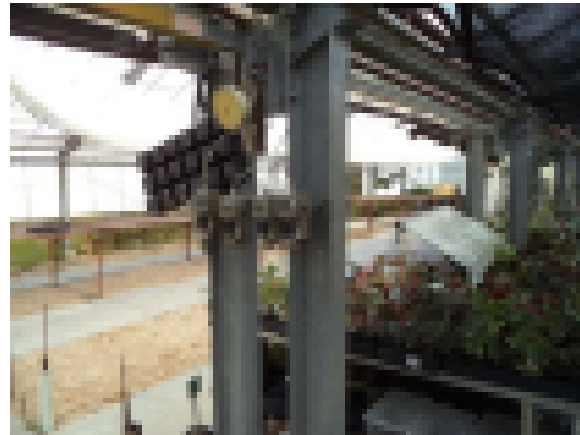
Single Stage Thermostats

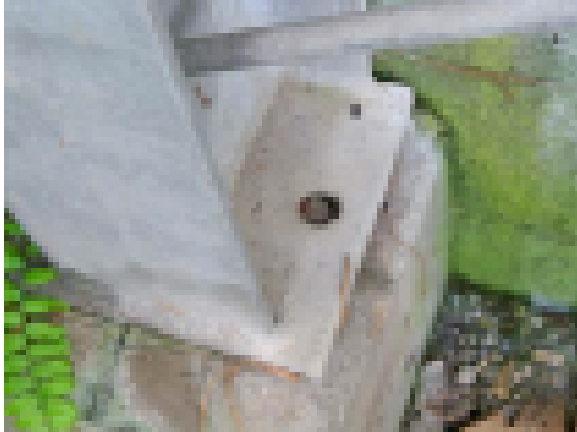
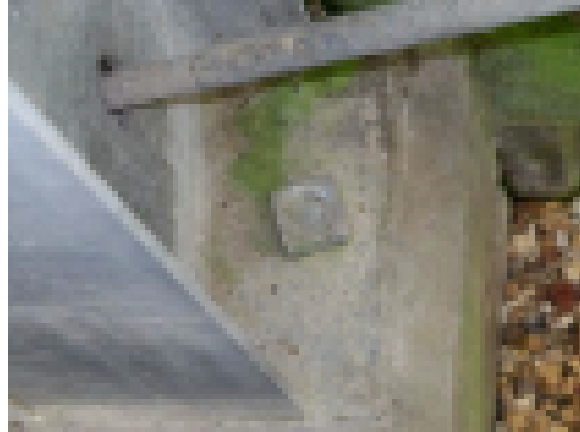
Many of the anchor bolts which were intended to connect the steel columns to the foundation were installed with inadequate bolt projections and thus did not properly engage the anchor bolts nuts. In some cases, the nut was simply omitted as shown in the photograph below, left; in some cases, the nut was applied but lacked proper engagement with the anchor bolt, as shown in the photograph below, right; and in other cases, the bolt was plug welded to the base plate. 56 of the 104 anchor bolts installed in this greenhouse (54%) lacked sufficient attachment and require remediation. It is recommended to plug weld these bolts to the column base plates and apply a zinc rich repair paint to the welded area.

Missing Anchor Bolt

Plug Welded Anchor Bolt

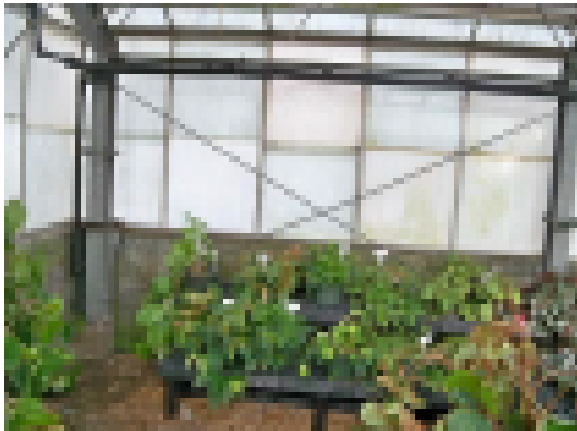
There are eight wall X-braces within the Greenhouse. Most of these are loose and require re-tensioning. It is recommended to re-tension braces to a snug tight condition. The anchor bolts at the southeast corner of the building were set too close to the edge of the plinth which contributed to the spalling of the plinth. It is recommended that the spalled area of the plinth be removed and the plinth reinforced and enlarged to provide a minimum 2.5" clearance over the anchor bolts. Drill and epoxy three #3 U-shaped bars into the side of the plinth to be enlarged and repair with Sikatop 111 Plus repair mortar.

Loose X-Bracing

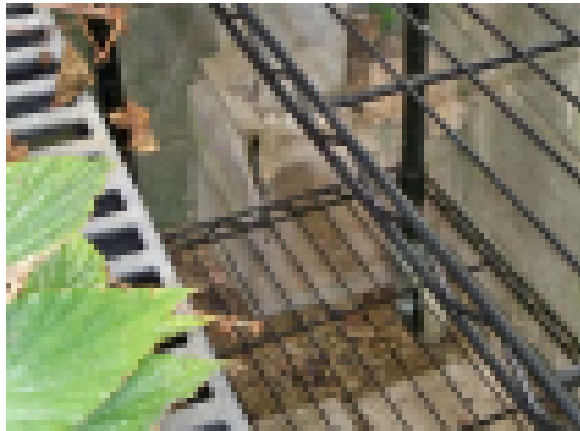
Plinth Spalling

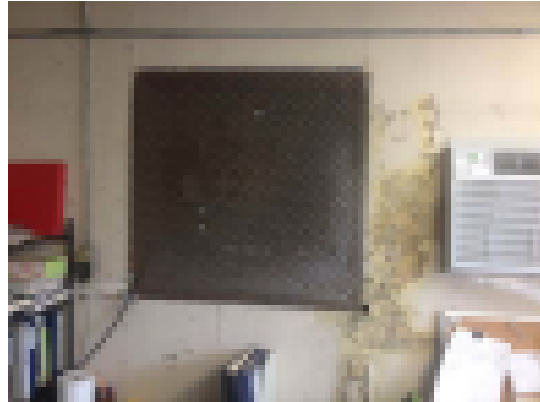
Wall Mount Exhaust Fan in Work Area

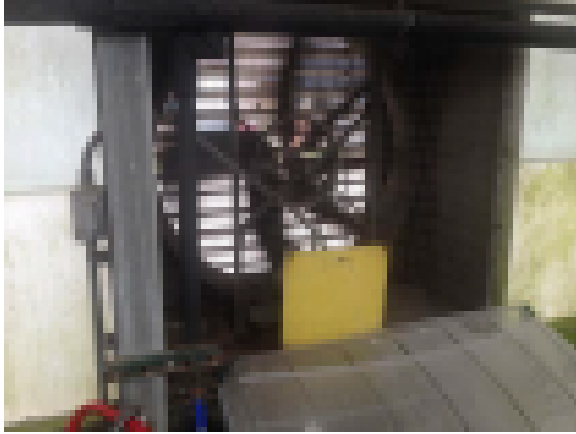
The five wall mounted exhaust fans appear to be original to the facility. Numerous exhaust fans squeak and have loose belts. It is recommended to replace the exhaust fans due to years in service of 22 years and have service life between 15 to 20 years. Costs for replacement of these fans is included in the Greenhouse insufficiencies.

Wall Mount Exhaust Fans

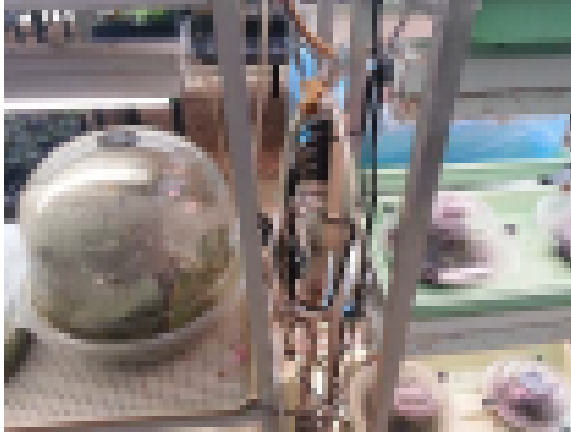
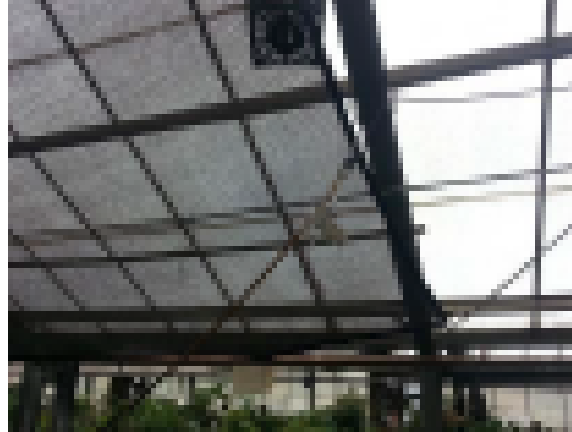
This Greenhouse needs more receptacles throughout the facility. Current needs are met using power strips and extensions cords. Provide two to four quadruplex receptacles per rack depending on rack use.

Example of Power Strips in Greenhouse

Example of Extension Cord Use

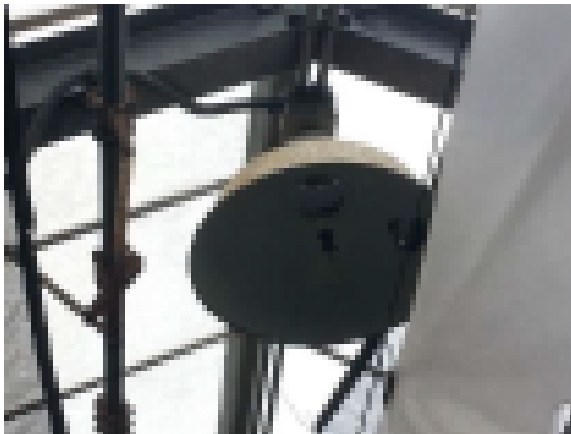
Existing general lighting is not operational and needs replacement with new LED fixtures.

Example of Non-Operational Lighting Fixture

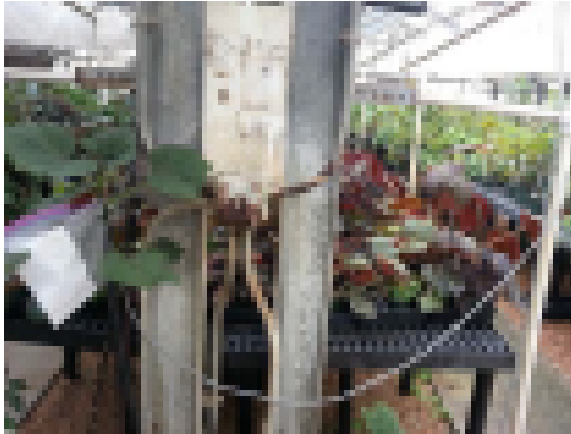
Power raceways are in disrepair throughout the entire building. It is recommended to repair these raceways.

Raceways Requiring Replacement

Repair/Replace Existing Raceways	\$2,500
Sub-Total	\$2,500
Contingency	\$500
Total Cost	\$3,000

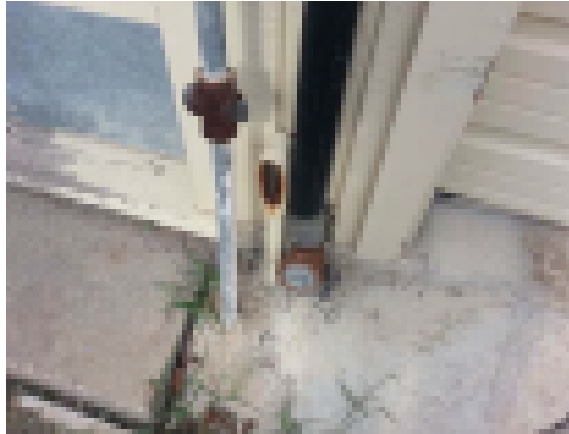
Raceways Requiring Repair

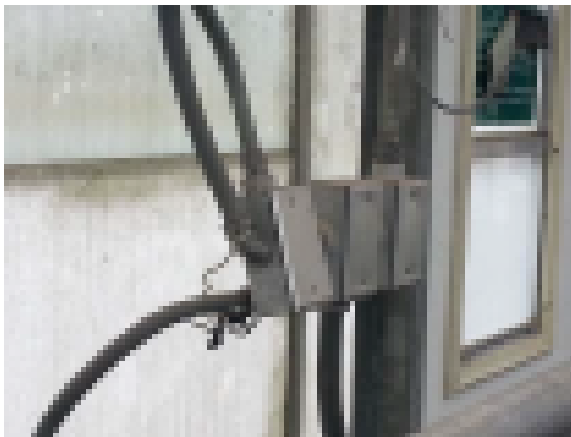
Raceways Requiring Repair
