Facility Assessment
Fort Worth Botanic Garden
3220 Botanic Garden Boulevard
Fort Worth, Texas 76107

August 31, 2018
PROJECT NO. 16-1031.00

Assessment – Fort Worth Botanic Garden

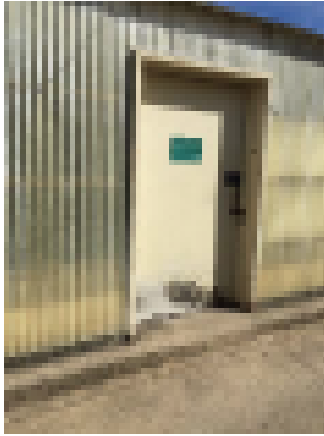
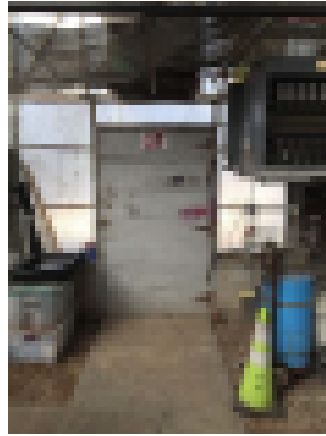
None of the three entrances are accessible as they exceed the 5 lbs of opening force at these heavy wood doors, along with the door jamb depth being greater than 8” (10” depth provided). The NW sliding door is constructed with a stepped foundation as you cross the threshold. The door hardware at the north swinging wood door does not meet current accessibility standards with its latch and should have hardware that meets accessible requirements. The 80” minimum clearance for projected elements such as various ceiling hung equipment does not meet accessibility compliance. Unit heaters in the area are currently hung at approximately 65” a.f.f.

Non-Compliant Door (West) Non-Compliant Door (North)

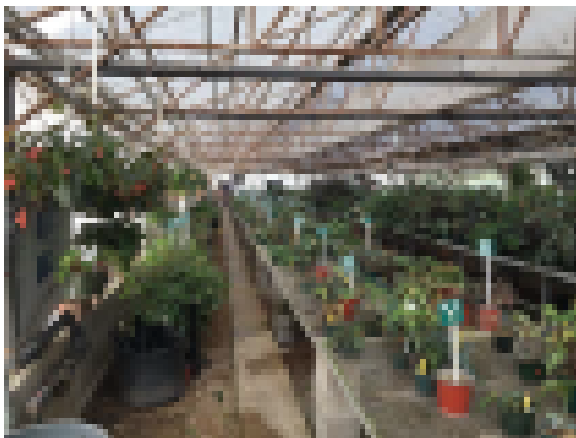
Concrete pathways provided on the interior are 18" and 24" wide. The minimum accessible route width is 36". These concrete pathways need to be 36" minimum. The exit signs above the egress doors are reflective and non-illuminated. These need to be illuminated exit signs. Pricing for all of these accessibility items is not provided as the overall recommendation is for demolition and replacement of the structure.

Narrow Concrete Pathways

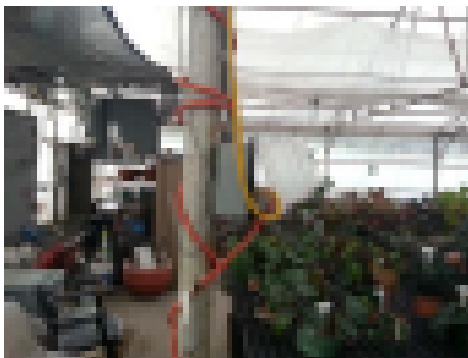
The Greenhouse needs additional convenience receptacles located throughout the facility. Current needs are met using power strips and extensions cords. Pricing for this item has not been provided as the recommendation is for total facility replacement.

Example of Extension Cord Use

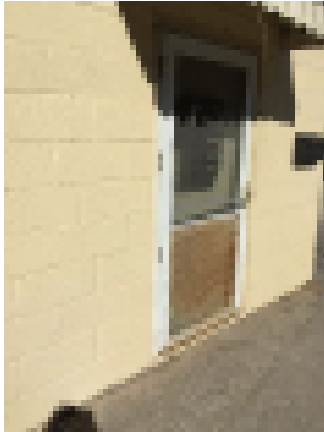
The office door threshold does not meet accessibility requirements with its change in elevation. There is a rise greater than 1/2" between the slab and the outside grading in addition to a storm door threshold increases this height restriction. Paving outside this entrance should be modified to allow for an accessible approach.

Shop Office Door Threshold

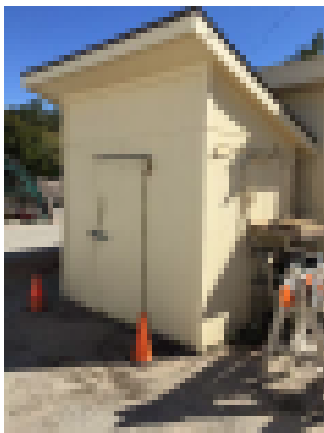
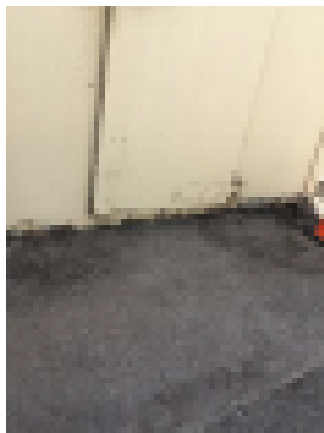
The wood paneling at the base of the refrigerated building is deteriorating from moisture and contact with the ground. Existing cladding should be removed and new weatherproof cladding should be applied to this structure. However, considering the function and location of this structure, consideration should also be made for an exterior rated pre-fabricated cooler. Pricing below reflects re-cladding.

Bulb Cooler Deterioration

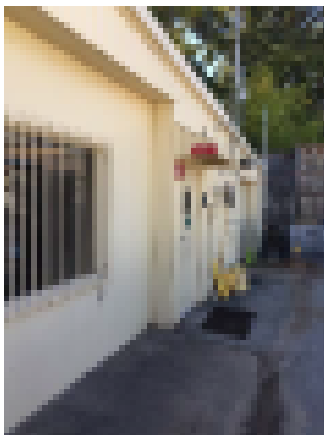
The north break room entrance door does not meet accessibility requirements due to its change in elevation at the threshold as well as the exterior approach slope. There is a rise greater than 1/2" between the floor slab and the outside grading in addition to a sloped stoop to the threshold. The south break room entrance door from the Japanese Gardens does not meet accessibility requirements due to its change in elevation at the threshold as well as the exterior approach. There is a rise greater than 1/2" between the floor slab and the outside stoop as well as the change in elevation from grade to the exposed aggregate stoop.

North Entry

It is recommended to demolish the interior of this building and reconfigure the space with accessible break room, restroom, locker, and shower provisions. It is also recommended to reskin this building with new metal panels and to add insulation at the roof and walls.

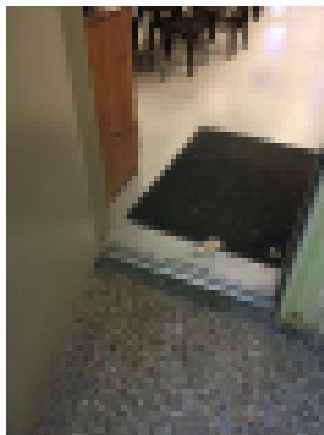
South Entry

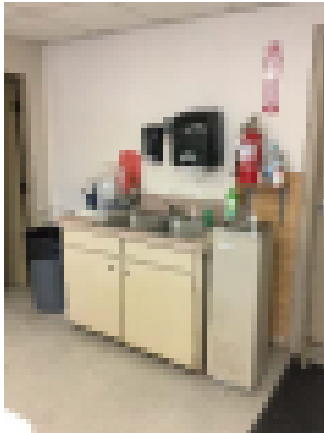
An accessible sink and counter with allowable knee space and appropriate height needs to be provided. An accessible Hi/Lo electric water cooler needs to be provided.

Sink and Water Cooler

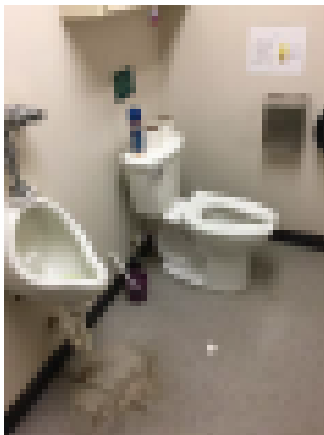
The restroom does not provide the accessible clearances required for fixtures, accessories, or proper turning radii. The shower room does not provide an accessible changing bench, turning radius, or an accessible shower with shower seat or rollover threshold. There are a considerable amount of stained ceiling tiles from either roof leaks or suspected mechanical condensation.

Employee Restroom

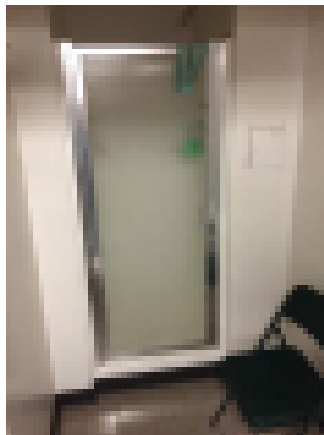
Shower Area

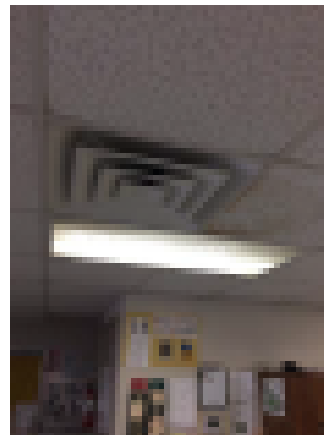
Stained Ceiling Panels

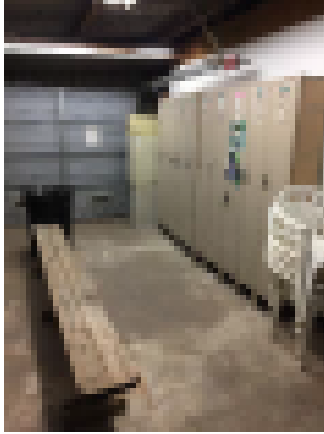
The locker room door does not meet accessibility requirements with its change in elevation at the threshold. There is a rise greater than 1/2" between the break room floor and the locker room floor. The locker room does not provide an accessible locker with proper reach ranges and heights require. The locker room bench is not accessible, though as this is not a changing room it is not required. Should the function of this locker room change to meet this requirement, an accessible bench would have to be provided. The fire proofing on ceiling inside the locker room area has been removed. It is suspected that the fire proofing was required with its former occupancy but is not required for the current one.

Locker Room

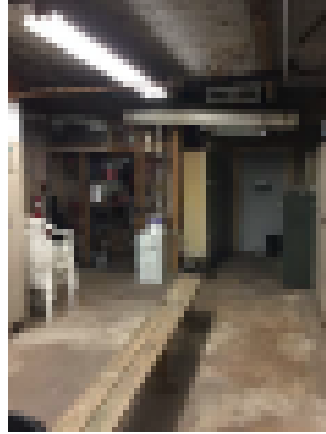
Missing Fireproofing

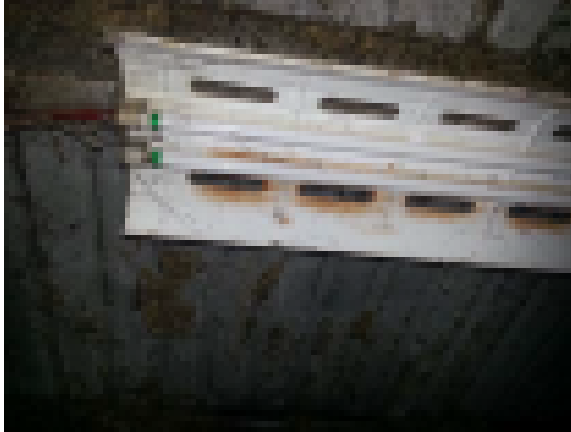
Locker room lighting shows signs of corrosion and needs to be replaced. In addition, the lighting in the office needs to be controlled separately from the locker room. There is a mostly unsupported MC cable installed on the east side of the Breakroom Building. This cable needs to be replaced with a conduit suitable to withstanding exterior environments. The back exit in the Breakroom Building has a non-lit exit sign. This sign needs to be replaced with an illuminated one.

Example of Corroded Lighting Fixture

Replace Lighting Fixtures in Locker Room	\$1,200
Provide Separate Controls for Office	\$300
Replace MC with Conduit	\$200
Replace Exit Sign	\$500
Sub-Total	\$2,200
Contingency	\$440
Total Cost	\$2,640

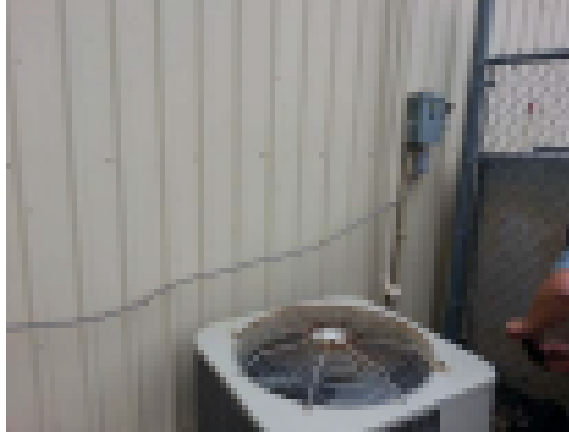
Exterior MC Cable Without Protection

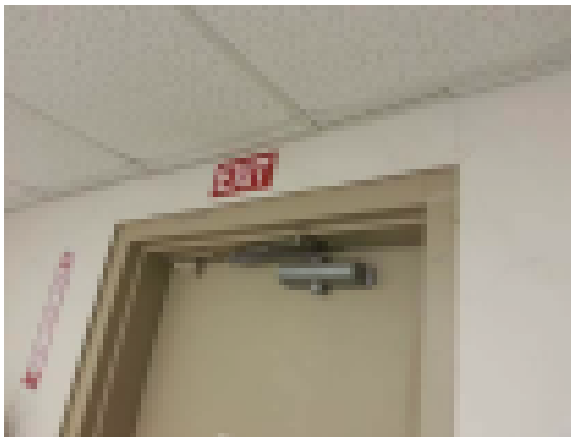
Non-Illuminated Exit Sign

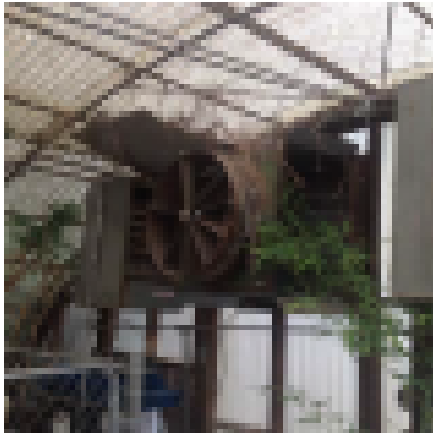
It appears that the unit heaters and circulation fan have been abandoned in place. It is recommended to demolish this equipment and its associated piping since it is no longer utilized. Pricing for the equipment removal and providing new is included in the overall pricing of the new building.

Unit Heaters and Circulation Fan

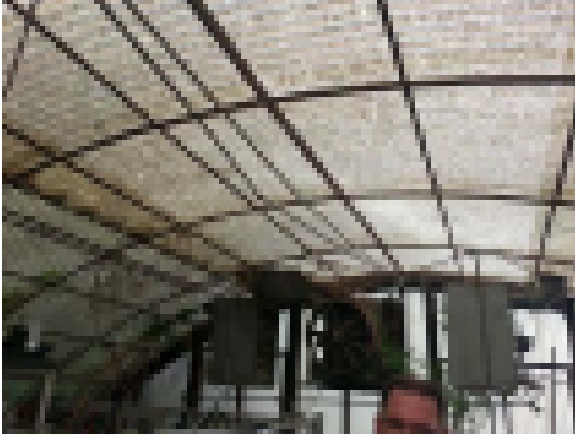
Equipment abandoned in place needs to be removed. Electrical raceways to remain need to be supported according to code, however, recommendation is for demolition of the entire facility, so pricing for this and providing new is included in the overall pricing of the new building.

Example of Unsupported Raceway

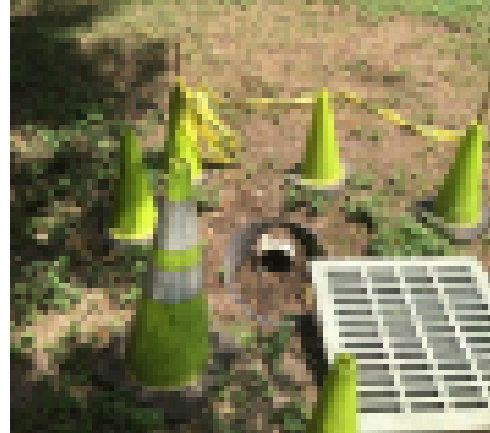
The North Vista lawn is elevated above the adjacent grade impeding the drainage patterns from West to East. Over years, this lawn has become compacted and worn resulting in localized puddling. Over time, staff has installed area drains to alleviate localized drainage issues. However, after rain events or heavy use, the lawn in the North Vista still sustains visible wear such as rutting, standing water and muddy areas.

Localized Drainage Solutions

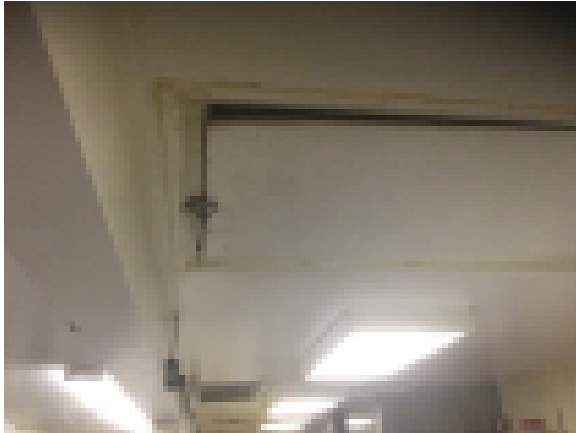
The kitchen needs to be renovated to be more efficient with its current layout. The current layout is two galley type runs that dead end which makes maneuvering difficult. The attic access, wall construction and finish materials are in disrepair and need to be completely renovated. With this renovation, consideration towards bulk storage should be given without use of the Triplex Building (17B) as a separate structure.

Attic Access

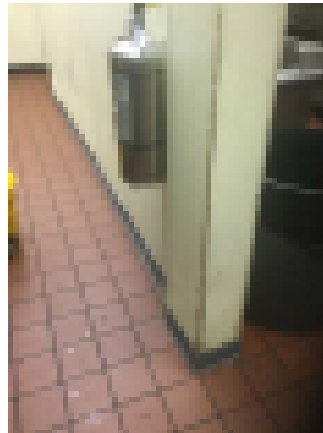
Finishes in Disrepair

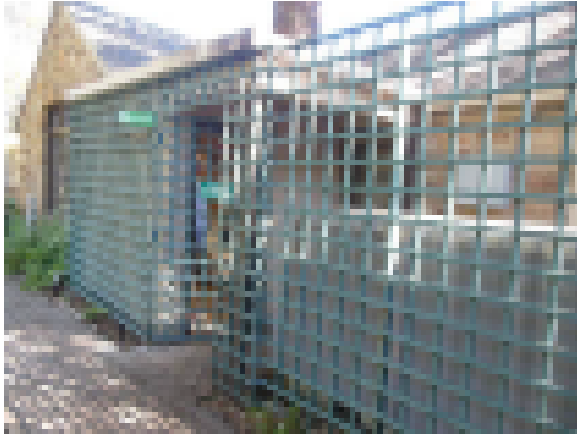
Restroom Access

The exterior public restroom accessed from the Fragrance Garden, does not provide the accessible clearances required for fixtures, accessories, or proper turning radii. Signage should be removed that points patrons to this restroom. Instead, the signage should point to the recently renovated public restrooms at the Japanese Gardens nearby.

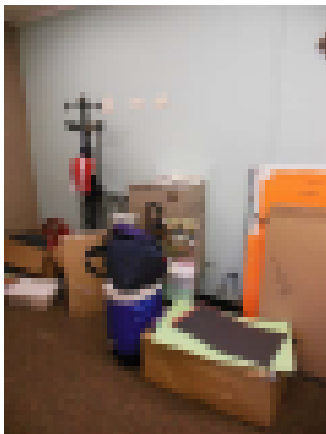
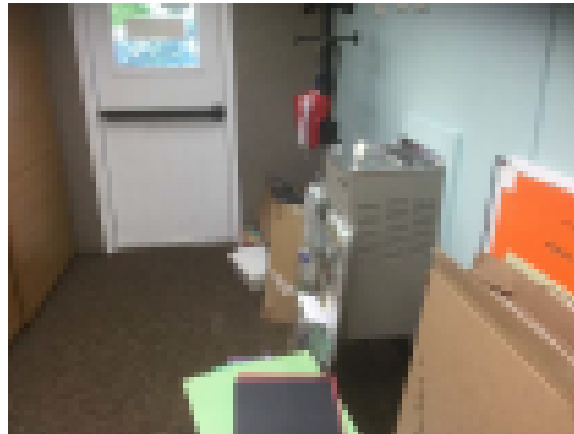
Office Water Cooler

Accessible water coolers should replace the currently inaccessible coolers.

Renovate Office Restroom and Break Area	\$51,750
Replace Knob Hardware	\$6,900
Replace Water Coolers	\$4,600
Sub-Total	\$63,250
Contingency	\$12,650
Total Cost	\$75,900

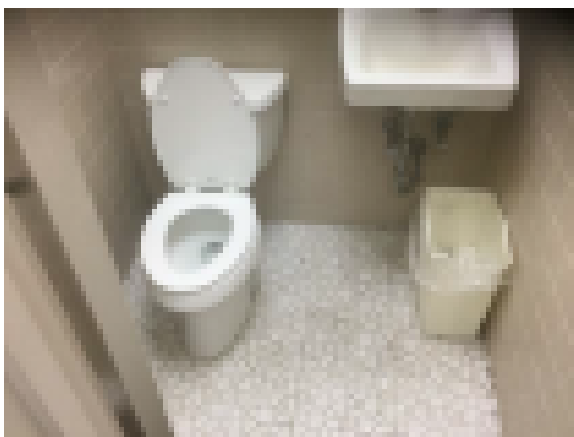
Inaccessible Office Restroom

The administrative restrooms do not provide the accessible clearances required for fixtures, accessories, or proper turning radii. These restrooms should be renovated along with the small break area adjacent to it.

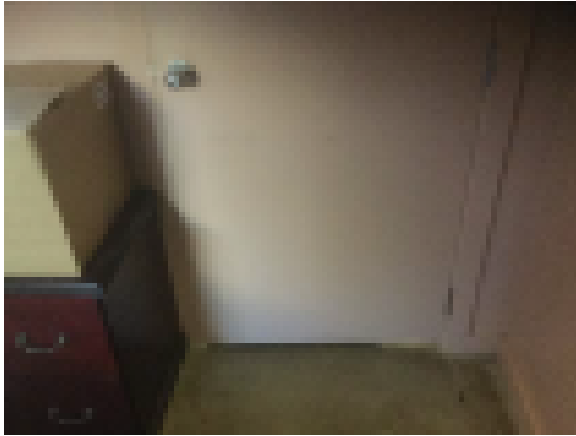
Knob Hardware

Doors throughout these spaces have knob hardware that should be replaced with lever type hardware except in those doors original to the 1934 construction.

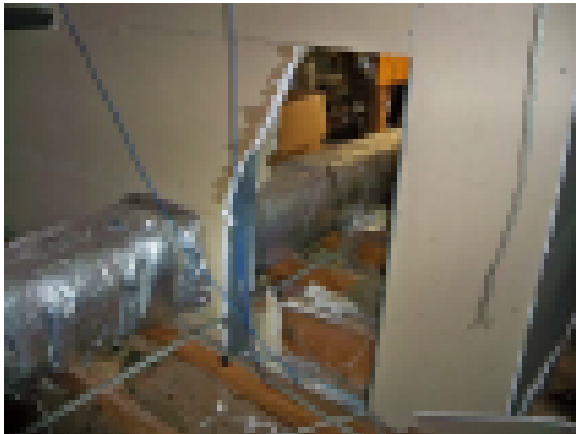
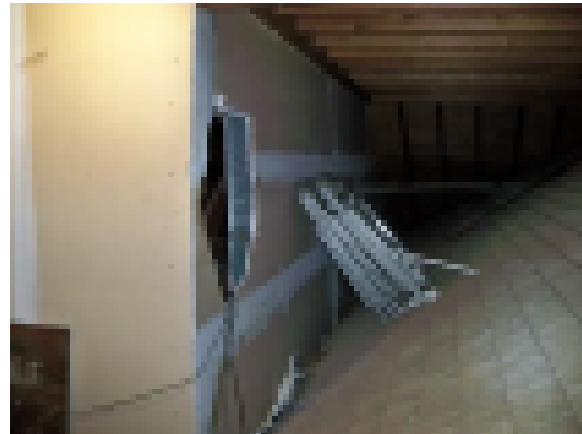
Breach at Fire Wall Penetration

The fire wall between the building expansions has been compromised. Penetrations through the rated enclosure need to be reconstructed and sealed properly.

Fire Wall Repairs and Sealant	\$3,450
Sub-Total	\$3,450
Contingency	\$690
Total Cost	\$4,140

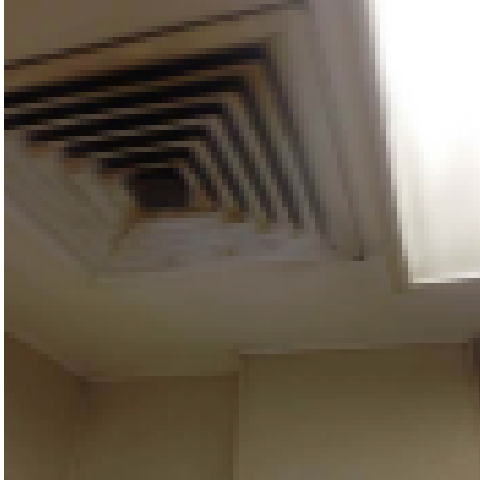
Rusted Air Device

There are numerous ceiling mounted air devices that are missing or have rust on the face of them. There is a return air grille not installed in the wall. There are bushes that are overgrown onto the outdoor condensing units. It is recommended to provide the general maintenance to resolve these issues.

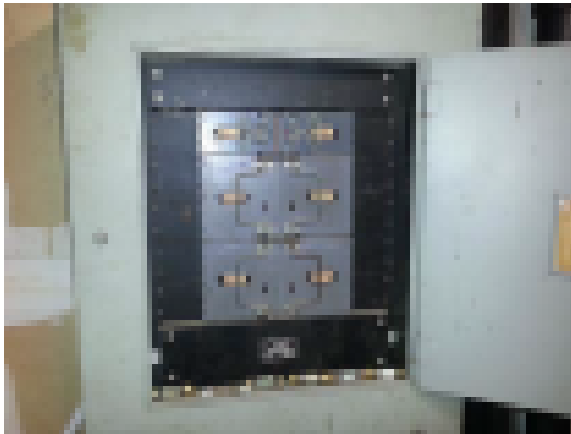
Mechanical Room Panelboard

The mechanical room panel, the dining room panel and the three panels in the back of the building need to be replaced. These panels have reached the end of their service life including the distribution panel in the rear which has a damaged bus.

Replace Panelboards		\$22,000
	Sub-Total	\$22,000
	Contingency	\$4,400
	Total Cost	\$26,400

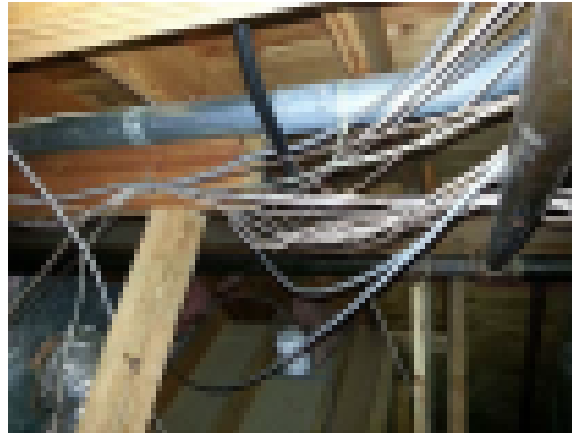
Examples of Cabling Needing Maintenance

Throughout the building, there are wiring devices in need of covers. The attic also has conduits and MC cables in need of support and general maintenance. An exit light requires relamping or replacement.

Replace Covers in Attic	\$500
Replace Lamps and Exit Light	\$1,000
Sub-Total	\$1,500
Contingency	\$300
Total Cost	\$1,800

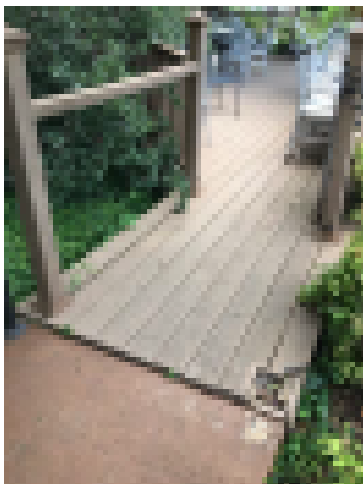
Deck Railing in Need of Repair

An elevated deck dining terrace is located between the Gardens Restaurant and Rock Springs Road, patrons can access the deck by either using steps or a ramp. This deck and railing is constructed out of composite material. Portions of the ramp rails have been damaged or are missing, and the threshold between the concrete walk and decking exceeds the maximum allowable change in elevation. The ramp approach and handrails should be reconstructed to be in accordance with current standards.

Concrete Walk & Ramp Replacement	\$15,000
Deck Rail and Ramp Approach	\$3,500
Rear Entry Ramp Replacement	\$5,500
Sub-Total	\$24,000
Contingency	\$4,800
Total Cost	\$28,800

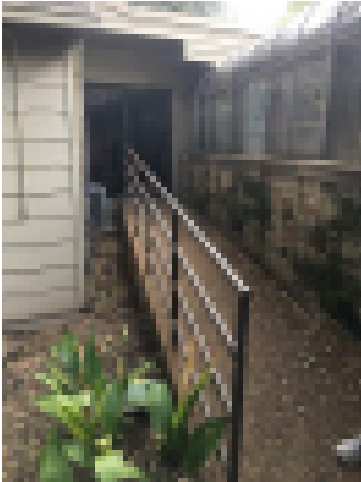
Existing Rear Entrance Ramp

The ramp exit at the rear of the Gardens Restaurant does have a landing at the door that is in accordance with the current accessibility standards. This ramp should be reconstructed.

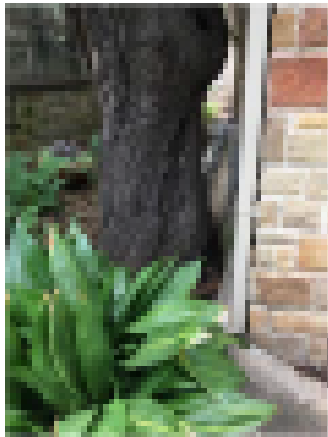
Concrete Drainage Flume

The flat planting area between the Exhibition Greenhouse and the Gardens Restaurant contains a concrete drainage flume that is intended to drain the downspouts and surface runoff in this area. Currently, a large oak tree has grown into the flume and interrupts the drainage flow causing backup into the Gardens Restaurant. This concrete flume should be removed (with careful attention around tree roots) and a new landscape drain / subsurface drainage system should be installed. All trenching should be performed using an air spade to keep the oak root system intact.

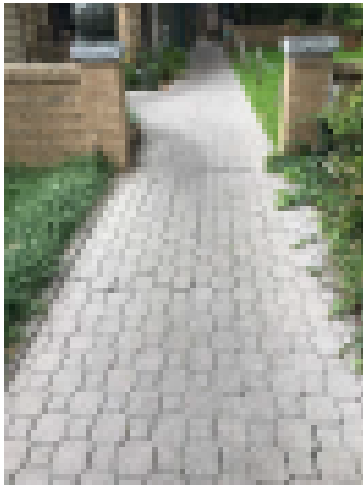
Shifting Pavers in Fragrance Garden Area

The concrete pavers in the walk behind The Gardens Restaurant leading to the Fragrance Garden appear to be shifting due to the proximity of the roots of a large tree nearby. These pavers should be reset and leveled.

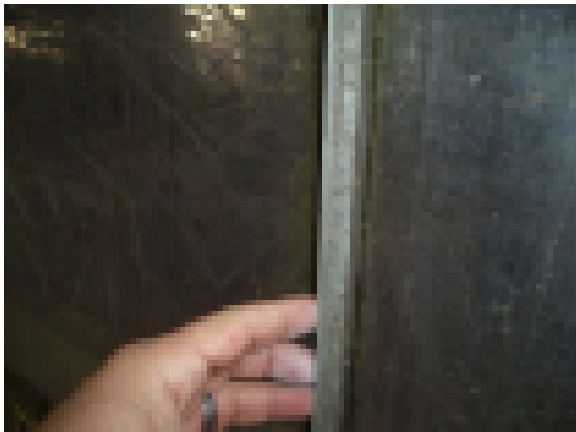
Outdated Glazing Bars

The existing glazing is in need of replacement. It is recommended to replace the glass as well as new glazing compounds. Existing aluminum glazing bars to remain. The manual ridge vent drive system is non-operational and it is recommended for replacement. Replacement recommendations include new drive shafting, rack and pinion vent operators, and automated drive motor(s)

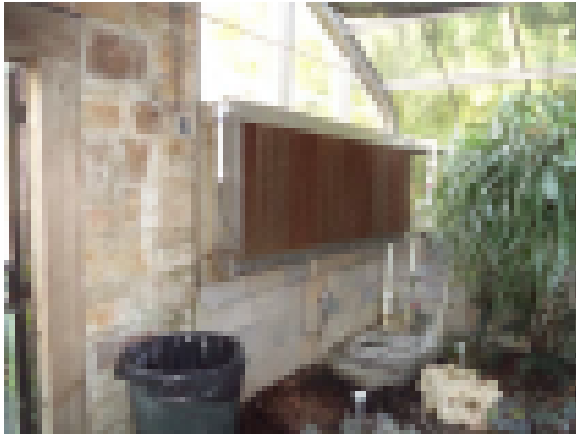
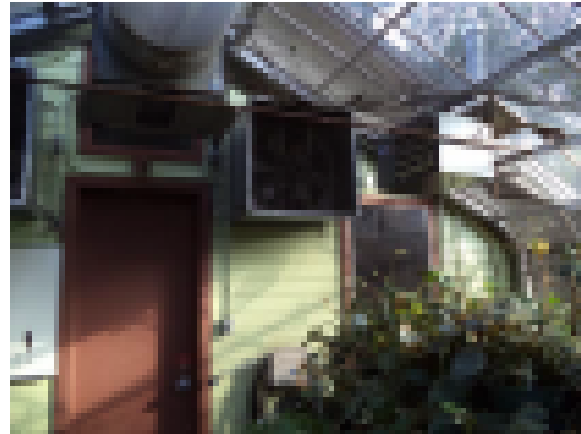
The existing cooling system consists of wood stringers and sunken reservoir kits. It is recommended to replace the existing evaporative pad cooling system and all wood supports with a new efficient evaporative pad cooling system using new aluminum stringers, framing, and flashing. Currently there are no HAF (horizontal air flow) fans. It is recommended to install HAF fans for better air circulation, as well as update to new more efficient exhaust fans. The existing system consists of unit heaters that 'blow' warm air through a fan jet tube that restricts space in the greenhouse. The fan jet model of heat distribution is outdated and inadequate. A more efficient and 'plant growth friendly' means is to relocate and mount the unit heaters to diagonal corners and utilize HAF fans to distribute and de-stratify warm air. It is suggested removing the jet tube system and relocating the existing unit heaters.

Evaporative Cooling Pad System

Exhaust Fans and Unit Heaters

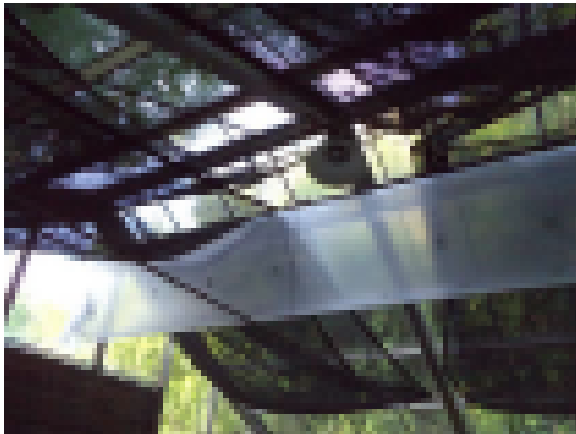
Existing Shade Material

The existing shade cloth is an exterior type shade cloth suspended between trusses. It is recommended to install a new automated interior shade cloth/heat retention system with flame retardant shade cloth. The current Wadsworth STEP (Simple Total Environmental Program) controls are no longer supported by Wadsworth Controls and are obsolete. It is recommended to upgrade to a newer and supported Wadsworth environmental control system.

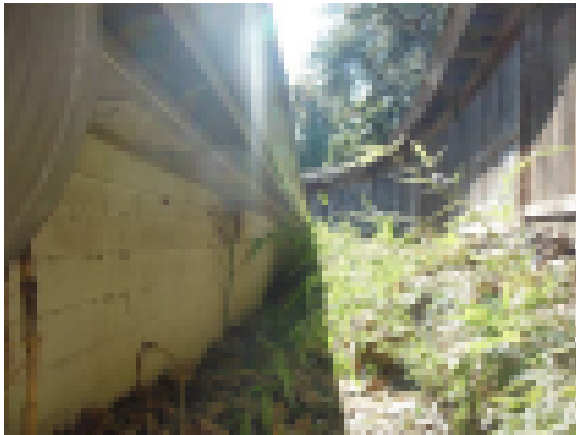
Grading at Exterior Wall

Due to repetitive water intrusion, the wood framing and plate is suspected to be subject to rotting compromising the building structure. Along with improvements to the grading around the building included in the site scope, the interior plywood paneling and exterior cladding along the back and side walls needs to be removed to examine the condition of the wood framing then replaced with an appropriately waterproofing detail. The gutter and downspout system connections need to be repaired to correct the rain water collection into the sub grade drainage system.

Exterior Wall and Waterproofing	\$17,250
Interior Cladding Replacement	\$4,600
Repair Gutter and Downspout	\$345
Sub-Total	\$22,195
Contingency	\$4,439
Total Cost	\$26,634

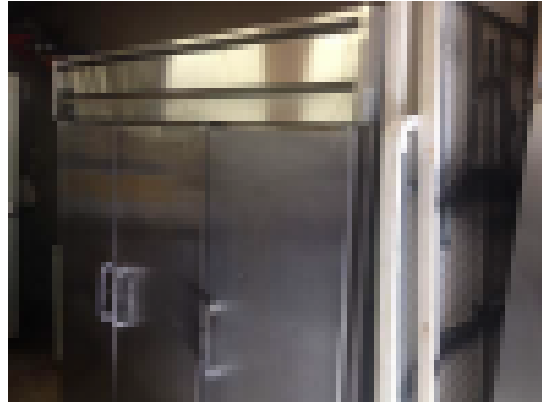
The room that contains kitchen dry goods and houses kitchen coolers, freezers, and other equipment is extremely warm. It is recommended to provide an air conditioning system to this room and incorporate some treated outdoor air to provide a slight positive pressure. Air conditioning this space should aid in the longevity of kitchen equipment. It is also recommended to provide forced air ventilation into the storage room portion of this building. Fresh air is currently being provided manually by propping a door open,

whereas fresh air movement should be provided with an outdoor air intake louver as well as an exhaust air vent out of the building.

Dry Goods Area

Kitchen Equipment in Dry Goods Area

Provide New Air Conditioning	\$19,000
Power for New Air Conditioning System	\$6,000
Provide Ventilation for Storage Area	\$4,000
Sub-Total	\$29,000
Contingency	\$5,800
Total Cost	\$34,800

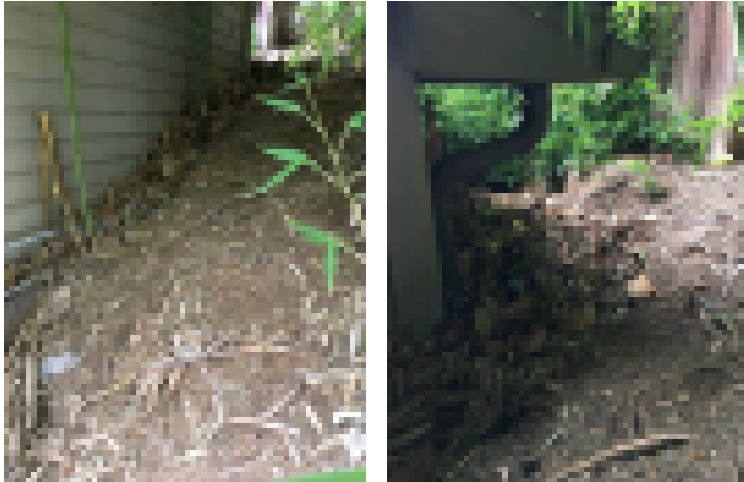
Triplex Building Slopes

The ground slopes toward the Triplex building, allowing sediment and debris to build up at the base of the wall which has raised the elevation of the ground above the foundation. This has resulted in water seeping inside the structure. This area should be excavated and a French drain with drainage mat installed along the entire wall face below grade, then backfilled with a free draining fill with a perforated PVC pipe at the base of the wall that daylights either to the surface or connects to the adjacent storm drain.

This building is located directly adjacent a utility easement which may limit the amount of excavation allowed in this area. If excavation for the suggested improvements is not possible within this area then it is recommended that this building be demolished and reconstructed.

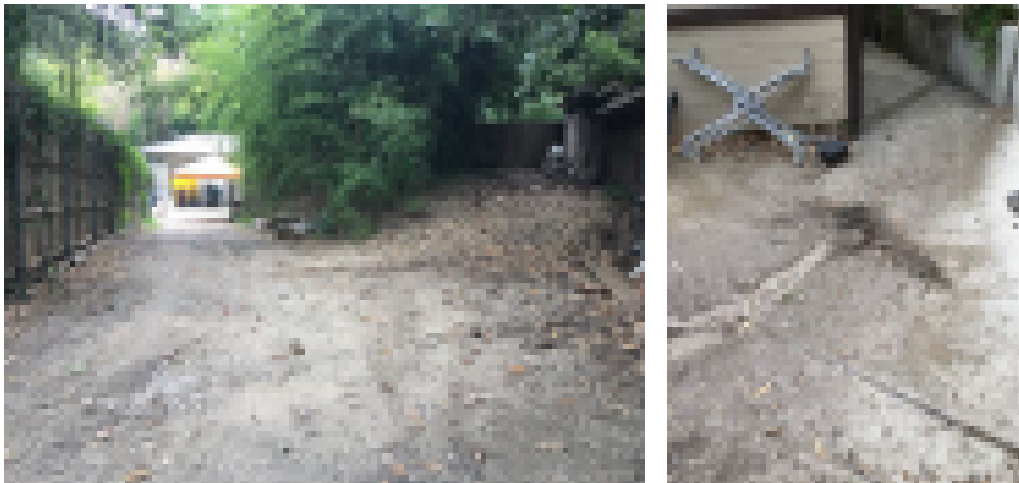
Existing Service Drive & Drainage Between Restaurant and Triplex Building

The service drive at the rear of the Gardens Restaurant and Exhibition Greenhouse, adjacent to the Triplex Building, slopes toward the buildings and collects at an area drain in the service area at the rear of the building. This drive is unpaved and runoff from this area carries debris and sediment which clogs the drain and leads to standing water. In the long term, this service drive should be reconstructed with concrete pavement with subsurface drainage collecting storm water. The concrete should be sloped in a manner so that, if clogged, the water overflows to the existing 24" inlet in adjacent landscape area. In addition, a pipe rail gate should be installed near the end of the service drive at Old Garden Road.

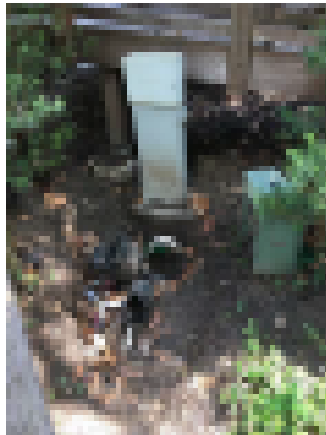
The irrigation system that is in use today was installed in 1981. Since that time, it has been modified extensively due to countless repairs and site improvements. This current system utilizes untreated river water, and the materials and equipment are out of compliance with today’s standards. The current system relies heavily on rotary heads which provide poor water coverage of the planting areas and extensive overspray on walkways which poses a slipping hazard and a maintenance issue throughout the Japanese Garden. The entire system should be upgraded with a new system that is installed to meet current City of Fort Worth irrigation design standards. It is also recommended that the irrigation system be upgraded with water conserving irrigation components. The controller should be connected to an overall Botanic Garden central control system.

Aging Irrigation Infrastructure

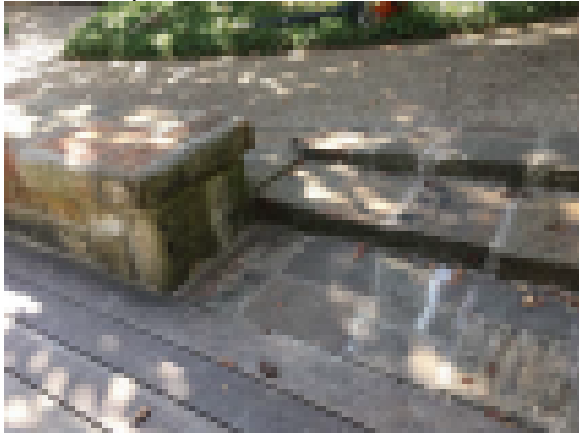
The pond overlook and koi feeding area at this location is constructed of natural stone surfaces and has two steps down from the adjacent pedestrian walk. At this transition, there is also a stone seat wall. Where the face of wall, pavement, and steps interface, the stone has an irregular and abrupt change in elevation. This stone pavement should be removed and reconstructed with original stones to eliminate this trip hazard.

Trip Hazard at Koi Feeding Area

Flagstone Repair		\$500
	Sub-Total	\$500
	Contingency	\$100
	Total Cost	\$600

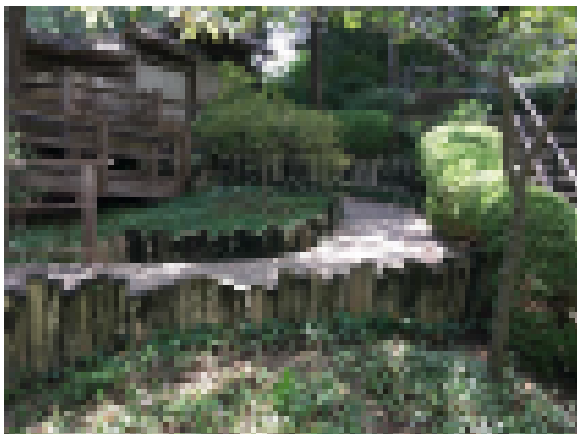
Just east of the feeding station and pond overlook in the northernmost pond there is a series of ramps and steps that provide pedestrian access from the pond to an upper level walkway. It appears that the ramps were constructed as an alternative accessible ramp adjacent to the concrete steps. This switchback walkway consists of both wooden boardwalk and concrete pathways. The concrete portions of the walkway are difficult to negotiate for visitors and slopes is out of compliance with current regulations. This walkway will need to be removed and reconstructed in accordance with current standards.

Steep Slopes on Accessible Pathway

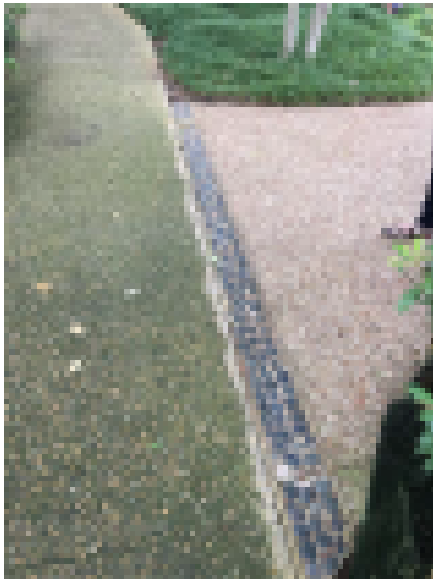
The intersection of the exposed aggregate concrete pathway near the entrance and the pathway to the restroom building has a black river rock paving band with exposed redwood expansion joints. This material is slippery when wet and of the rocks have popped out creating an irregular walking surface. There are approximately a dozen bands that should be removed and replaced with a slip resistant stone pavement.

River Rock Paving Bands

Replace Stone Paving Bands		\$8,000
	Sub-Total	\$8,000
	Contingency	\$1,600
	Total Cost	\$9,600

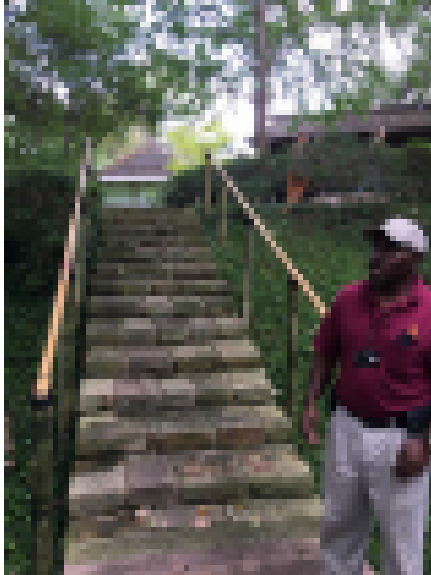
Non-Compliant Stone Steps

Repair Stone Steps and Rail	\$9,500
Boardwalk Drop Off Modifications	\$4,500
Sub-Total	\$14,000
Contingency	\$2,800
Total Cost	\$16,800

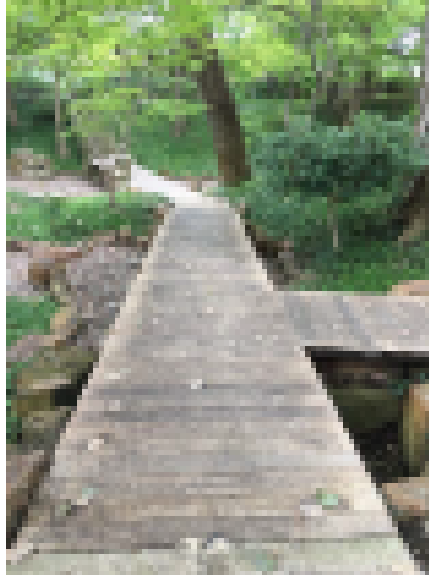
The pathway is constructed of both exposed aggregate concrete and an ipe wood boardwalk with no rails. Portions of the boardwalk appear to have a drop-off of over 30” above the adjacent surface, which by code requires installation of a guardrail. In lieu of a guardrail, additional fill and river rock could be added to bring the lower surface elevation to within compliance which is how costs are based.

Ipe Boardwalk Without Railing

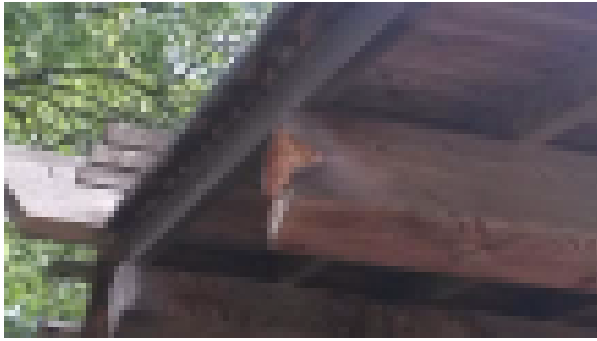
The smaller entry gate is a wood framed structure with heavy timber posts. Based on available drawings, this structure was constructed in 1981. The structure is in fair condition with some deterioration at cantilevered ends of the 6x8 roof beams from water and insect attack. It is anticipated that these beams will need to be replaced within 5 years.

Deteriorating Beams

Replace (2) 6x8 x 9-4" long redwood beams at the smaller entry gate.

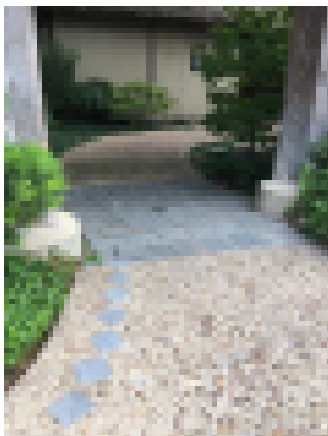
This area is well maintained however the paver portion of the walkways are shifting which has created an irregular walking surface. These pavers should be removed and re-laid on a new stable base material.

Unit Pavers Near Ticket Office

Repair Unit Pavers		\$1,000
	Sub-Total	\$1,000
	Contingency	\$200
	Total Cost	\$1,200

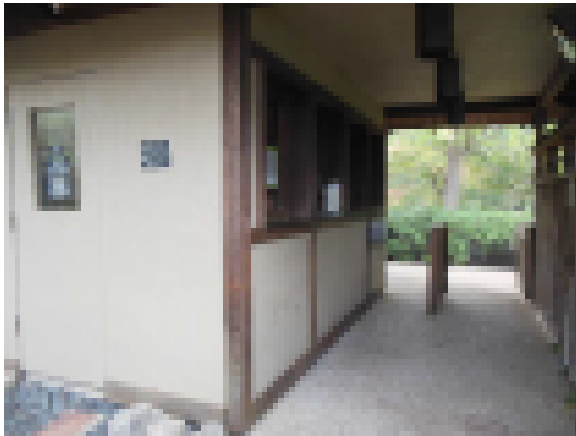
While the exterior of entire building is in fair condition, the exterior screen wall at the east ticket windows needs refinishing. The door and hardware at the west employee entrance has exposed rust damage and should be replaced. The wood trim at the base of the building has deteriorated from weather and needs replacing. It was reported that periodically in heavy rains, the cedar shake roof does leak. The current ticket transaction counter is not handicap accessible. A 36" wide portion of this counter will have to be lowered to 34".

Inaccessible Ticket Counter

Refinish Screen Wall	\$1,150
Replace Door at Rear Entry	\$1,725
Repair Trim	\$1,208
Accessible Counter	\$3,450
Sub-Total	\$7,533
Contingency	\$1,507
Total Cost	\$9,039

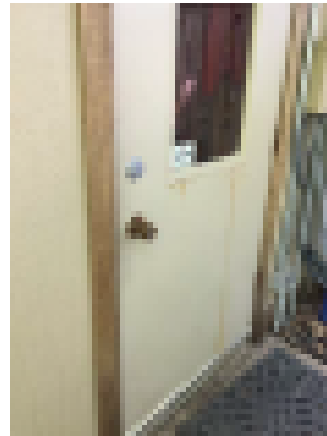
Damaged Door and Hardware

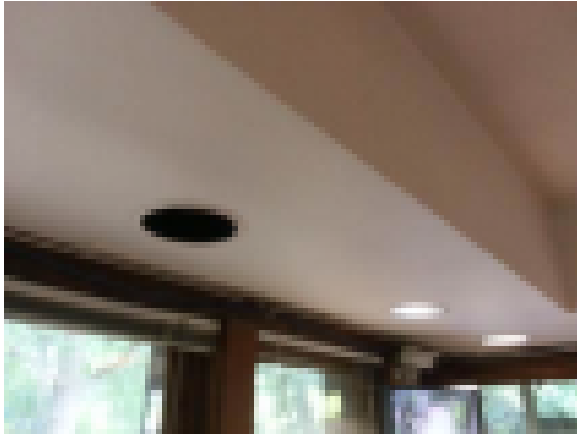
Interior Downlights Need Upgrading

It is recommended to upgrade switching in the restroom to occupancy sensors set for a minimum 20-minute delay, replace incandescent lamps with energy-efficient, LED lamps and provide a lighting fixture in front of the ticket window to allow ticket staff to see buyer clearly.

Upgrading to Occupancy Sensor	\$50
Replace Lighting with LED Lamps	\$250
Provide New Lighting for Ticket Window	\$350
Sub-Total	\$650
Contingency	\$130
Total Cost	\$780

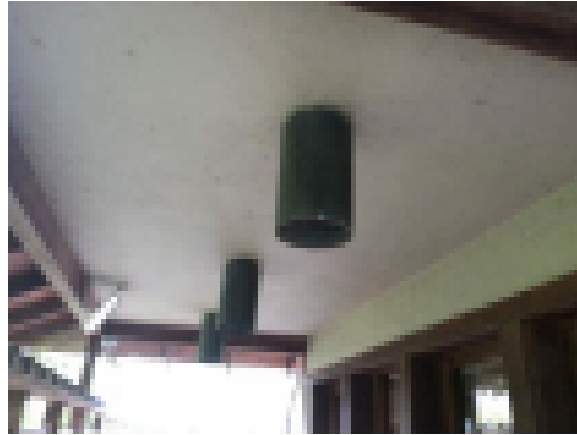
Exterior Cylinder Lights do not Light Adequately

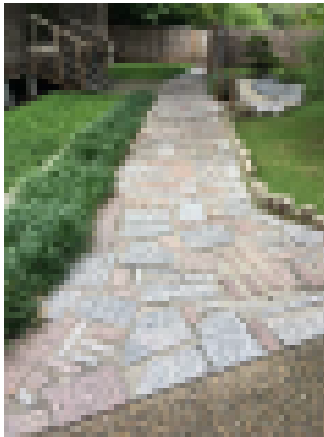
The garden itself is in good condition, but the approach walkway is constructed of small granite blocks in an irregularly laid pattern. These paver stones have a slick, polished surface and large uneven joints which pose a slip and fall hazard for visitors. This walkway should be replaced and reconstructed with a similar color granite paver that has a slip resistant (thermal) finish and laid in a pattern that has smaller and shallower grouted joints to provide a smooth walking surface. Additionally, just east of the garden is an overlook terrace that is constructed of natural flagstone on sand base. The stones are laid in an irregular pattern with variable width joints which present a tripping hazard. These flagstones should be removed and re-laid so they are level on a newly prepared flat sand setting bed with tight joints.

Approach Walk

Walkway Repairs		\$10,500
	Sub-Total	\$10,500
	Contingency	\$2,100
	Total Cost	\$12,600

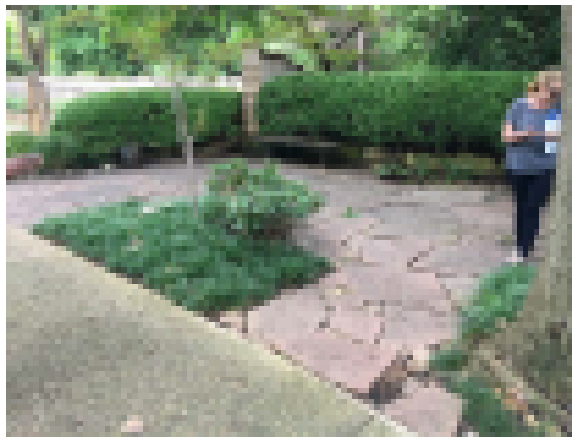
Irregular Flagstone Paving

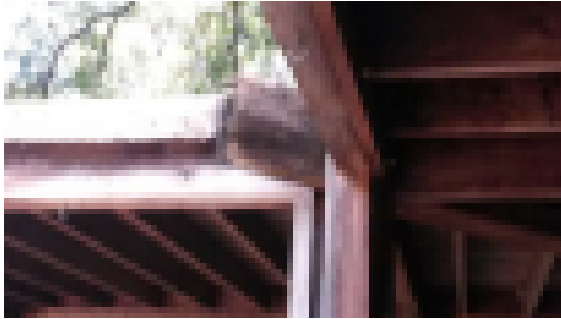
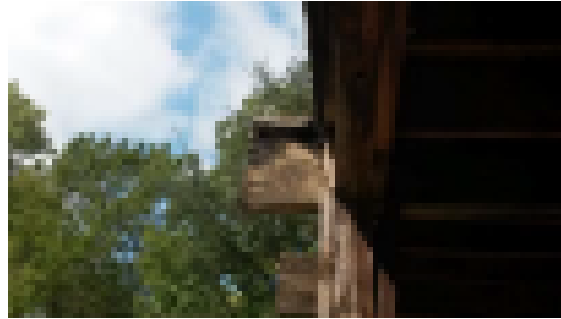
The exposed roof framing of the building is in fair condition with significant deterioration from water exposure which was only observed at the ends of roof beams. These conditions were observed throughout the structure.

Roof Beam Deterioration

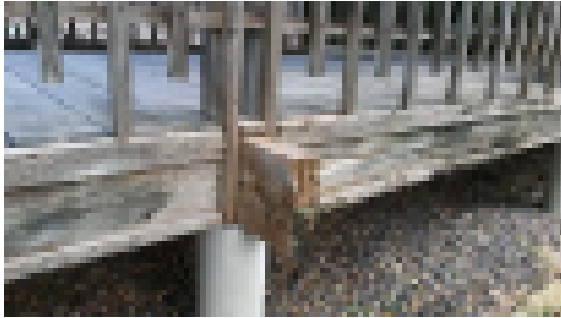
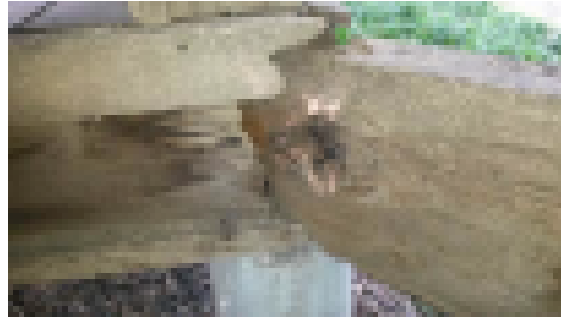
The floor framing is in poor condition with severe deterioration at most perimeter beams, caused by water exposure and insect attack. This deterioration has also compromised the beam to pier connections. The advanced deterioration of the floor framing compromises remediation efforts. It is believed that the safest and most cost-effective solution would be to demolish the building and reconstruct. While it is not believed that this condition constitutes an immediate life/safety issue, it is recommended that the building be taken out of service and reconstructed within the next 12-18 months. Refer to Architectural for building replacement costs.

Damaged Perimeter Beam

Building Demolition and Replacement	\$727,375
Sub-Total	\$727,375
Contingency	\$145,475
Total Cost	\$872,850

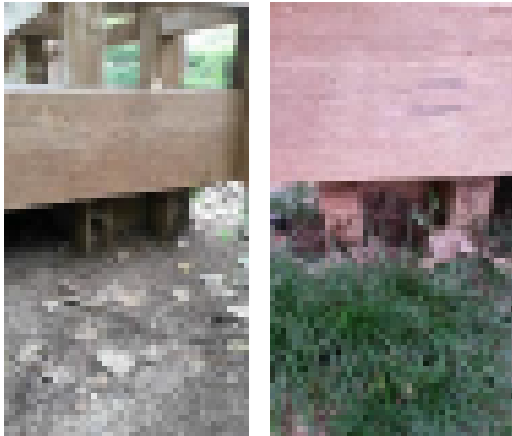
There is significant deterioration of the floor beams at the southeast and southwest corners of the structure. The deterioration occurs at the beam ends where they are too close to, or in contact with the soil. This deterioration was caused by moisture and insect attack. This condition does not constitute an immediate life safety issue, but should be repaired within the next 12 to 18 months. The recommended repair would entail shoring up the structure and replacing the damaged floor beams. Further, it is recommended that the replacement beams be from a wood species that is less susceptible to moisture and insect attack (such as ipe, teak, or other durable hardwoods).

Southeast and Southwest Floor Beams

Remove Existing Floor Beams and Replace with (4) 4x12 Ipe Floor Beams	\$5,520
Sub-Total	\$5,520
Contingency	1,104
Total Cost	\$6,624

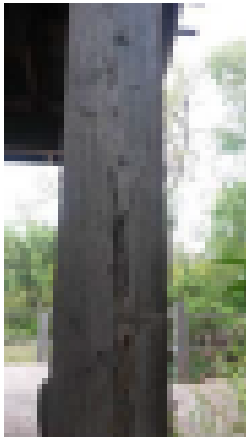
The wood framed arbor is supported on a concrete slab foundation. The wood posts and railing systems are badly deteriorated, having suffered moisture and insect attack. Examples of this deterioration was observed at the base of the northwest post, at the base of the southeast post, and at the dislodged railing adjacent to the northwest post.

Deteriorated Post

The wood structure is in poor condition with its column deterioration at the base, loose railing, and exposure to the elements. It has been recommended to demolish and rebuild the arbor in its current location.

The wood structure has been compromised by deterioration due to moisture and insect attack. The deterioration does not constitute an immediate life/safety issue, but should be addressed within the next 12-18 months. It is recommended that the superstructure (wood portions) be demolished and rebuilt with materials that are less vulnerable to moisture and insect attack (such as lpe wood). Refer to Architectural for anticipated costs to replace structure.

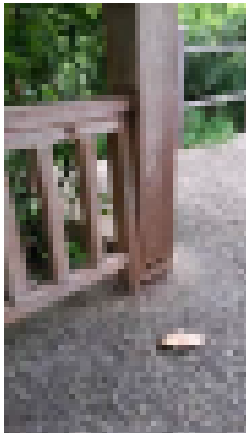
Dislodged Railing

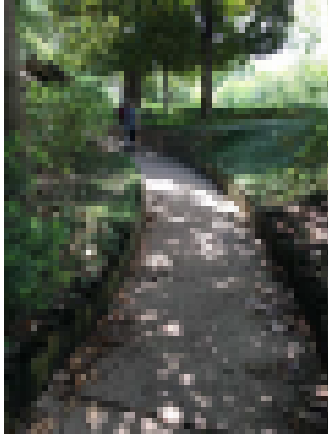
Just east of the Hill Arbor there are two parallel walkways that are constructed out of exposed aggregate concrete. The eastern most path is identified with granite block markers as an accessible pathway. Both paths are out of compliance with current standards due to steep running slopes, cross slopes and shifting pavement at joints caused by invasive tree roots. These pathways should be reconstructed to meet current regulations and eliminate existing trip hazards.

Steep Slope

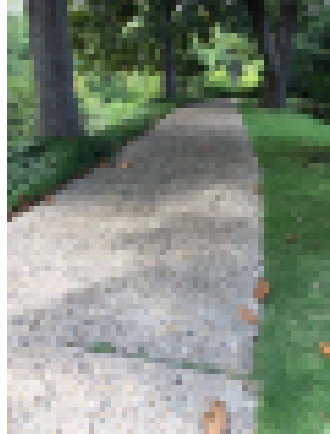
Trip Hazard

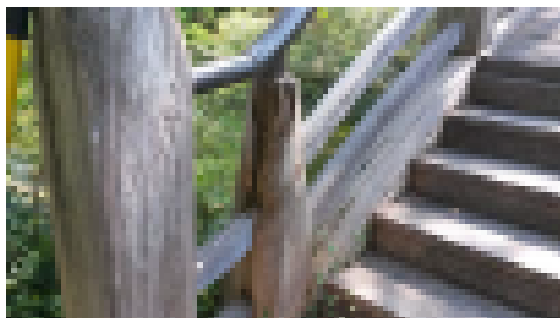
The wood bridge structure is in poor condition with its deterioration at the beams, steps and railing. It has been recommended by our team to abandon, demolish and rebuild a new bridge in its current location. During the timing of this assessment, this structure had been taken out of circulation to the public.

Bridge Deterioration

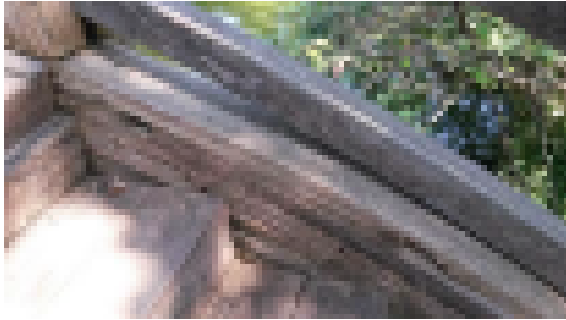
The wood glue-laminated beams and guardrail posts are severely deteriorated (photographs below). The bridge is a safety hazard and should immediately be abandoned and if desired, replaced with a new bridge. Refer to Architectural for Probable Construction Cost.

Deteriorated Beam

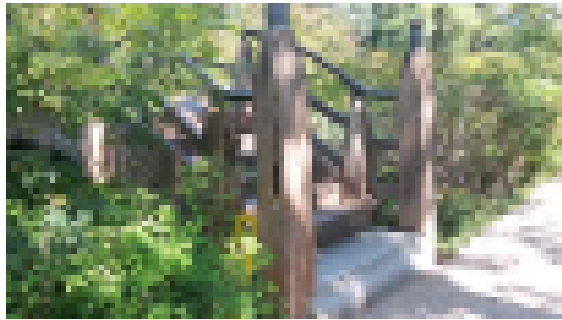
Deteriorated Posts

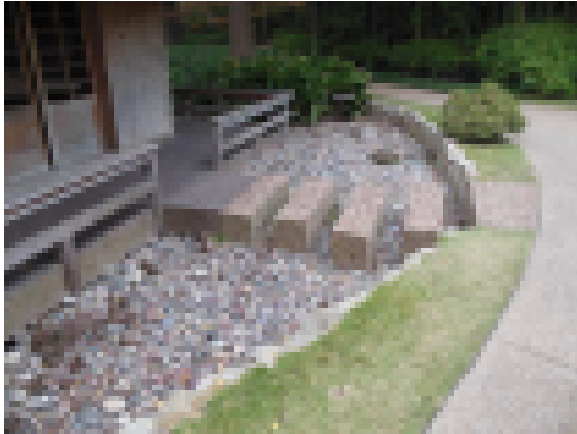
The 24" guardrail does not meet the current height requirements with the limiting capacity of a 4" sphere to pass through the guardrail openings. The entry to the teahouse walkway decking is inaccessible and extremely dangerous. A bridge or solid pathway should be installed in lieu of the stepping stones currently in place. The redwood decking at the perimeter walkway as well as the exterior paneling needs refurbishing.

Inaccessible Path

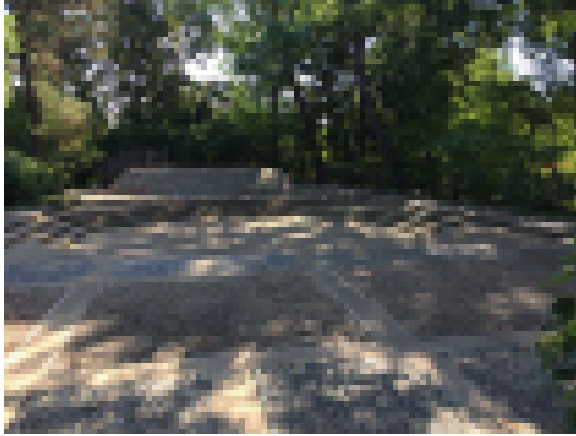
The concrete stage and sunken performance areas are in need of power wash cleaning.

Stage and Sunken Performance Area
