Facility Assessment
Fort Worth Botanic Garden
3220 Botanic Garden Boulevard
Fort Worth, Texas 76107

August 31, 2018
PROJECT NO. 16-1031.00

Assessment – Fort Worth Botanic Garden

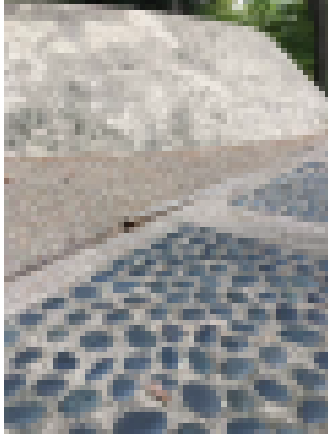
The redwood expansion joints are not sealed and consistently warp and heave creating tripping hazards. In addition, the river rock panels are extremely slippery when wet. All redwood joints in this area should be replaced and sealed. All river rock panels should be replaced with a more slip resistant stone or other decorative finish.

Heaving joint

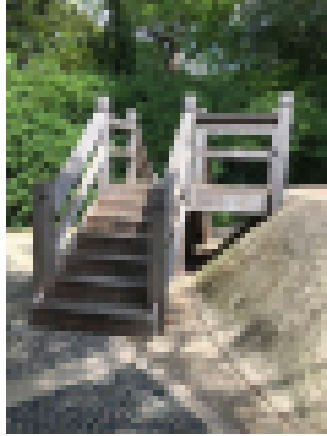
The steps that lead to the elevated stage are intended to provide performers with access to the stage area. The stage edge has a dangerous drop off that should not be accessible by garden visitors. A lockable gate that is complementary to the stair construction should be added to limit visitor access to the elevated stage platform. If the public is allowed to access the stage area, the stage edge drop (which exceeds the 30" maximum) should be addressed with the incorporation of a 42" high railing.

Steps to Performance Stage

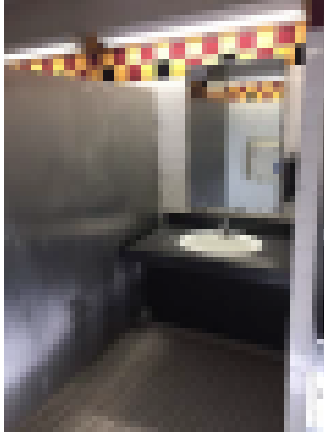
The Bride's Room and Restroom is in good condition. The plastic laminate countertops in the restrooms are starting to delaminate and should be replaced with a solid surface or a similarly durable counter for this semi-exterior condition.

Peeling Countertops

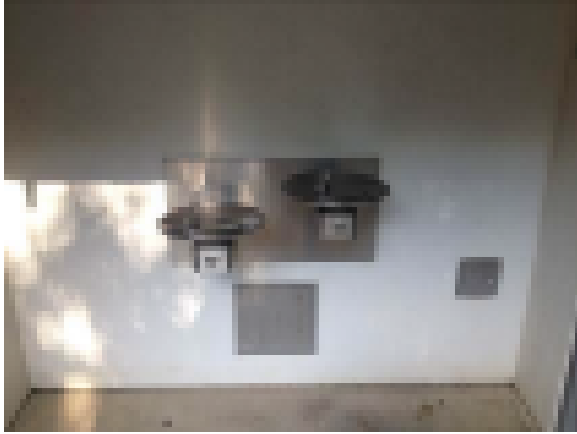
The lower water fountain was not operational. It is recommended to investigate and repair the issue. Until the cause can be determined, a cost can not be provided. A cost for the investigation is provided.

Hi-lo Drinking Fountain with Lower Bubbler not Functioning

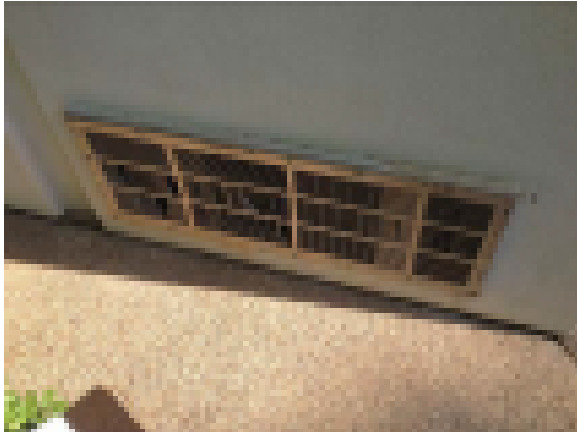
The exterior unit ventilator grille is damaged, and it is recommended to replace it.

Damaged Unit Ventilator Grille

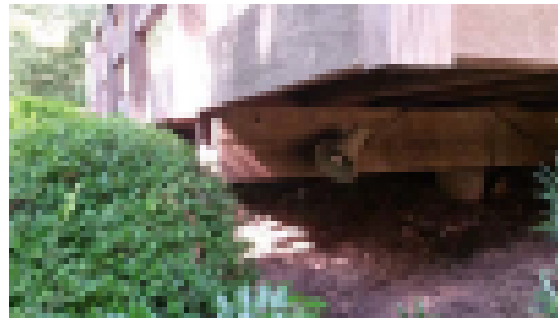
All five structures are wood framed and supported on a wood framed deck supported on concrete piers. The only distress observed was splitting of one of the floor beams at its cantilevered end near the northeast corner of the easternmost Pavilion. We believe that this splitting is related to wood shrinkage and has not compromised the beams' ability to support the imposed floor loads.

Beam Splitting

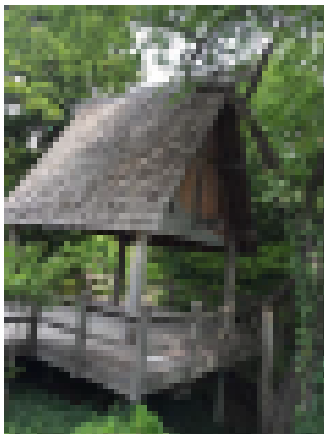
All structures need to have their cedar shake roofs repaired as they all leak onto their plywood paneling ceilings. After replacement of these roofs, damaged wood panel ceilings should be replaced. The exterior of the kitchen structure needs to be cleaned and refinished due to exposure. Several trim pieces are damaged from an apparent smoke exposure and should be replaced.

Pavilion Roofs

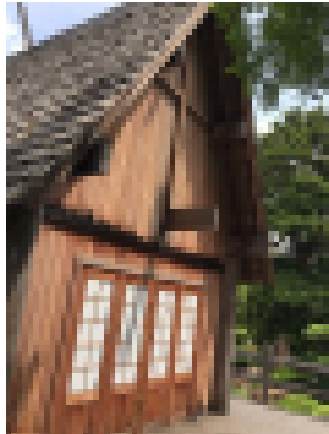
Kitchen Exterior

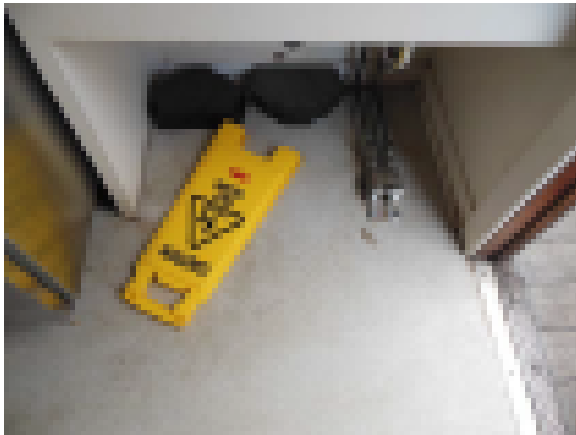
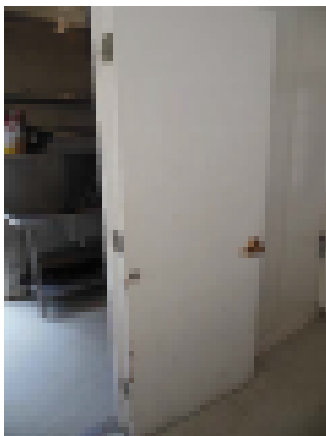
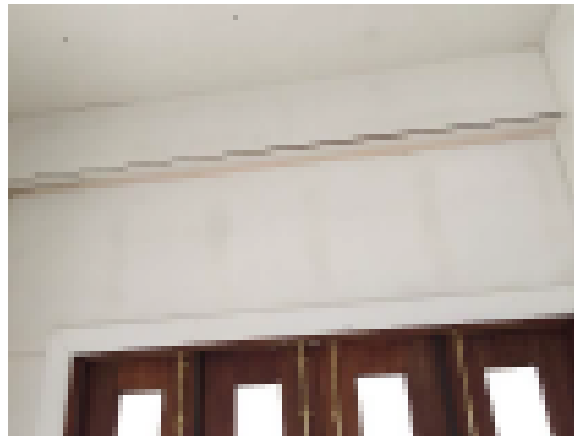
The finish materials in the Pavilion Kitchen have outlived their useful life. The laminated wall panels are splitting at their seams, while the plastic laminate countertop and millwork are becoming delaminated and stained. The hardware on the exterior door as well as the door and hardware on the interior door need to be replaced. The sheet vinyl floors are worn and have outlived its useful life and should be replaced. It is recommended to replace the millwork and install a solid surface countertop in lieu of the laminate finish due to this semi-exterior condition.

Damaged Sheet Vinyl Floor

Damaged Door

Damaged Laminated Paneling

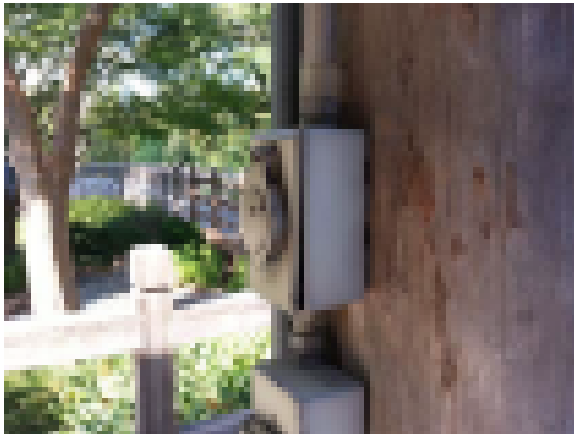
Damaged Dimmer Cover

It is recommended to upgrade the Pavilion lighting fixtures to energy-efficient LED downlights with new supports for downlights and new dimmers.

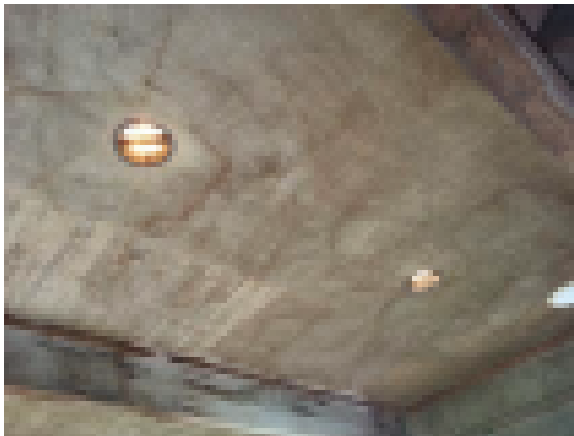
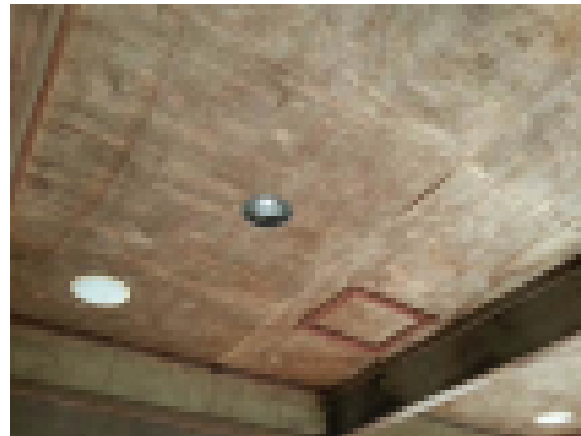
Downlights in need of upgrading

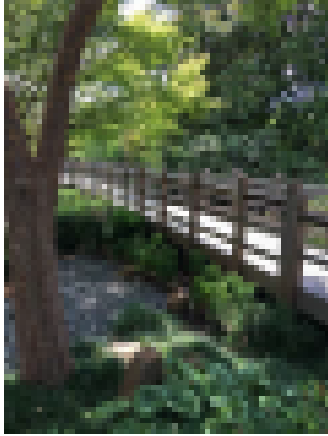
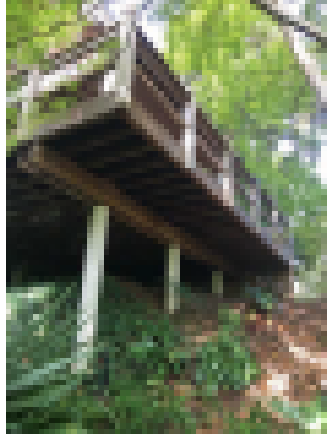
The guardrails that are installed have large gaps between members which appear to exceed limits allowed by current standards. These guardrails should be modified to reduce all openings to 4” or smaller.

Ipe Path and Rails

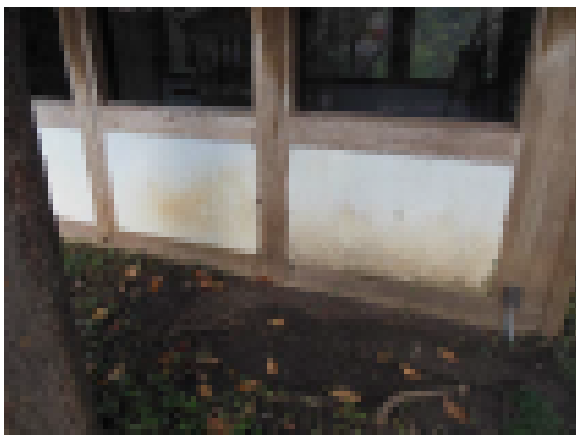
The faux stucco panels at the exterior walls are stained, cracking and coming loose and need replacement along with the base wood trim which has considerable water damage. The north stair entry needs to be reworked to provide an accessible handrail. The roof shows signs of water leaking and needs to be repaired.

Damaged Panels

Replace Concrete Board Panels		\$3,220
Replace Wood Trim		\$1,581
Stair Handrails		\$1,150
Replace Roof		\$5,175
	Sub-Total	\$11,126
	Contingency	\$2,225
	Total Cost	\$13,352

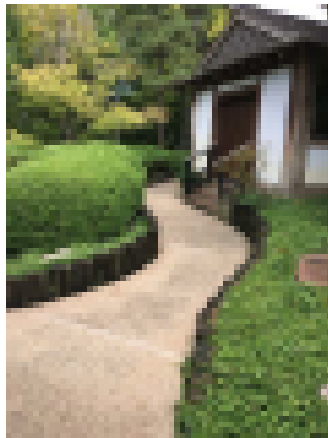
Adjacent to this shrine is a long meandering pathway that leads down to the pond and koi feeding area. Closest to the Mikoshi Shrine, the pathway is an exposed aggregate material lined with a landscape timber border. Approximately halfway down the slope, the surface transitions to asphalt as it continues to the pond. The walkway is difficult for some visitors to negotiate because of its variable slopes, cross slopes, and meandering character. This walkway should be demolished and reconstructed using a similar exposed aggregate paving in a new configuration that provides an accessible pathway around the building and incorporates a level landing at the entry steps to the shrine.

Sloping Pathway

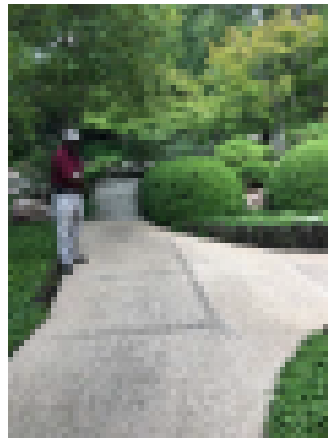
Intersection of Paths

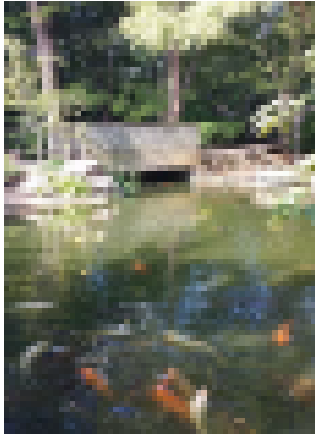
There are multiple locations where drain lines, valves, and pump equipment are deteriorating or in disrepair. In addition, pond weirs are leaking and causing erosion in multiple locations. New sumps with valves and drain line connections to the storm sewer system should be installed. The pond should be drained. The pond liner, including concrete shell and waterfall weir structures, should be repaired and waterproofed.

Pond with Concrete Liner

Pond & Waterfall Repairs		\$625,000
	Sub-Total	\$625,000
	Contingency	\$125,000
	Total Cost	\$750,000

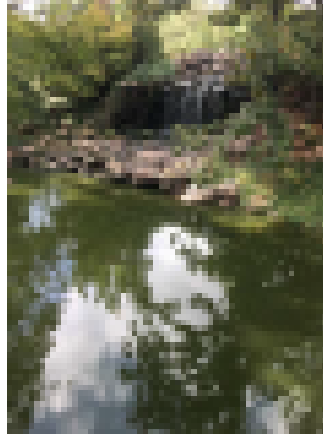
Waterfall Garden Feature

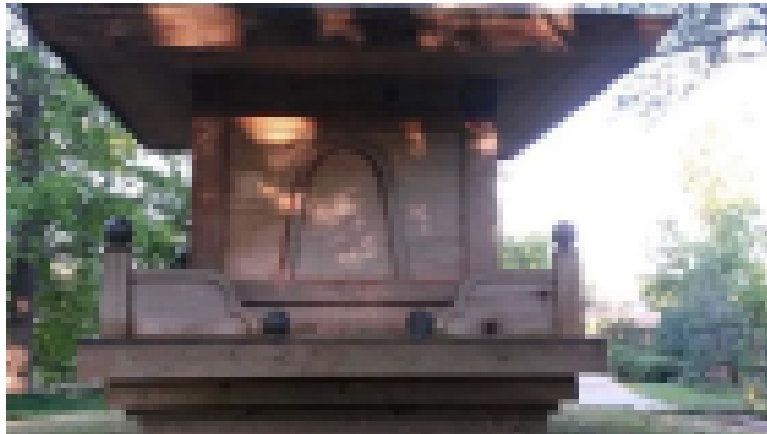
Lower Tier Detail of Pagoda

The Pagoda is in good shape, however, the redwood trim is starting to show wear and needs to be replaced where possible. The lower gusset and base of the Pagoda are showing the most amounts of wear on the trim and panel facing closest to the ground. Lower levels should be cleaned to match the upper levels.

Clean Exterior and Repair Trim		\$575
	Sub-Total	\$575
	Contingency	\$115
	Total Cost	\$690

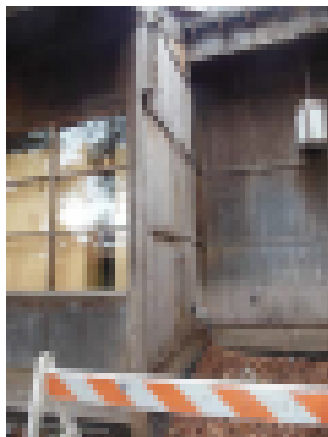
The exterior of the Treasure Tree Gift Store identified a few insufficiencies. The cantilevered deck accessed from the North Entry, provides a low 24" guardrail which does not comply with current code requirements. A 42" guardrail should be provided. The exterior wood paneling on the west side of the building which is not protected by a roof overhang, needs replacing due to weather exposure. The west side paneling also suffered from additional water damage due to a broken pipe in late December 2016. This paneling needs to be replaced along with several sections of wood trim which have rotted and are missing.

Damaged Paneling

Replace Exterior Wood Panels		\$5,520
Replace Doors		\$2,760
Clean Entire Exterior		\$5,750
Replace Wood Guardrails		\$1,610
	Sub-Total	\$15,640
	Contingency	\$3,128
	Total Cost	\$18,768

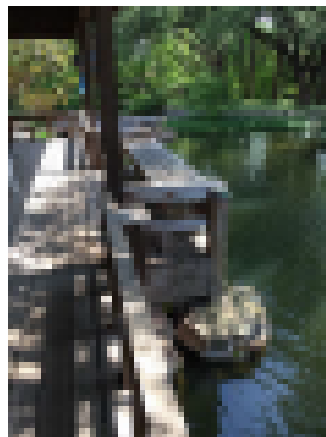
Low Guardrails

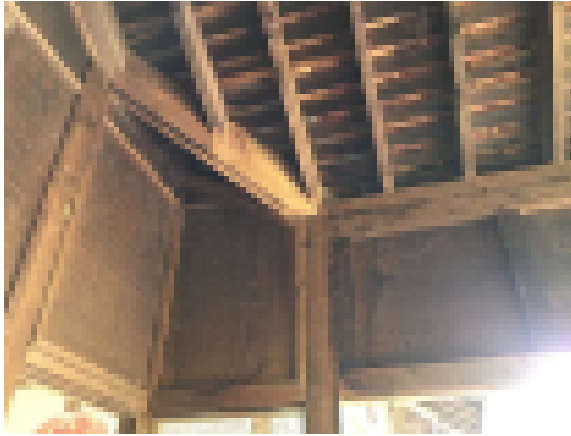
Much of the exterior is extremely dirty from weathering and should be cleaned – especially the walls and underside of the exterior roof deck. Two doors on the exterior are in disrepair and should be replaced.

Dirty Roof Deck and Panels

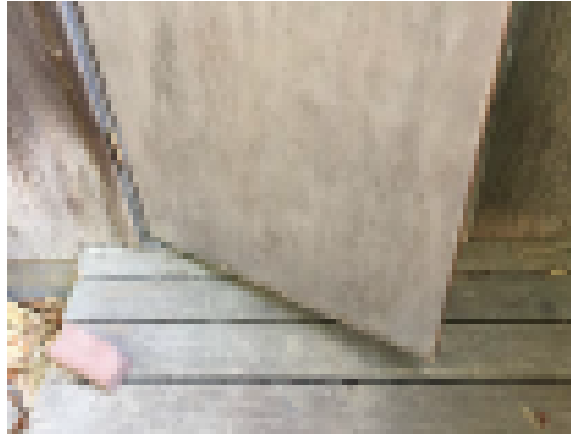
Damaged Door

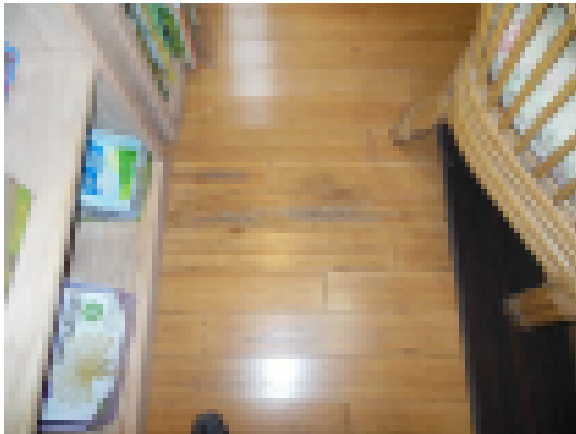
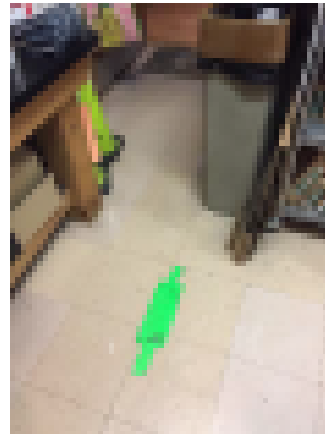
The interior bamboo sales floor suffered some water damage due to the broken water pipe and shows signs of warping and cupping. Eventually these cupped edges will show signs of traffic wear due to their raised edges. The adjacent stockroom has also suffered from the same water leak in that the flooring substrate was damaged and has allowed for delamination of the VCT flooring.

Damaged Flooring

Replace Door Hardware	\$7,360
Replace Store Room VCT	\$1,035
Replace Damaged Wood Floor	\$1,725
Replace Millwork	\$2,875
Repair Wall Cracks	\$1,150
Sub-Total	\$14,145
Contingency	\$2,829
Total Cost	\$16,974

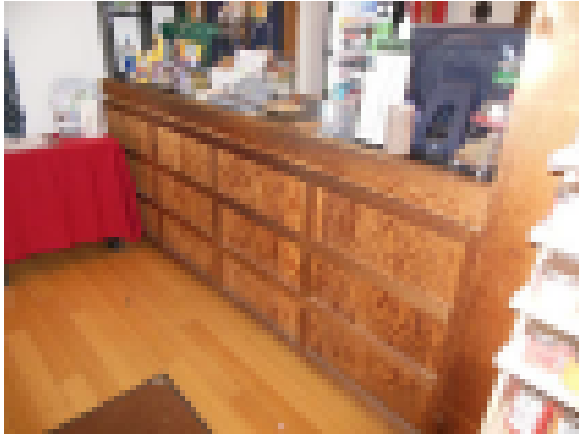
The single employee restroom is not accessible; however, employees can use the accessible restrooms located in the adjacent Entrance Plaza. The main sales counter is too high and needs to be modified with a 36" wide by 34" tall section for accessibility. Doors throughout the building currently have knob type hardware and need to be replaced with lever type.

Inaccessible Counter

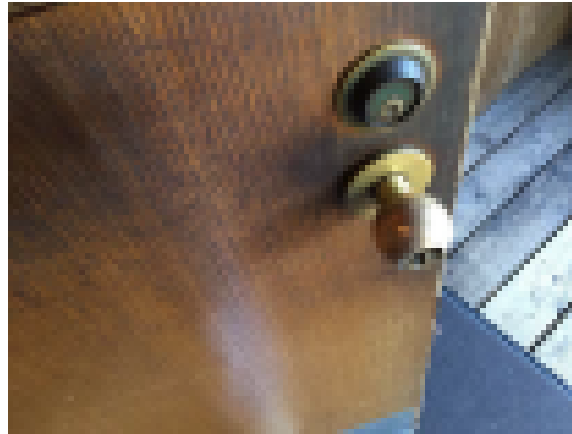
Knob Type Hardware

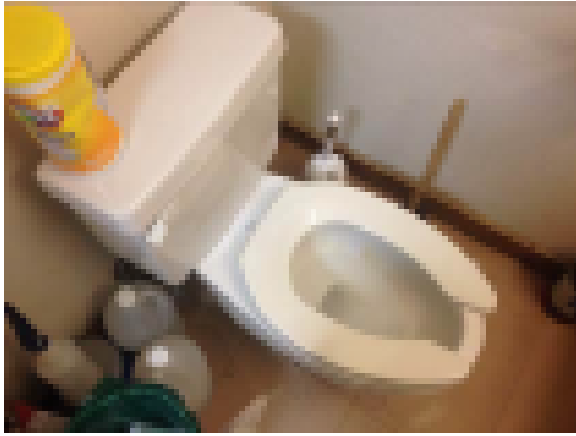
The tank-type water closet appeared to have constant running water. It is recommended to repair the water closet to stop the constant flow of water. Repair would include changing out flapper and valve assembly.

Water Closet with Constant Running Water

Repair Water Closet		\$125
	Sub-Total	\$125
	Contingency	\$25
	Total Cost	\$150

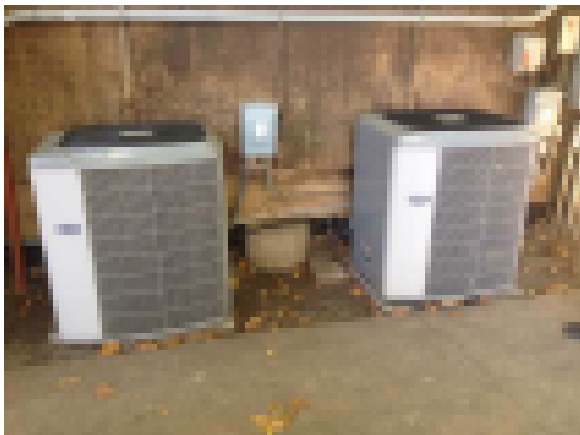
The current two 5-ton split systems appear to have been installed in 2004. With an expected life service of 15 years, these units are coming close to reaching their service life, and therefore should be considered for replacement.

Existing two 5-ton condensers

Replace Two 5-ton Systems		\$15,000
	Sub-Total	\$15,000
	Contingency	\$3,000
	Total Cost	\$18,000

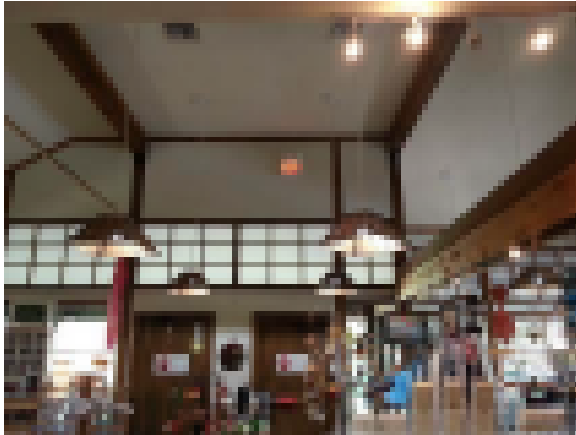
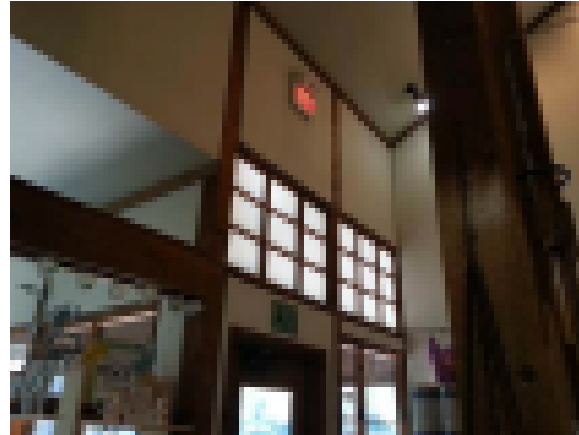
Exit signs are too high to provide any guidance in case of fire. It is recommended to lower existing exit signs within code height requirements above doors.

Exit Sign Mounted Too High

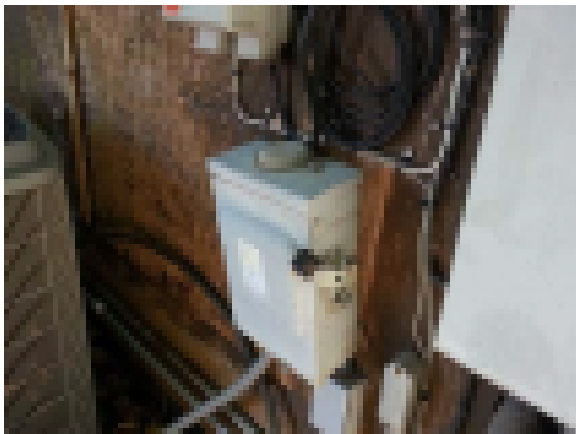
Exterior equipment installed in the back of the store shows signs of deterioration. The A/C disconnect needs to be supported and wiring devices need proper covers.

Disconnect Without Proper Support

Repair Exterior Equipment		\$500
	Sub-Total	\$500
	Contingency	\$100
	Total Cost	\$600

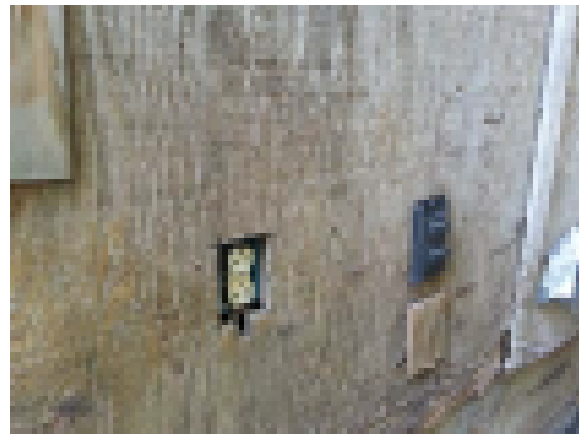
Wiring Device Without Cover

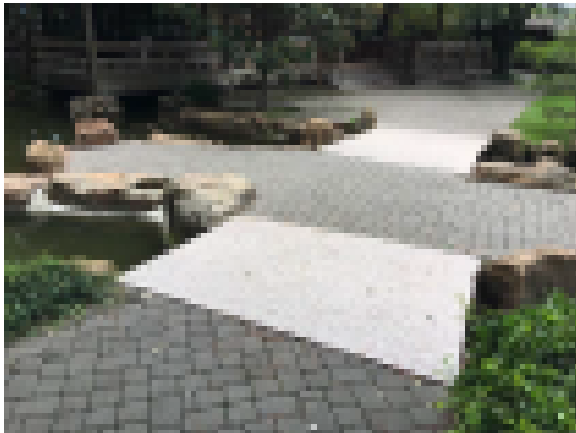
The walkway leading to the Gift Store building transitions from exposed aggregate concrete to a meandering pathway of concrete unit pavers and stone bridges which cross the southernmost pond in the Japanese Garden. The unit pavers are constructed on a setting bed of sand and are showing signs of settling and moving. This flexible and constantly shifting sub-base material creates an irregular walking surface and requires ongoing attention from maintenance staff. This picturesque setting is frequently used for weddings and ceremonies both day and night. The irregular paving surface create a tripping hazard. The pavers in this area should be removed and reinstalled on a stable sub base material.

Stone Bridge Over Pond

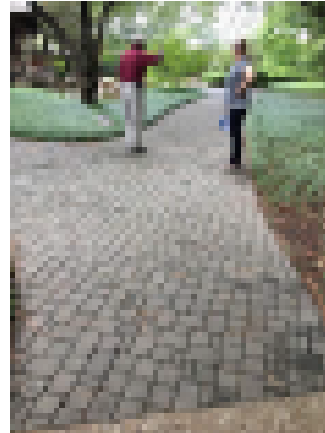
Unit Paver Pathway

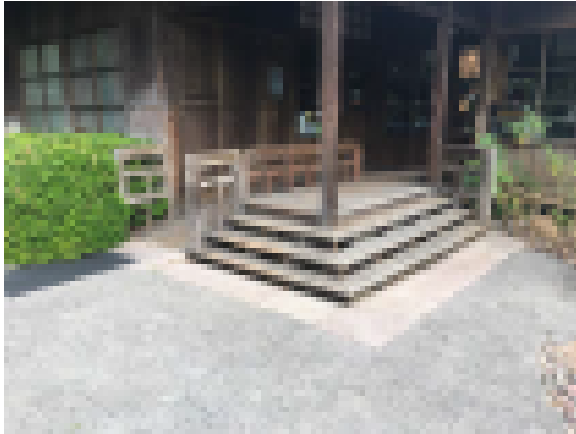
The turnstile that was previously at this pavilion has been removed. A new self-closing unidirectional self-latching gate and hardware should be constructed in its place. The low courtyard fence is braced and in need of repair. The cedar ramp and steps are in disrepair and do not have adequate handrails. They should be reconstructed with durable ipe wood to match the other deck renovations in the area.

Gift Store South Entry Steps

Replace Exit Turnstile with Gate	\$5,000
Rebuild South Entry Steps, Ramp, Railing	\$8,500
Repair Courtyard Fencing	\$1,000
Sub-Total	\$14,500
Contingency	\$2,900
Total Cost	\$17,400

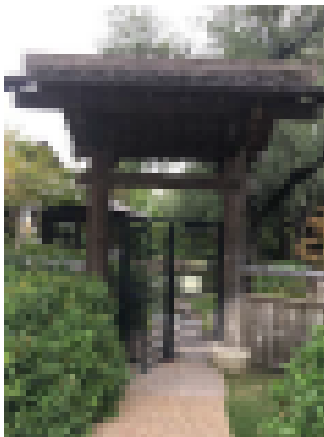
Exit Gate with Turnstile

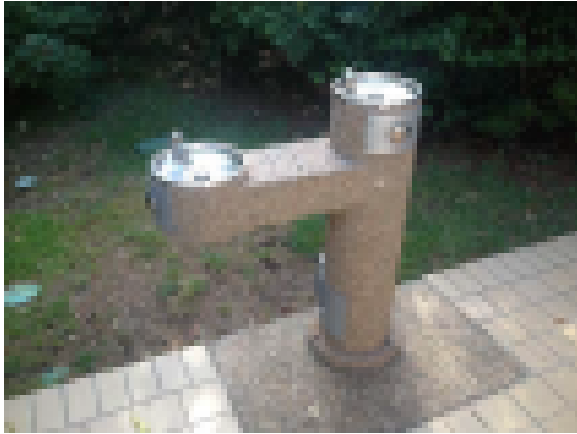
There was no running water for the exterior mounted high-low drinking fountain. Botanical Garden staff indicated the existing drinking fountain should be replaced.

Exterior Mounted Drinking Fountain

Replace with freeze resistant drinking fountain	\$9,500
Sub-Total	\$9,500
Contingency	\$1,900
Total Cost	\$11,400

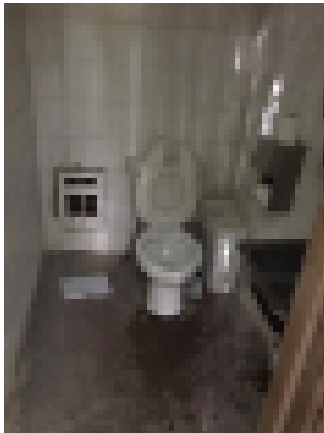
It is recommended that the concrete floor be tiled (or epoxy painted) to allow for easier maintenance with less staining of the concrete. The door hardware needs to be upgraded to lever type handles as existing hardware is in disrepair. The acoustical ceiling system has rusted and needs to be replaced utilizing vinyl faced ceiling tiles that are designed for moist conditions. Signage needs to be provided directing visitors to the nearest accessible restrooms located to the east at the Bride's Room Restrooms.

Restroom Fixtures

Tile Flooring	\$1,725
Door Hardware	\$1,380
Replace Ceilings	\$759
Restroom Signage	\$230
Sub-Total	\$4,094
Contingency	\$819
Total Cost	\$4,913

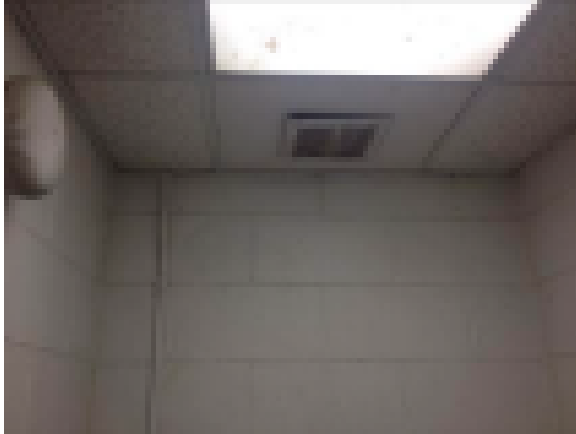
Both the exhaust fan and heater show signs of rust and corrosion. It is recommended to replace both units in each restroom.

Exhaust Grille in Restroom

Exhaust grille/electric heater replacement	\$2,000
Sub-Total	\$2,000
Contingency	\$400
Total Cost	\$2,400

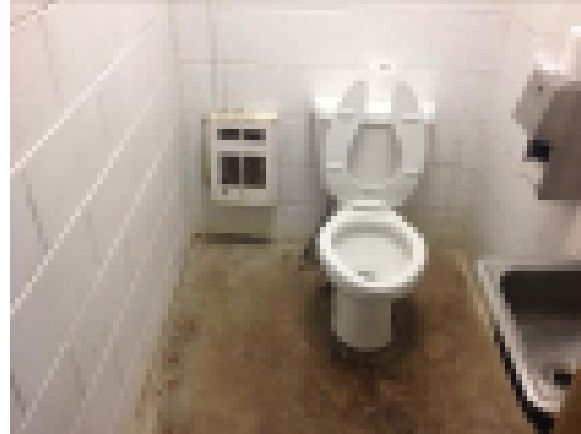
Electric Heater in Restroom

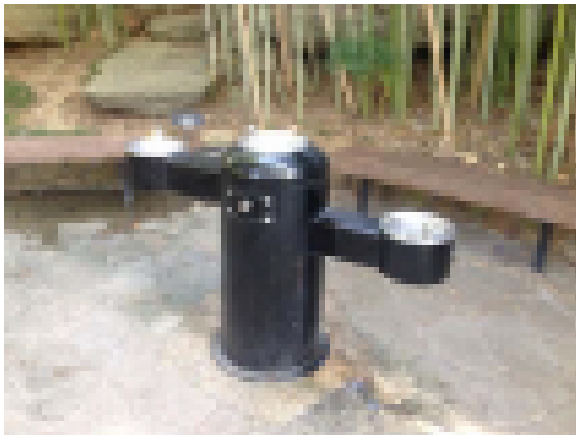
The drinking fountain with three bubblers is not functioning properly. One of the bubblers is not functioning as no water is coming out, and it has been indicated by Botanic Garden staff that this drinking fountain be removed.

Drinking Fountain

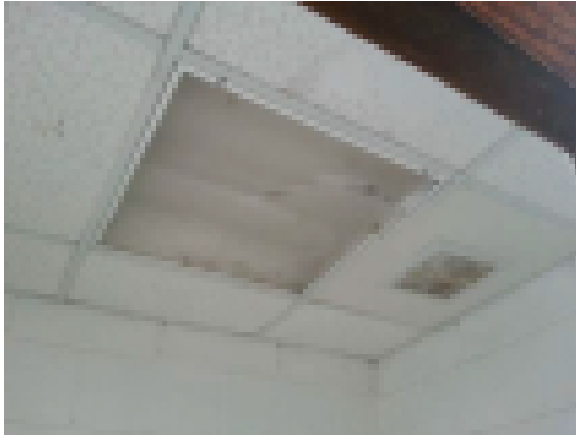
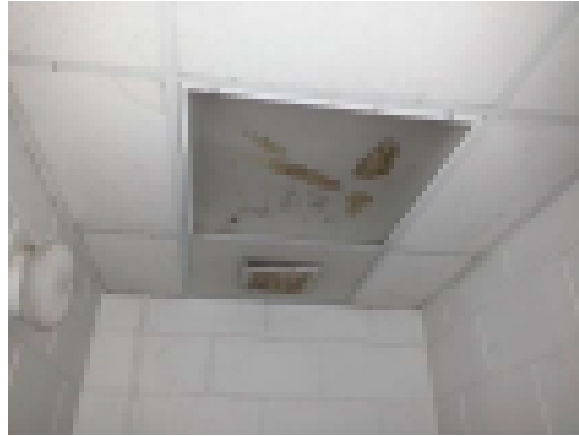
Each restroom has fluorescent lighting in poor condition.

Lighting in Need of Replacement

Upgrade lighting for each restroom to new energy-efficient, LED fixtures and occupancy sensors set for a minimum 20-minute delay.

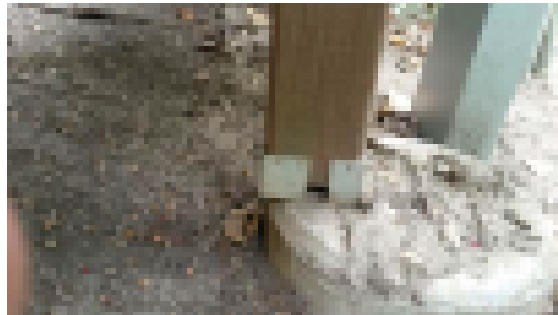
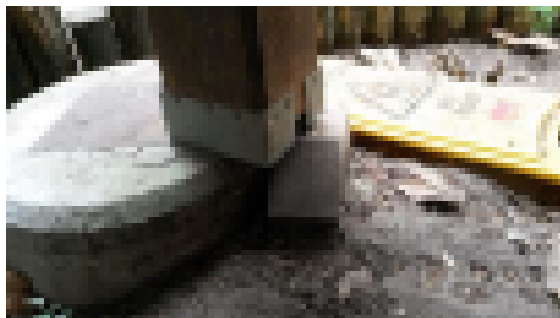
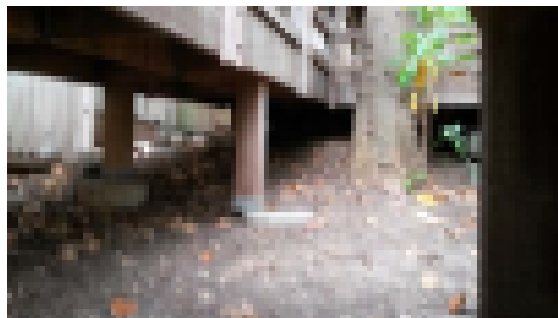
Ramp transitioning between upper east walk and lower east walk (map location Grid K22): This wood framed ramp appears to have been added as part of an accessible route. While we did not observe any distress to the structure, we noted that several of the support posts are not properly seated on the piers. This appears to be a fairly new structure. It is recommended that the Engineer of Record (EOR) for the project review the as-built condition and provide comment on the sufficiency of the post connection to piers.

Support Posts Not Properly Seated

Support Posts Unseated

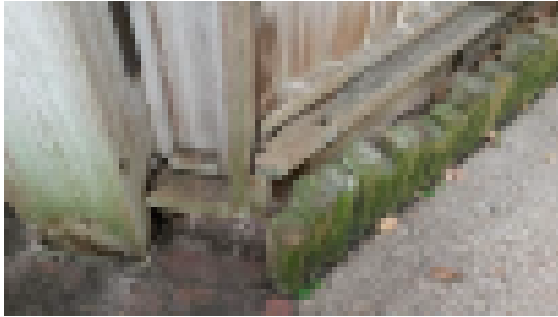
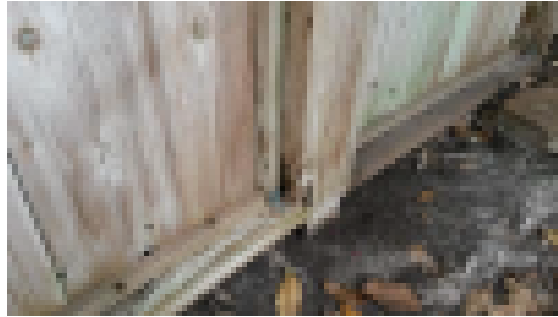
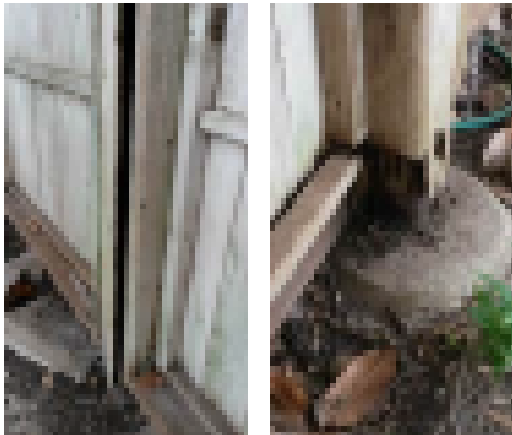
East Fence (map location Grids L20 and L21): The fence is composed of steel posts embedded in concrete piers with wood framing/fencing between the steel posts. The steel posts support a wood framed roof system. The roof system and steel posts appear to be in good condition. However, the wood fencing, especially at lower portions of fence, has deteriorated from moisture and insect attack. The wood trim attached to steel posts has also deteriorated and is separating from the posts.

East Fence Deterioration

East Fence Trim Deterioration

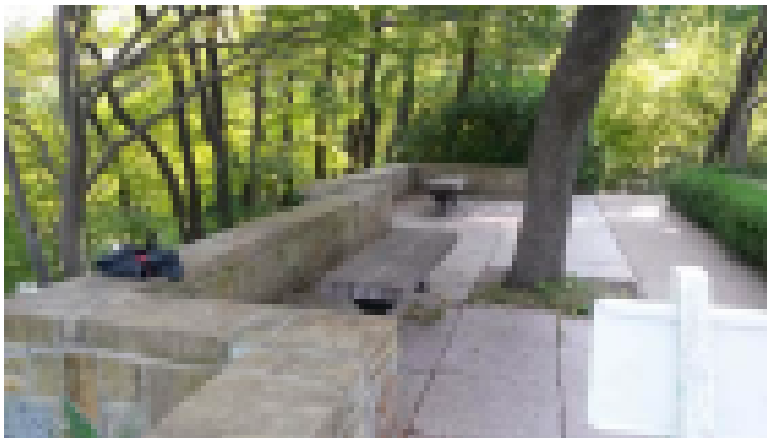
Retaining Wall at Pagoda

Stone Faced Retaining Wall adjacent to Pagoda (map location Grid 25G): No distress or structural insufficiencies noted. The granite stones in this zone is not the preferred paving surface. It is recommended that the stones are removed and replaced with exposed aggregate concrete that will match other locations in the garden. It has also been recommended by Botanic Garden staff that the live oak tree be removed.

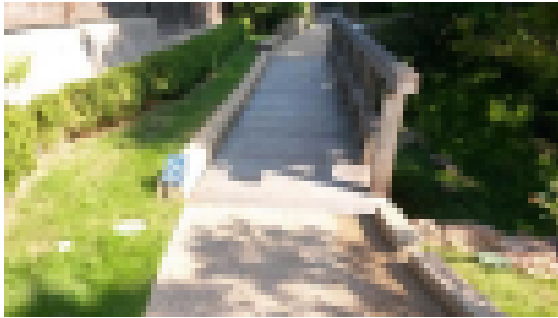
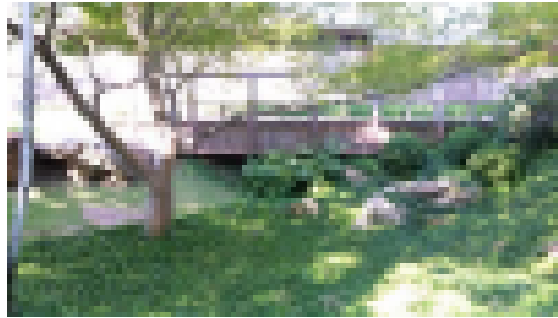
Bridge (map location Grid F24): This bridge runs parallel to the west fence line and is composed of wood planks supported on steel bar joists.

Wood Plank Bridge

Bridge (map location Grid F24): Mild rusting of bar joints and bridging was noted. While this is not a current life safety issue, it is recommended that the steel structure be cleaned and painted to extend its useful life. We anticipate that the cleaning and painting will require removal and replacement of wood skirting.

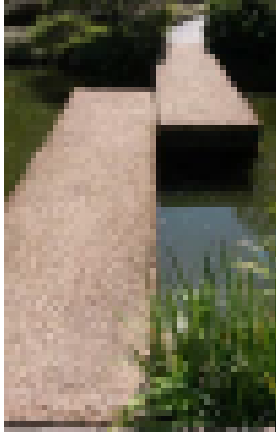
Bridge at west side of island (map location Grid H22): This bridge has insufficient bottom concrete cover for the lower reinforcing steel and has experienced spalling resulting in exposure and deterioration of the bottom reinforcing steel.

West Island Bridge

This bridge has insufficient bottom concrete cover for the lower reinforcing steel and has experienced spalling resulting in exposure and deterioration of the bottom reinforcing steel. This is not a current life/safety issue, but it is recommended that the following repairs be performed within the next 5 years:

Remove any loose, delaminated concrete and all concrete within $\frac{3}{4}$ " around an exposed reinforcing bar. Wire brush clean rebar to white condition. Coat exposed reinforcing bars and concrete surface to be patched with Sika Armatec 110. Patch concrete with Sikatop 123 Plus.

Repair Concrete		\$800
	Sub-Total	\$800
	Contingency	\$160
	Total Cost	\$960

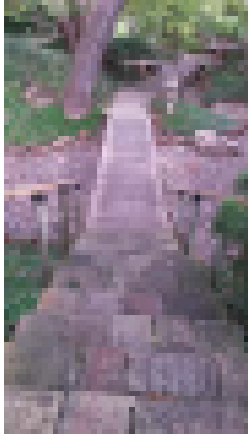
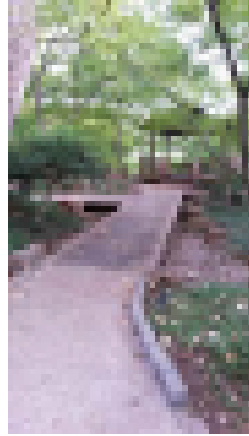
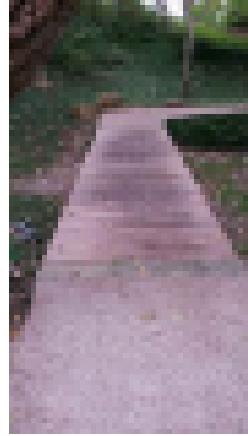
Three Wood Plank & Steel Framed Bridges (map location Grid H26): Per available drawings, these bridges were constructed circa 2005 and consist of wood planks spanning between steel joists running along each side of the bridge. There is also wood skirting attached to the outside faces of the steel joists.

Wood Plank Bridges

Three Wood Plank & Steel Framed Bridges (map location H26): Mild rusting was observed on the bar joists and bridging, particularly along bottom chord of joists. Although there is no current life/safety issue, it is recommended to clean and paint the steel structure to prolong its useful life. We anticipate that the cleaning and painting will require removal and replacement of the wood skirting.

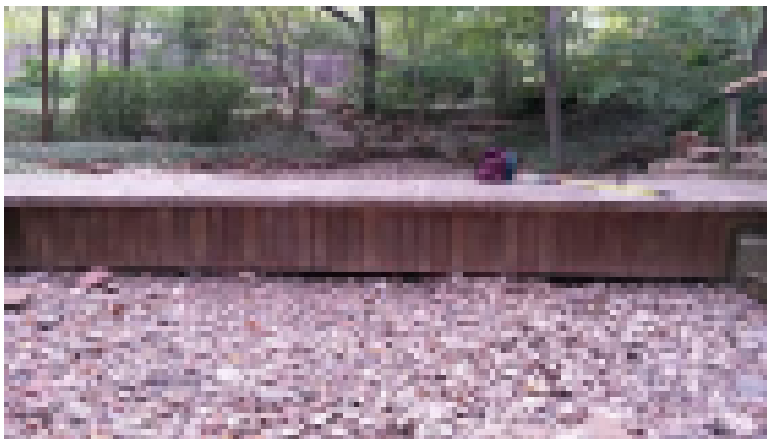
Wood Skirting

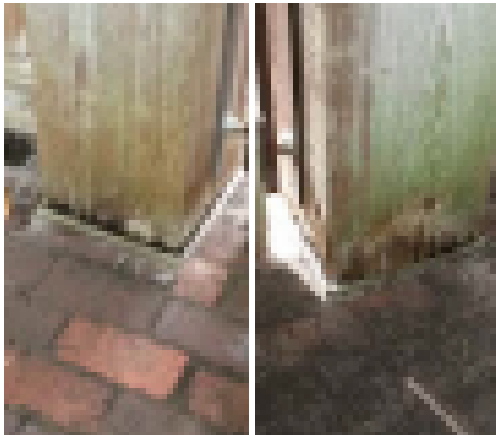
The bottoms of the heavy timber wood posts are starting to show signs of deterioration due to water and insect attack related to the insufficient separation of the post from the ground. It is anticipated that these posts will need to be replaced within the next 5 years.

Post Deterioration

Replace Two 6x6 Treated Posts	\$500
Sub-Total	\$500
Contingency	\$100
Total Cost	\$600

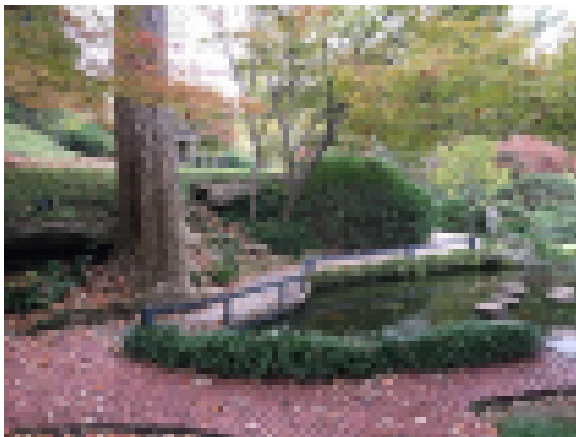
Bridge Requiring Cleaning and Painting

Bridge (map location Grid J22): It is recommended to clean and paint the steel structure of this bridge to extend its useful life.

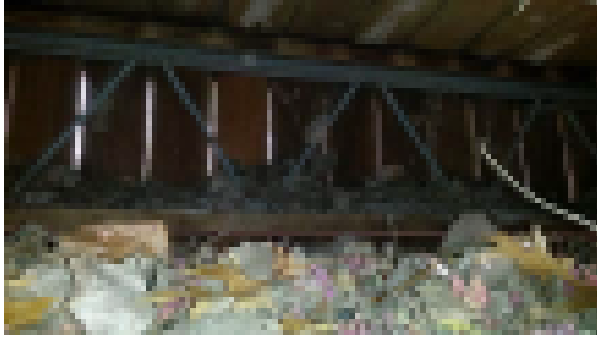
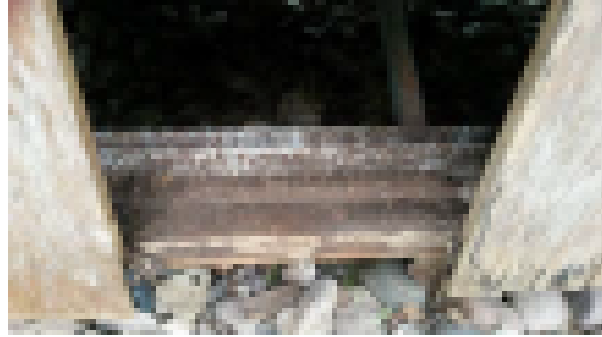
Steel Requiring Cleaning and Painting

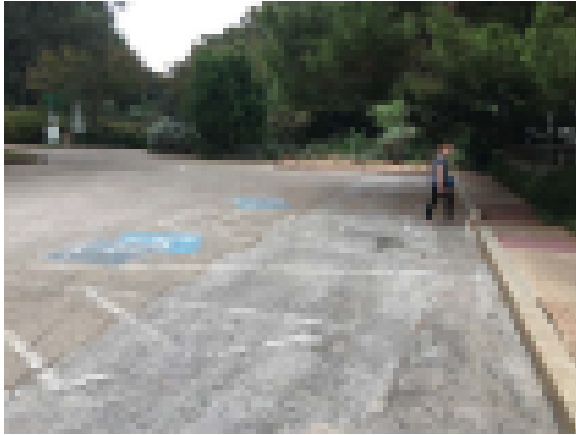
The asphalt parking lot slopes primarily from the west to the east. The surface of the lot is beginning to show wear and the parking striping is difficult to see in some areas. The lot should be overlaid with a new asphalt surface topping and the parking spaces restriped.

Worn Asphalt Parking Surface and Striping

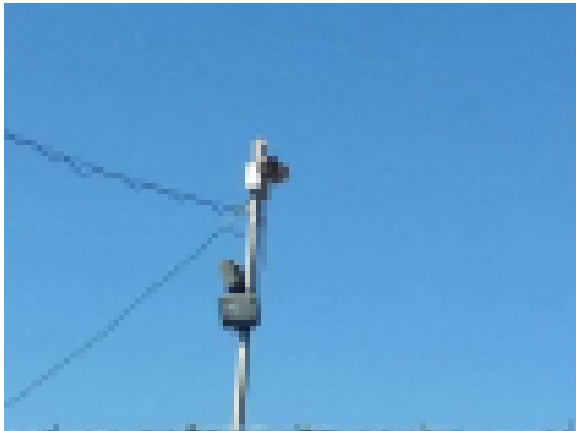
Existing Light Pole

It is recommended to upgrade the parking lot lighting with more efficient LED lighting.

Replace with LED Lighting	\$40,000
Sub-Total	\$40,000
Contingency	\$8,000
Total Cost	\$48,000

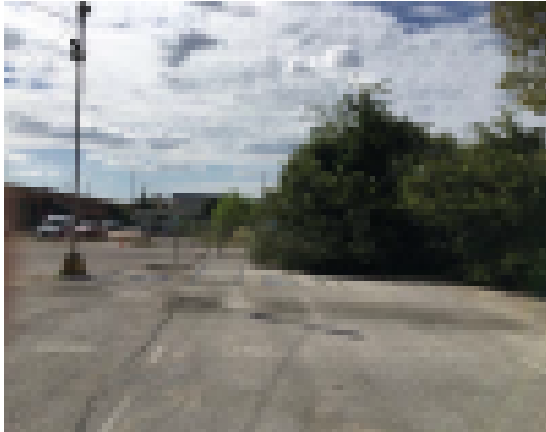
In addition, the parking lot striping has become worn and faded over time. The entire lot should be re-striped and handicap accessible spaces clearly marked.

Parking Slope & Striping

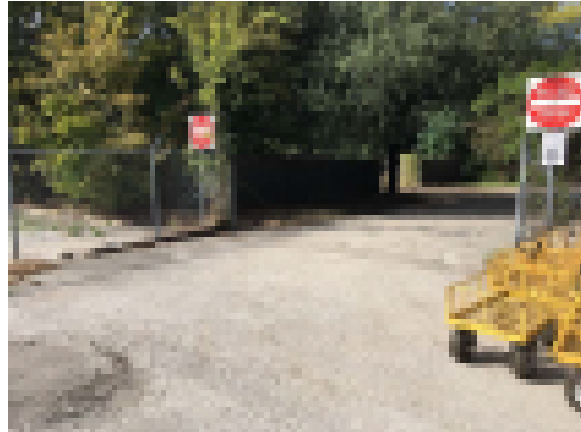
Vegetation and Debris Collection at North Fence Line

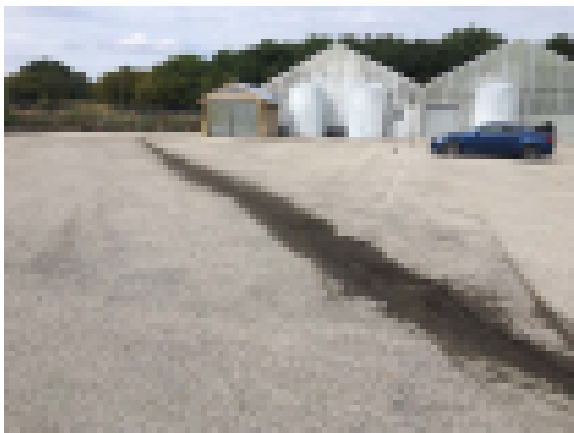
The eastern portion of the Weekend Parking Lot is located adjacent to the South Production Greenhouses. This large asphalt parking area is separated by chain link fence and plantings from the main weekend parking lot area. The paving in this area is in similar condition to the main Weekend Parking Lot. Primary surface drainage is collected in an asphalt flume running from the west side of the Production Greenhouses southeast to the center of the parking area. Drainage patterns take surface flow from this flume toward the I-30 service road. This concentrated drainage pattern is causing deterioration and accelerated wear of the asphalt surface. It is recommended to replace the flowline of the swale with a concrete flume to ensure positive drainage on a more durable surface.

Drainage Swale at Surface of Asphalt Parking

With parking lot striping in a similar worn condition to the west side, the entire parking lot should also be re-striped and handicap accessible spaces and signage clearly marked.

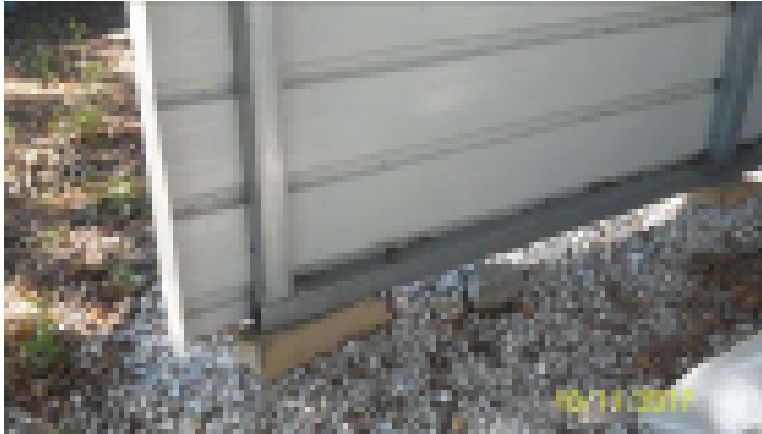
The pre-fabricated shelters are set on pieces of limestone with rebar anchors driven into the ground (like a tent stake) near each of the four corners. The provided tie-downs are insufficient to resist wind uplift forces. New properly sized helical or screw type anchors should be installed near each corner of the two shelters.

Shelter Anchoring

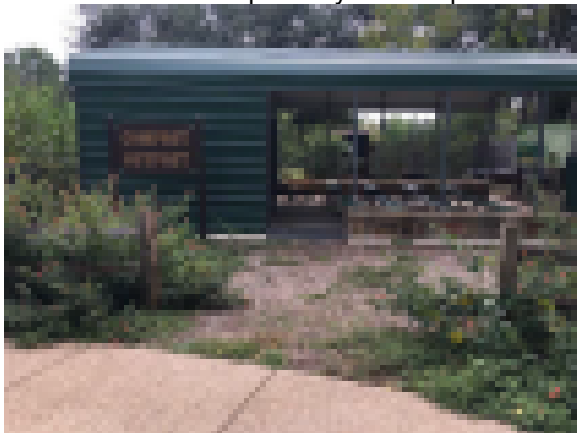
The mulch pathways throughout the Compost Outpost have settled and vegetation is growing through the material creating an irregular walking surface. A new concrete walkway from the existing sidewalk to the classroom area should be installed. Throughout the mulched pathways, weeds and volunteer plants should be removed and the pathways then top-dressed with mulch to provide a smooth walking surface.

Approach to Compost Outpost from Existing Sidewalk

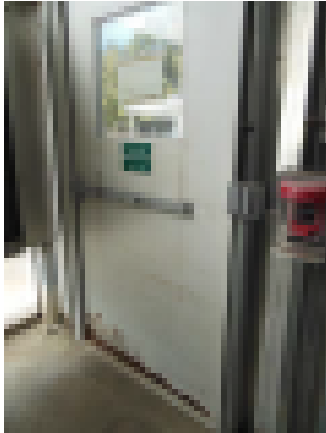
The South Production Greenhouse has some elements which show signs of corrosion such as an exterior metal door as well as welded joists within the greenhouse structure.

Rusted Man Door

New VCT Flooring in Administrative Areas	\$11,954
Replace Door	\$1,380
Sub-Total	\$13,334
Contingency	\$2,667
Total Cost	\$16,001

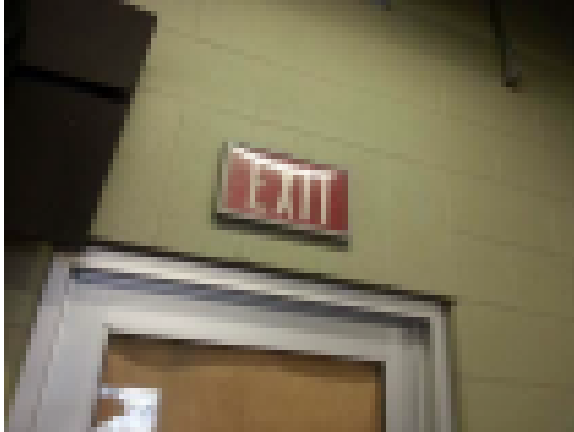
Non-illuminated exit sign

Replace (6) non-illuminated exit signs with LED exit signs with 90-minute emergency batteries.

Replace (6) Exit Signs		\$3,000
	Sub-Total	\$3,000
	Contingency	\$600
	Total Cost	\$3,600

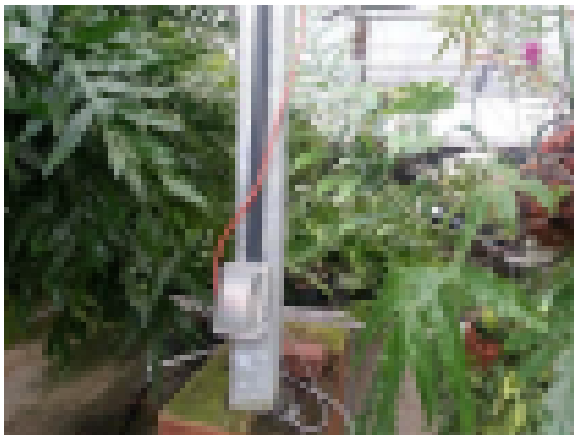
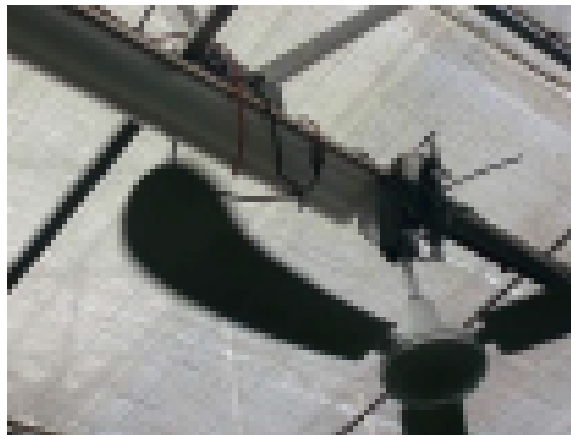
Two ceiling fans in the greenhouse are connected through an extension cord. Provide permanent wiring for the ceiling fans.

Extension Cord that Feeds Ceiling Fans

Ceiling Fan Connected with Extension Cord.

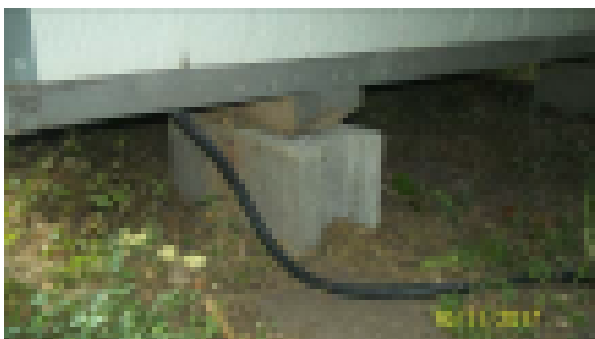
The pre-fabricated sheds were set on Concrete blocks with no tie-downs. It is recommended that the sheds be properly anchored to the ground by properly sized helical or screw anchors to resist wind uplift forces and reduce the risk of the unit being lifted and thrown during a wind event.

Shed on Concrete Blocks

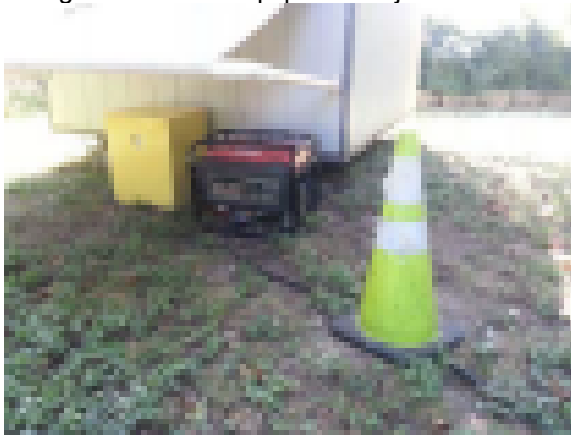
The shed has a temporary connection from closest light pole. It is recommended to replace with permanent wiring from service equipment adjacent to shed.

Temporary Wiring for Shed

b. Replace shed wiring with permanent, code-compliant wiring

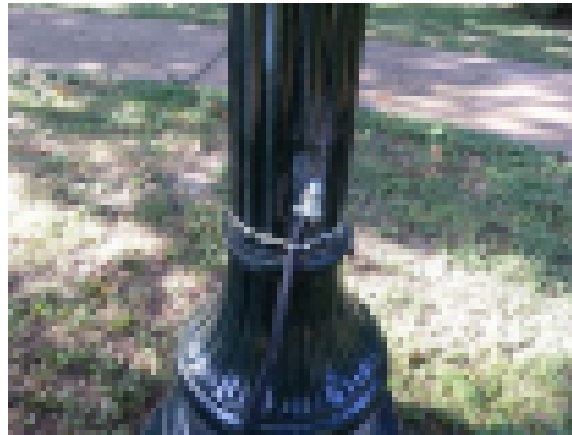
Connection to Light Pole

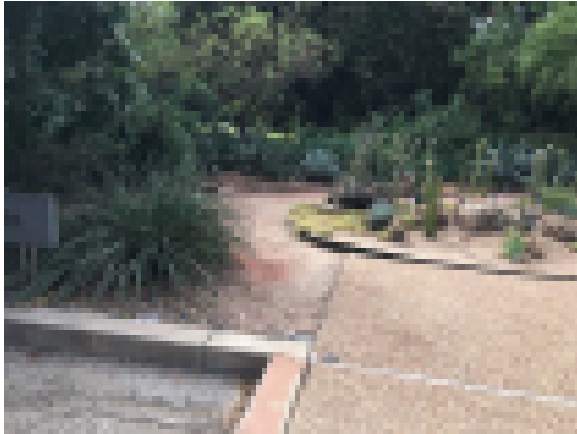
The decomposed granite pathways have settled due to erosion and wear. Pathways should be top dressed to bring the walkways flush with top of the adjacent concrete walks.

Decomposed Granite Walk Connection to Concrete Walkway.
