Facility Assessment
Fort Worth Botanic Garden
3220 Botanic Garden Boulevard
Fort Worth, Texas 76107

August 31, 2018
PROJECT NO. 16-1031.00

Assessment – Fort Worth Botanic Garden

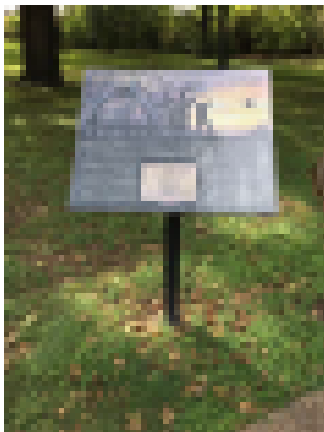
The interpretive sign at the Charlie Company Vietnam War Memorial is damaged, peeling and faded. This sign panel should be removed and replaced with a new sign.

Interpretive Sign at Memorial

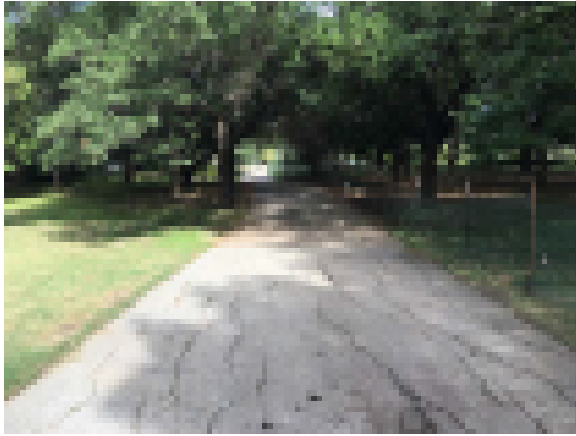
The access road from the Japanese Garden parking lot through the Grove to the weekend parking lot is a well-traveled route for both visitors and maintenance vehicles including pick-up trucks, and all-terrain vehicles. The asphalt surface is beginning to show wear and cracking in multiple locations. The roadway should be resurfaced with asphalt topping for the entire length of the roadway.

Asphalt Access Drive

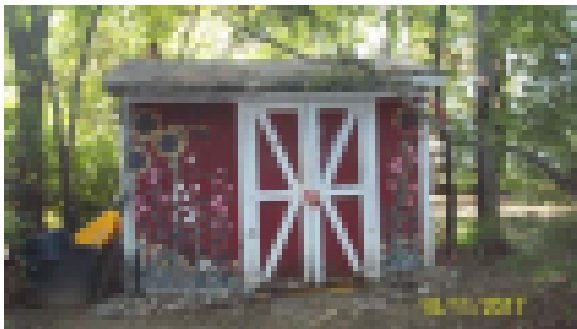
The storage shed located to the south of the gazebo is in poor condition with significant deterioration of the wood structure and veneers.

Storage Shed

The wood shed structure is in poor condition and should be replaced.

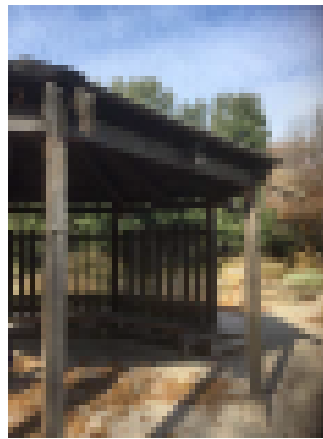
The wood pavilion structure at the center of the Trial Garden is in fair condition but is nearing the end of its useful life and should be replaced.

Trial Garden Gazebo

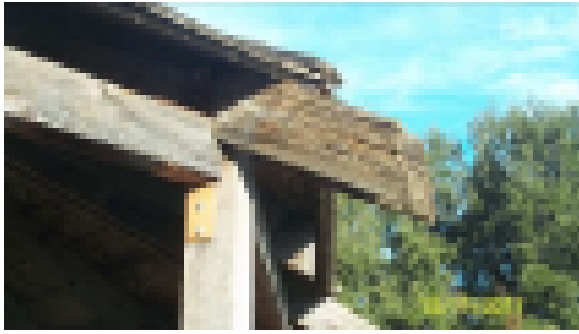
The wood framing is in fair condition with significant deterioration noted within the non-loadbearing portion of the roof outriggers. The structure is nearing the end of its useful life and while its condition does not constitute a current life/safety issue, it is expected that the structure will require replacement within the next 5 years. Refer to Architectural for estimated replacement costs.

Roof Outriggers

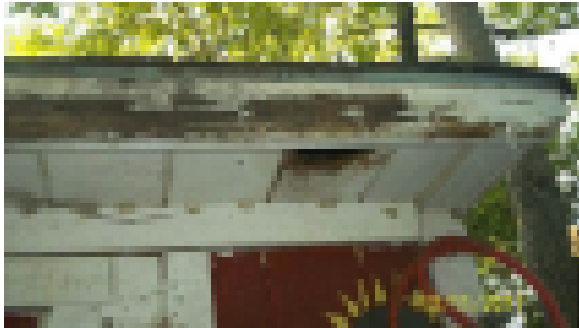
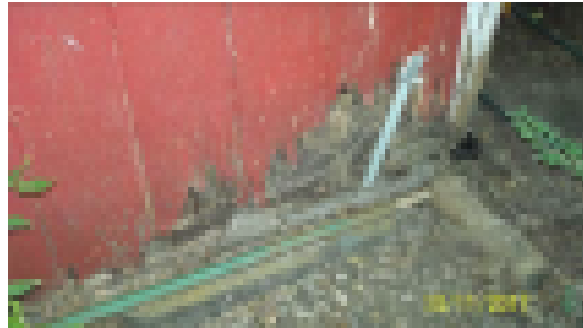
The Shed structure is in very poor condition and should be replaced within the next 12-18 months. Refer to Architectural for estimated replacement costs.

Storage Shed Deterioration

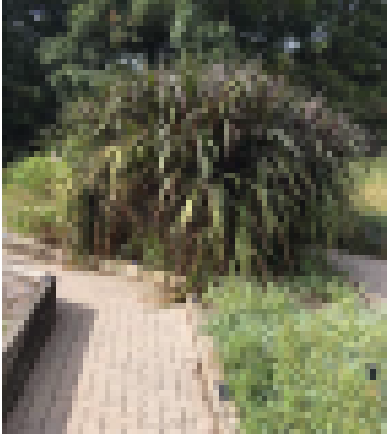
The landscape timbers at the display bed edges are beginning to decay and deteriorate. If it makes sense with the potential future modifications, it is recommended that these timbers be replaced with new landscape timbers.

Landscape Timber Edging at Display Beds

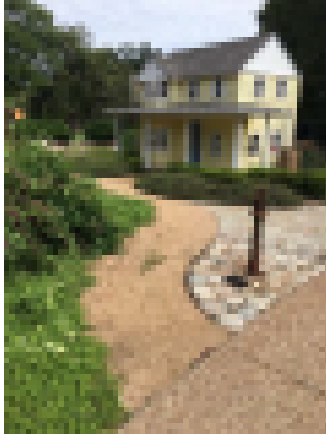
This popular garden has decomposed granite pathways that have settled over time due to heavy foot traffic. These pathways should be top-dressed with decomposed granite material and compacted to form a stable walking surface.

Decomposed Granite Pathways

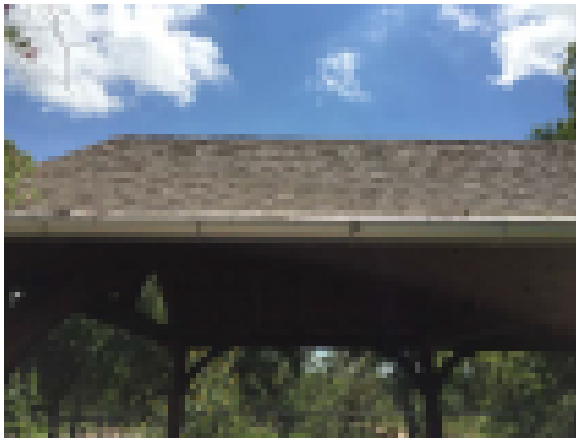
The gutter screens were turned up and therefore ineffective towards blocking debris from entering the catchment system. Screens need to be adjusted to catch debris appropriately. This is a maintenance item, so a price has not been provided.

Ineffective Gutter Screens

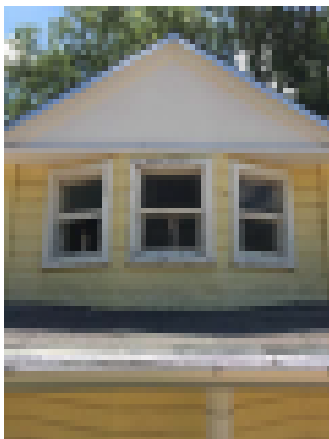
Wood trim and sills of the miniature windows are water damaged and in need of replacement. The bead board interior paneling is sustaining some water damage from the open windows and needs to be cleaned and painted. The interior loft has a low head clearance with the sloped roof decking above. The roof decking has sharp nails which have penetrated the wood decking and present a safety hazard as it is at standing head height for small children especially at the top of the ladder. A plywood soffit should be placed on the existing wood girts to conceal these roofing nails.

Deteriorated Wood Trim

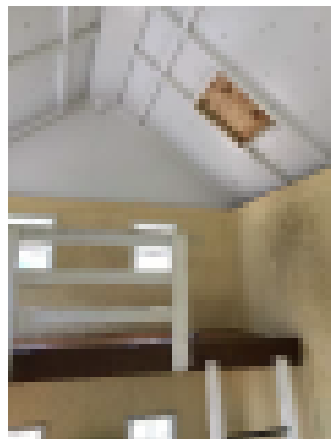
Exposed Nails at Decking

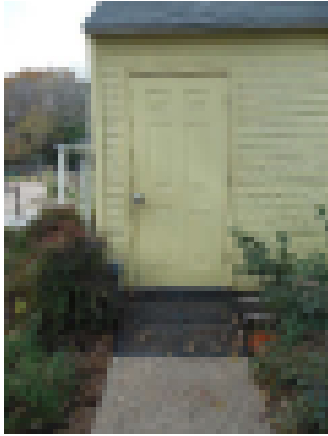
The hardware on both doors is missing or non-compliant and needs to be replaced. The walkway ramp at the rear entry needs a longer run with a slope that meets the entry threshold instead of using a metal grate ramp.

Non-Compliant Door Hardware and Ramp

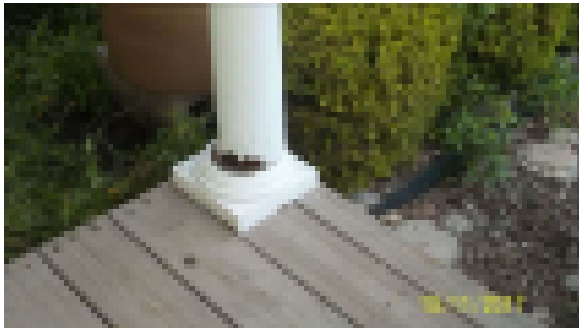
b. Replace porch column at playhouse.

The base of the southwest porch column has deteriorated and should be replaced.

Deteriorated Column

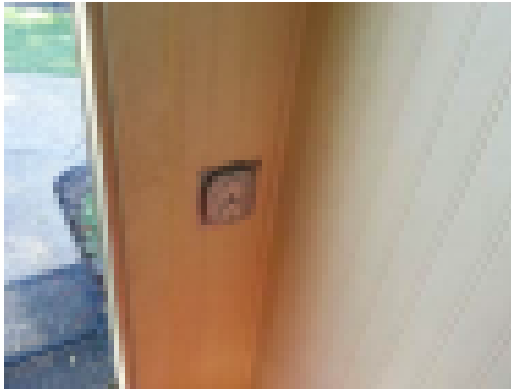
Non-GFI Receptacle

It is recommended to replace the existing convenience outlet inside the playhouse with a GFI receptacle.

Replace with GFI Receptacle		\$100
	Sub-Total	\$100
	Contingency	\$20
	Total Cost	\$120

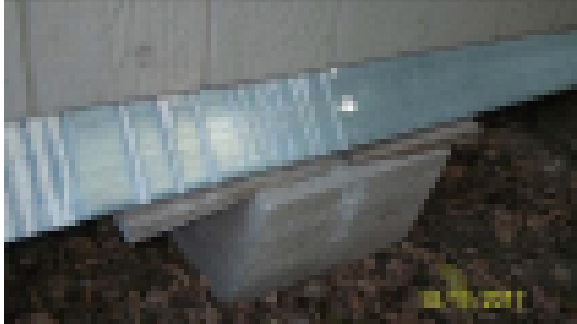
d. Reset piers and tie-downs

This structure is set on stacked concrete paver blocks and does not appear to have tie-down anchors. Further, the stacked paver blocks at the back of the building have settled causing the blocks to lean outward and the bottom rail of the building floor to twist outward.

Twisting Rail

It is recommended to reset the rear piers (stacked Concrete pavers) to a level condition, add stiffeners to back floor rail to prevent torsional twisting of rail, and add appropriately sized helical or screw type tie-down anchors at each corner of the building.

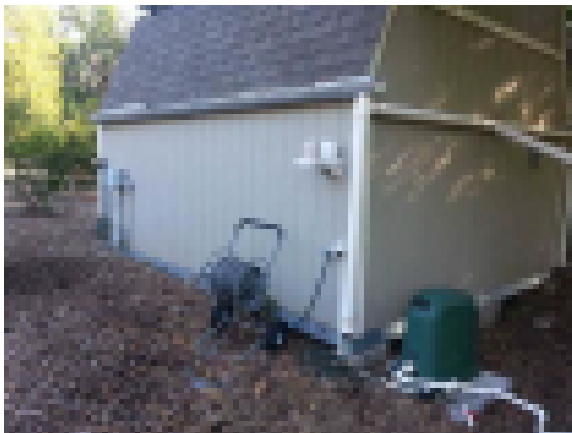
e. Provide GFI Receptacle

The shed's rain collection pump needs a GFI outlet close by. The existing non GFI receptacle is located at the front of the shed while the rain collection pump is located at the rear. The existing pump is currently connected with an extension cord. It is recommended to provide a GFI receptacle for the rain collection pump.

Rain Collector Pump Needs Receptacle

Replace with GFI Receptacle		\$300
	Sub-Total	\$300
	Contingency	\$60
	Total Cost	\$360

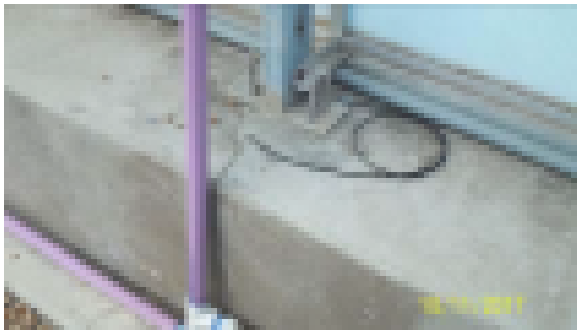
f. Relevel greenhouse

Superstructure distress was not observed, but cracking was noted within the grade beams along the north and south sides of the structure (photograph below, right). The grade beam cracking is the result of foundation movement and if left unchecked could become worse over time. It is recommended to relevel greenhouse grade beams using 6 steel push pilings or helical piers.

Cracking Grade Beam

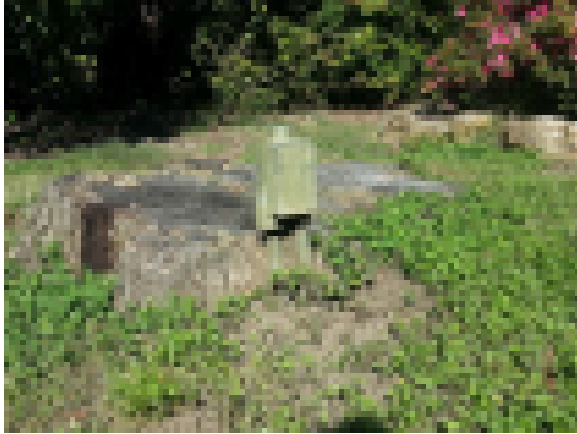
a. Remove Junction Box

There is an abandoned junction box located on the east side of the walkway towards the north end, adjacent to a tree stump. The junction box, associated conductors and raceways need to be removed.

Abandoned Junction Box and Conductors

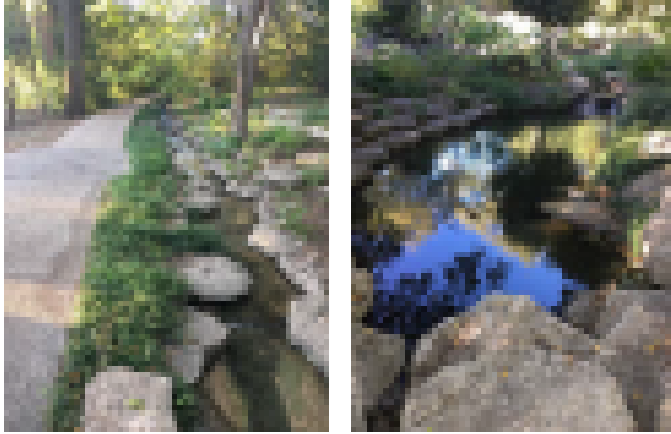
The Perennial Garden's dominant feature is a central pond that spills into an adjacent rock-lined stream. The stream then overflows into a storm drain inlet which outfalls into the adjacent creek. The existing creek liner leaks, the source of the leak will need to be identified and the liner repaired with new waterproof pond/creek liner.

The pond is fed by a raw line and is not filtered. The surrounding areas of the garden slope toward this water feature so the pond effectively acts as a large drainage basin resulting in a buildup of silt in the bottom of the pond. This pond should be drained and dredged to remove the silt. Currently the pond does not have a drain to empty the water for maintenance. Recommend installing a drain that for future maintenance.

Stream / Overflow to Creek Perennial Garden Pond

Dredge Pond		\$8,500
Install Pond Drain		\$7,500
Install Inlet and Storm Drain Pipe		\$6,500
Construct Swale		\$1,000
Repair Creek Liner		\$5,500
	Sub-Total	\$29,000
	Contingency	\$5,800
	Total Cost	\$34,800

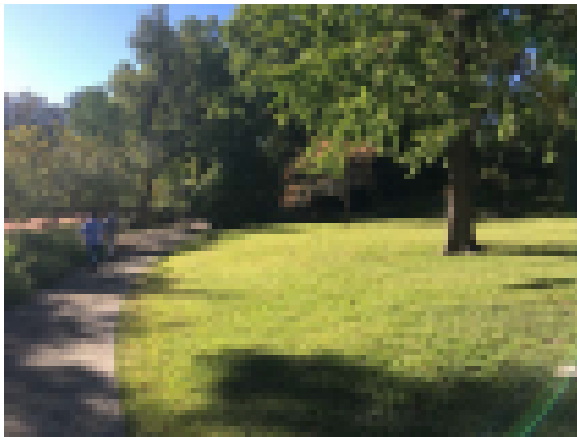
Adjacent to the Perennial Garden is a tree row and lawn area. This area slopes from West to East and carries large volumes of surface runoff to the adjacent walkways and into the Oval Rose Garden. This results in continual erosion and frequent flooding of the walk and Oval Rose Garden area in even minor rain events. A new inlet should be installed in the lawn area and a swale constructed to direct water away from the tree row and the adjacent walk toward the new inlet. The new inlet and drain pipe should be sized to handle the existing 24" drain line volume and the additional runoff captured.

Open Lawn Area Sloping to Oval Rose Garden

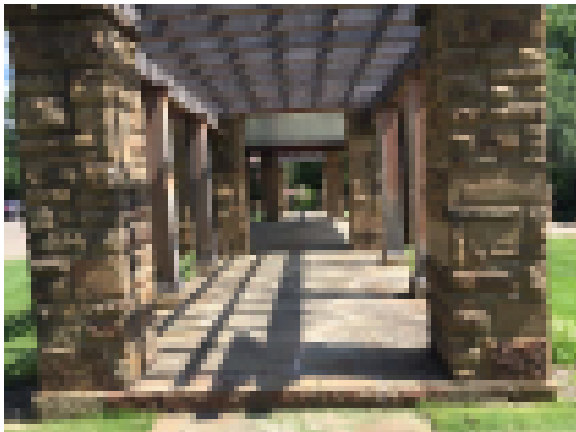
There is not an accessible route provided for visitors to enter the Shelter House pavilion. Modifications should be made along the accessible route beginning at the accessible parking spaces, providing a ramp at the step located along the west perimeter wall, as well as at the 7" raised slab of the Shelter House.

Step at Shelter House Foundation

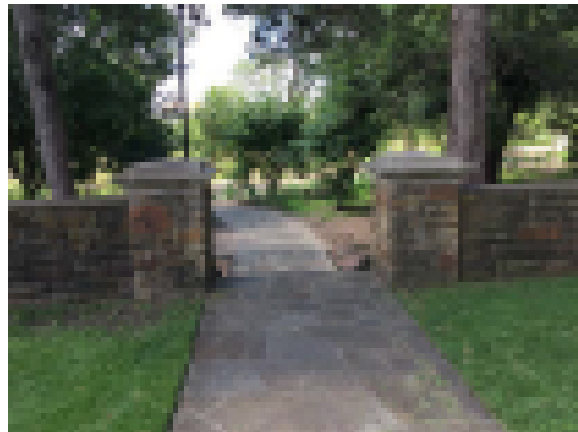
Step at Shelter House Perimeter Wall

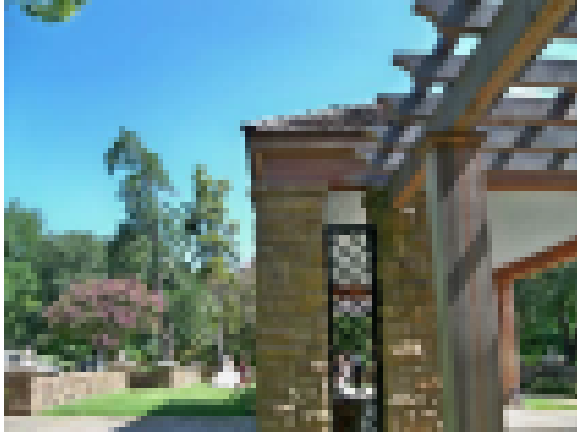
a. Foundation Issues

The southwest corner column appears to be leaning. Reference the structural assessment pertaining to this item.

There has been some differential movement of the Shelter House foundation that has caused the stone column at the southwest corner of the pavilion to lean outward and slight gaps opening up between the ceiling boards. While the observed foundation movement does not constitute a current life safety issue, we recommend that an elevation survey be conducted for this foundation to determine movement patterns and to assess the need for foundation underpinning to stabilize foundation against continued detrimental movement.

Leaning Column in Southwest Corner

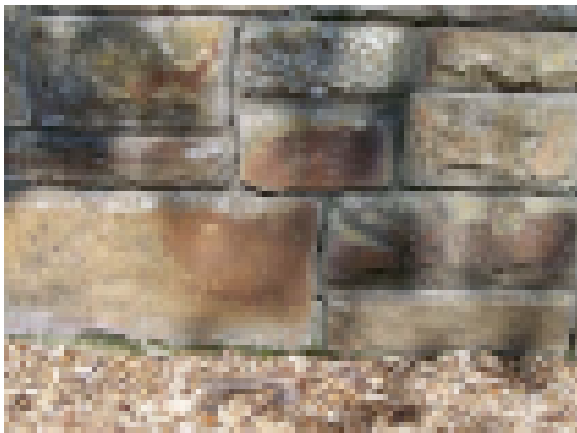
b. Mortar Cracks

Numerous fine cracks were observed in the stone walls on the east side of the Shelter House. A larger stair-stepping crack was observed in the southwest patio screen wall. These cracks do not constitute life/safety issues, but to extend the useful life of the structure, it is recommended that cracks with thicknesses larger than 1/16" be re-pointed as part of normal maintenance.

Shelter House Crack at Perimeter Wall

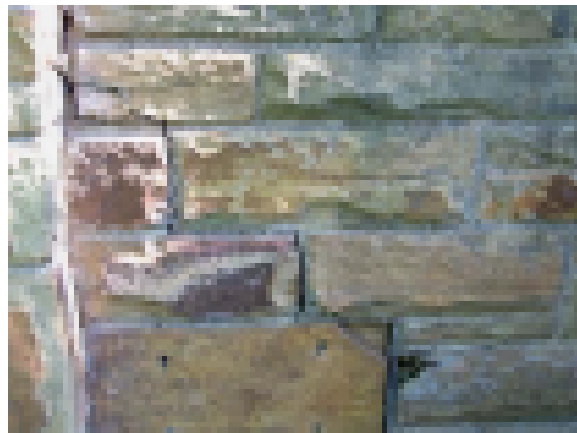
Stair-Step Crack at Perimeter Wall

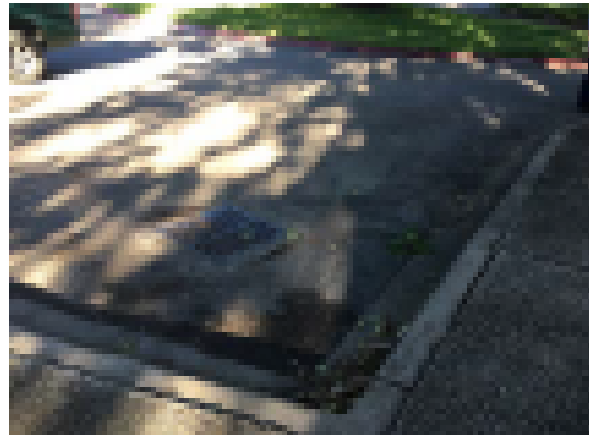
The asphalt parking lot is intended to slope toward the inlet in the southeast corner of the lot. The degraded asphalt surface and previous modifications have resulted in standing water after rain events. The asphalt should be resurfaced when Rock Springs Road is reconstructed. The new paving should be installed to promote proper drainage to the existing inlet and the parking spaces should be restriped. Additionally, all pedestrian curb ramps should be reconstructed to meet current accessibility standards.

Existing Drain Inlet

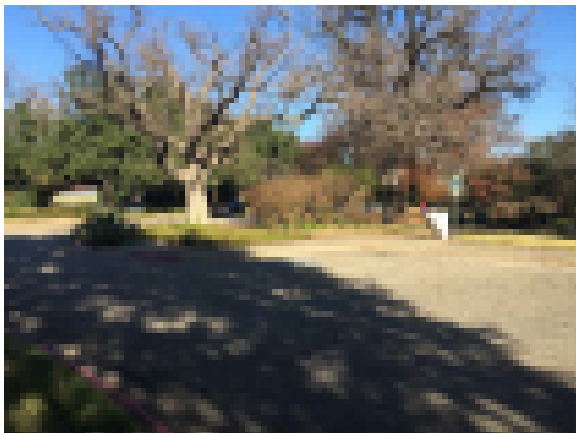
Relocate Existing Accessible Ramp

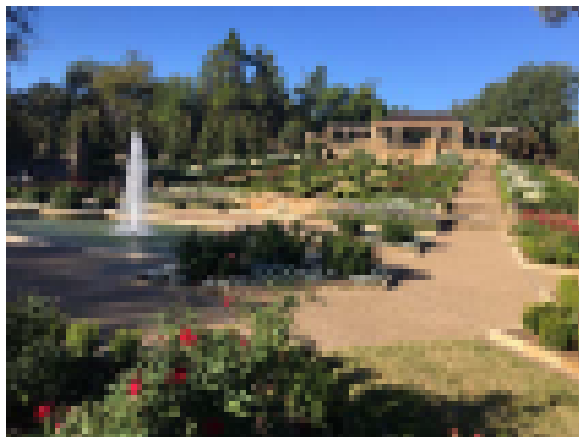
a. Drainage Improvements

In recent renovations, the Rose Ramp has incorporated new drainage improvements for the parterres. However in heavy rain events, runoff water from the Rose Ramp stairs flow over the steps and across the concrete paving into the Lower Rose Garden creating washout and nuisance water. Additional drain inlets should be installed at the base of the Lower Rose Garden and connect to an outfall into the Reflection Pond.

Rose Garden Pond & Parterres

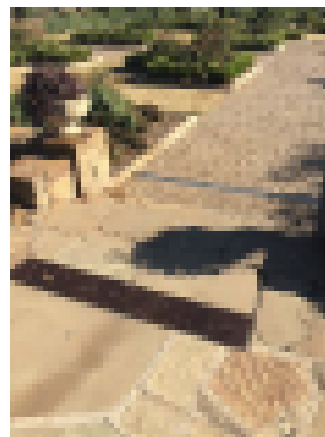
Existing Stair Drains

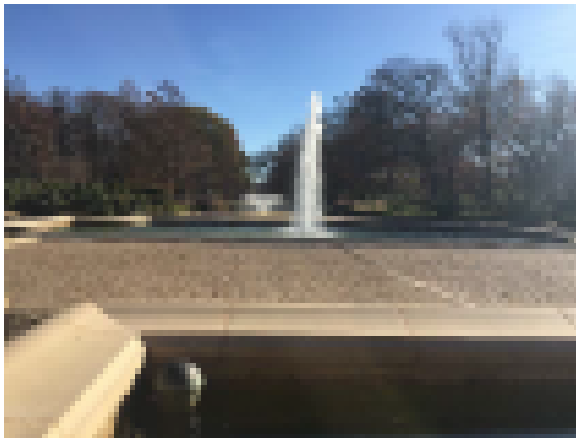
b. Fountain Improvements

The Rose Ramp includes a series of fountains that cascade from the base of the Shelter House through a series of terraced pools and weirs terminating in a large basin in the Lower Rose Garden. The cascade pools will need to be repaired with new waterproofing, drains and plumbing. Ground water is evident around the lower basin and there are spots located in both bottom basins where the waterproofing is breaking apart from hydraulic pressure under the structure. It is recommended that two relief wells be installed to relieve pressure, with piping for the excess water to go to the reflection pond. The type of pump will need to be submersible, but cannot be specified until the well is dug and the volume of water that will need to be transferred can be determined. Once this portion of the service has been completed, the water proofing can be removed, the surface prepped, and new water proofing installed.

Lower Cascade Basin & Fountain Pool

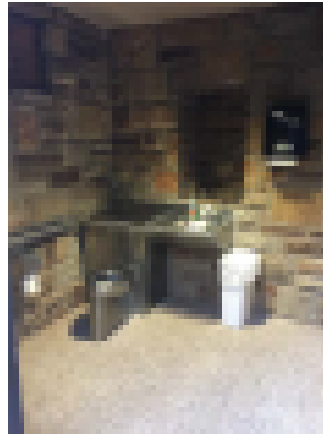
The Restrooms located southwest of the Shell Pavilion, were built as part of the original Rock Springs Garden construction. This facility has undergone recent renovations to repair the roof and framing, while keeping the original wall construction. The restroom signage currently indicates that these restroom facilities are accessible, however the arrangement of the stainless-steel fixtures and accessories are not in

compliance. As renovations to bring these restrooms into compliance might be cost prohibitive, the accessible signage should be removed and directions provided to the nearest accessible restroom facilities provided at the Japanese Garden courtyard.

Fixture Arrangement

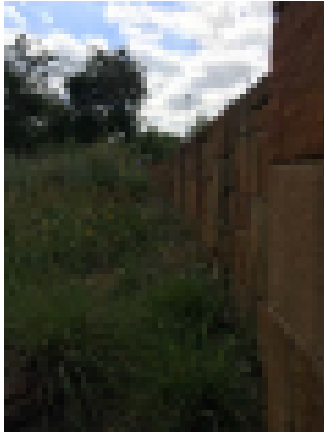
The raised walkway connecting the Bridge to the Overlook is constructed with no noticeable expansion joints or control joints with the exception of one provided at each end of the bridge itself. Expansion joints should be added at least 20' on center. In addition, the walkway has areas along its northern edge which exceed 30" to the adjacent grade below. These areas need to have the surrounding grade raised to decrease this drop-off distance and eliminate the need for a guardrail. The same situation occurs at the Overlook with a 42" drop along its edge. The adjacent grade should be raised to eliminate its need for a guardrail as well.

Raised Walkway

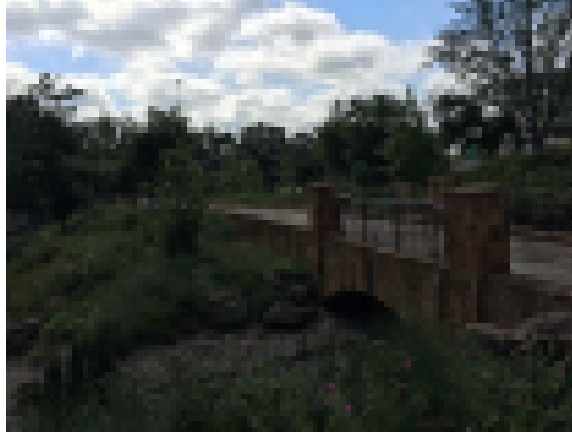
Stone Bridge and Connector

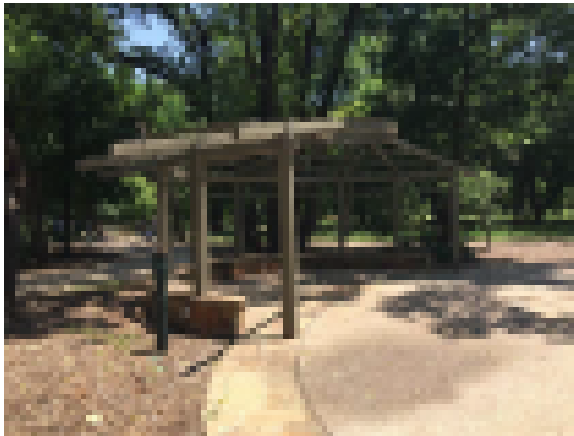
The field welded joints and steel connections of the Pavilion structure are showing some signs of rust and should be painted to help protect the connections.

Shell Pavilion

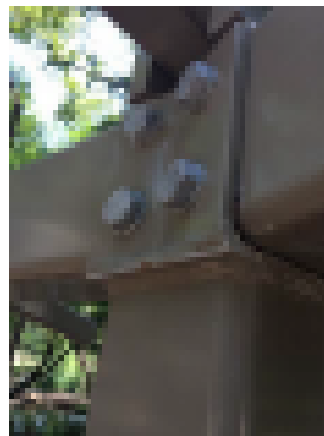
Rusted Welds

Paint Rusted Connections		\$2,875
	Sub-Total	\$2,875
	Contingency	\$575
	Total Cost	\$3,450

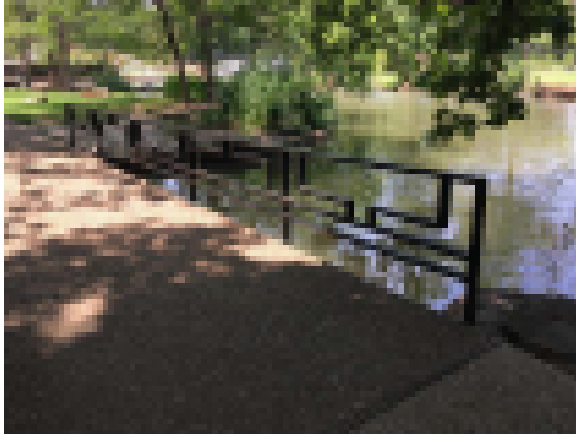
Reflecting Pond Bridge Railing

railing should be designed to match the existing design motif and should be constructed to utilize the existing weld plate embeds in the side of the concrete bridge.

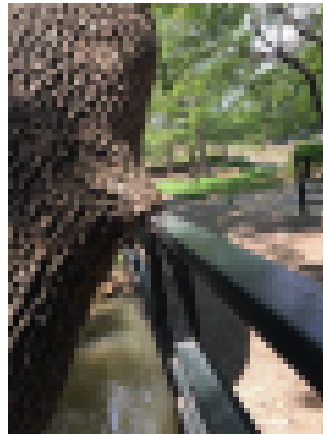
There is a second issue along the south railing of the bridge where an existing tree has come to rest on the top of the railing. Cutting down the limb may cause a problem with the natural landscape restoration in effect for the Rock Springs Garden. However, the new railing could be core drilled and placed further from the slab edge, while the tree limb is cable braced to avoid contact with the new rail.

Tree Limb Resting on Rail

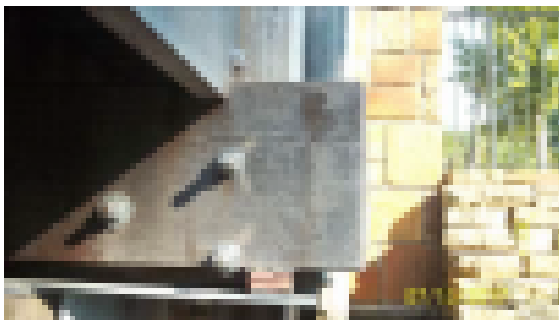
Several of the Boardwalk beams have been over-shimmed. The over-shimming appears to have been performed due to incorrect elevations of some of the column tops. The over-shimming resulted in the bolts being placed much closer to the bottom of the beam than indicated in the construction drawings, and some are closer than allowed by the National Design Specification for Wood Construction (NDS). Since this is a fairly new structure, it is recommended that the Engineer of Record (EOR) for the project be contacted to review the as-constructed conditions and provide comment on any remediation action required.

Over-Shimmed Beam

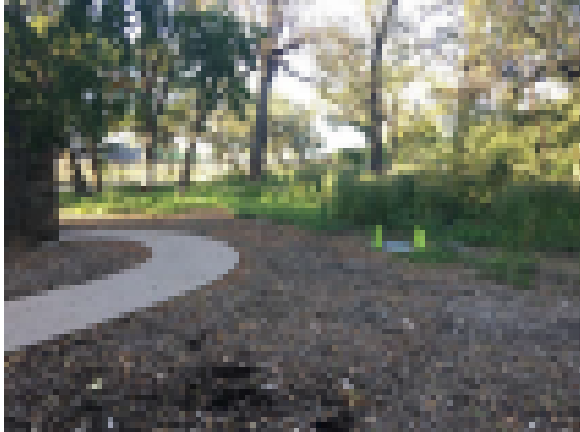
To remove surface water in this area, the current drainage system relies on small landscape drains that flow back to a 12' deep sump which is then pumped into the adjacent pond. In a significant rain event when the pond overflows the banks and the sump inlet, the pump remains on and is ineffective at removing water from the area.

Existing Sump

A comprehensive drainage analysis should be completed with the goal of developing a drainage solution that does not require mechanical pumping.

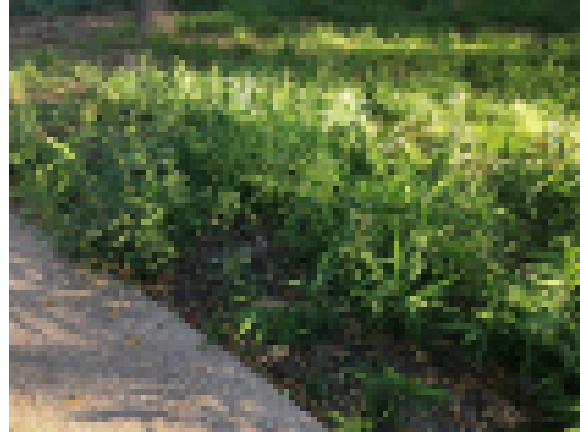
Area Drain in Planting Bed

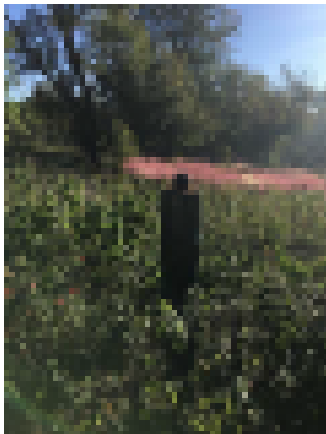
The existing rotary riser irrigation system is functioning adequately, but is in need of zone adjustments to prevent overwatering of some areas and underwatering of others. A licensed irrigator should be retained to perform these adjustments.

Existing Irrigation Head on Riser

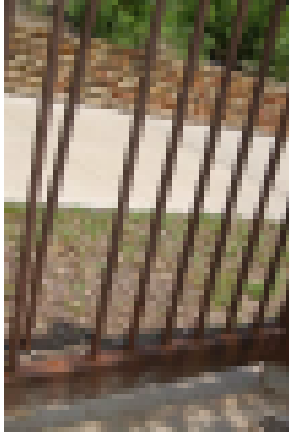
The Botanic Garden is bordered on University Drive and the I-30 Service Road by a custom ornamental metal picket fence with weathered steel finish. At the base of the fence is a continuous concrete mow strip/maintenance edge. Over time, staff has provided spot repairs as needed, but the overall condition of the pickets, posts, and rails is poor. In addition, several pickets are either missing, bent, or have rusted through. The concrete mow strip is also deteriorating, cracked or missing in several locations. It is recommended to replace the fence and mow strip in its entirety. The price below reflects the balance of the fence and mow strip on the Botanic Garden site in addition to the price reflected in the Zone 2 report.

Damaged Perimeter Fence

Replace Perimeter Fence and Mow Strip Fence (Zone 5 Only)	\$605,000
Sub-Total	\$605,000
Contingency	\$121,000
Total Cost	\$726,000

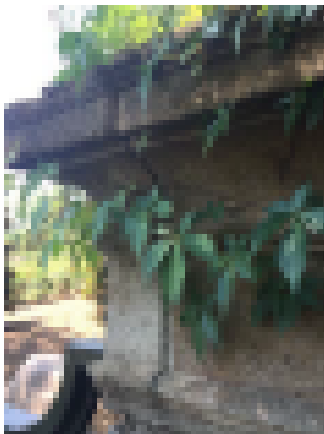
A few cast stone column caps located at the stone columns are showing signs of becoming unseated, cracking and separating at its mortar joints. There are also climbing vines growing around the column. Climbing vines can get inside the mortar cracks and cause further damage if not repaired. These cast stone caps need to be reset and repointed before further damage can occur.

Cast Stone Cap

Clean and Paint Fence and Gate		\$18,113
Repoint Cast Stone Caps		\$3,450
Replace Benches		\$4,600
	Sub-Total	\$26,163
	Contingency	\$5,233
	Total Cost	\$31,396

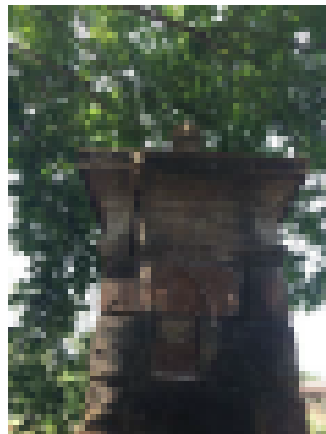
Unseated Stone Cap

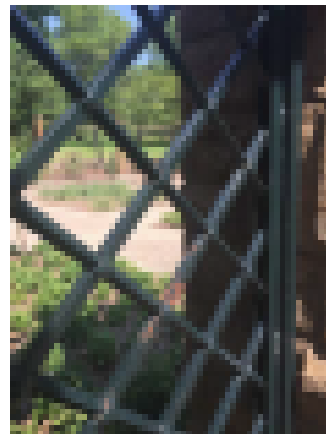
The metal lattice panel screens and framework located along the perimeter fence are showing small signs of rust and corrosion and will need periodic painting. Proper preparation including rust removal with a steel brush, application of primer and finish coating should be performed according to the strict Master Painters Institute (MPI) and manufacturer's recommendations.

Rust at Fence Panel

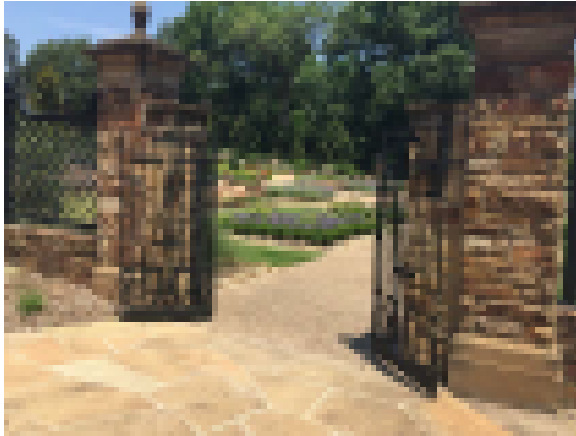
The 6' Garden Gate on the south side of the Lower Rose Garden is not used frequently as the gates are usually held in the open position. The hinges are showing signs of rusting and need to be greased and allowed to work its way into the hinge. If the hinges continue to rust, they will most likely corrode and become inoperable. The gates and framework will require periodic paint recoating. Proper preparation including rust removal with a steel brush, application of primer and finish coating should be performed according to the strict Master Painters Institute (MPI) and manufacturer's recommendations.

Ornamental Metal Gates Along South Side

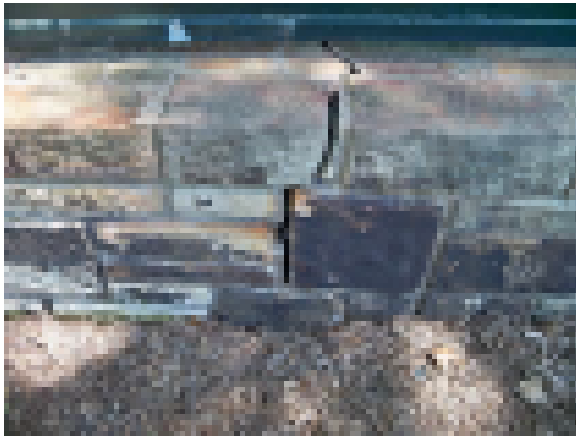
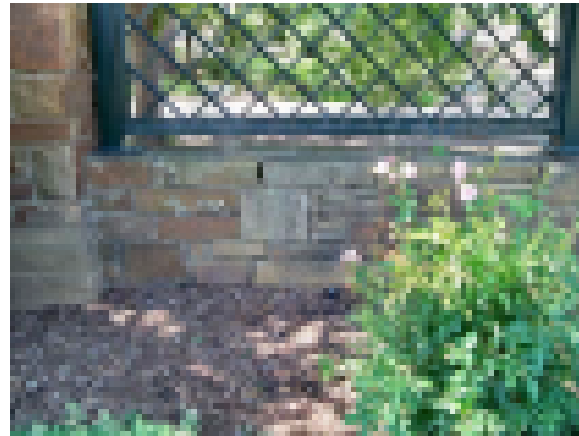
Cracking in the stone base wall of the perimeter fence was observed in various locations. The only significant cracks were a 1/4" wide crack observed on the south fence, a 3/4" wide crack on the north fence, a 1/4" wide stair-stepping crack on the west wall near the southwest corner, and a 3/8" wide crack on the north fence. It is recommended that these cracks be repointed.

Example of Cracked Wall

Repair Wall Cracks		\$800
	Sub-Total	\$800
	Contingency	\$160
	Total Cost	\$960

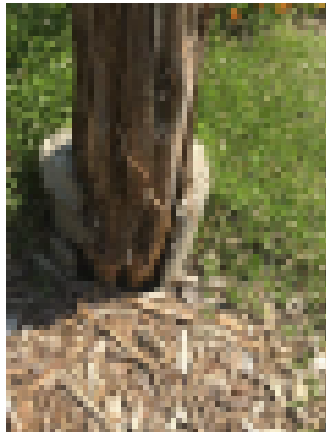
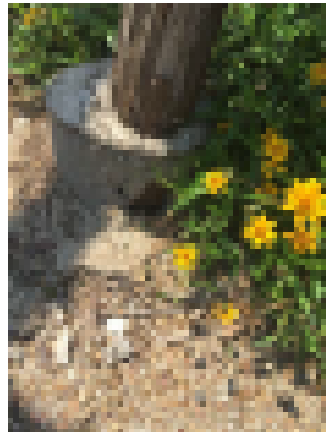
Two cedar arbors have footings that are cracked and exposing the cedar posts. The column bases are showing signs of rotting and termite damage. At several other arbors, the mulch bed has been raised up over the top of the concrete base which will cause faster decomposition.

Cedar Post Base

Repair Cedar Arbors	\$2,300
Knee Skirt at EWC	\$575
Sub-Total	\$2,875
Contingency	\$575
Total Cost	\$3,450

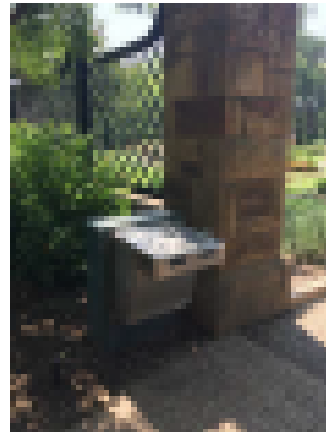
There is an existing electric water cooler located at the south end of the colonnade, just north of the Lower Rose Garden. This model EWC in its current arrangement, does not comply with the current projected object clearances required and needs to have an additional knee skirt added to this unit. Since this is an older model unit, a retrofit skirt may have to be located.

Projected Object in EWC

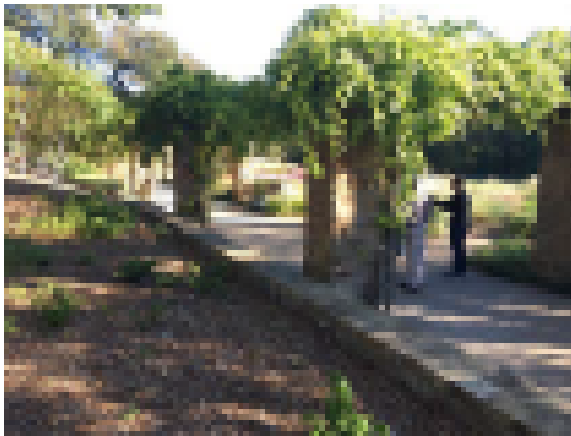
Water north of the Rose Ramp Stairs flows down the area known as Spirea Hill and over the wall into the Texas Republic Miniature Rose Garden. Drain inlets should be installed at the base of Spirea Hill, and should be connected with a drain pipe to outfall into the Reflection Pond.

Spirea Hill & Adjacent Trellises

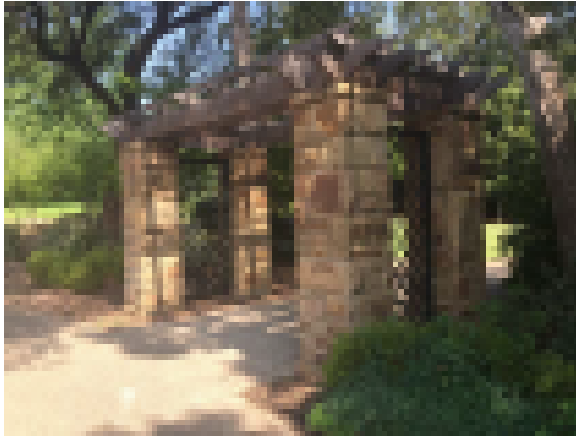
The metal lattice panel screens and framework are showing small signs of rust and corrosion and will need periodic paint recoating.

A few stone columns making up the four arbors that bound the central pavilion are showing signs of wear with vertical cracking in the mortar near the top cap (for example at the northwest corner of the southernmost arbor structure). There is evidence where climbing vine attachment devices were once used and have since been removed. Climbing vines can get inside the mortar cracks and cause further damage if not repaired. These mortar cracks need to be repointed and infilled before further damage can occur with climbing vines or water infiltration.

Arbor with Lattice Panels

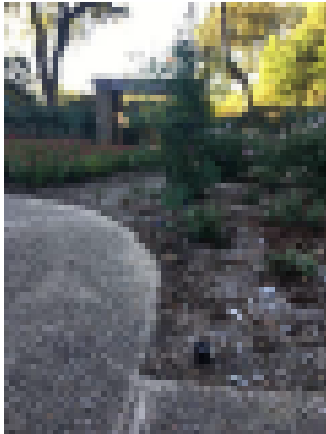
The Oval Rose Garden irrigation system is aging and in need of a full upgrade. The new system should be controlled by the central irrigation controller.

Existing Irrigation System

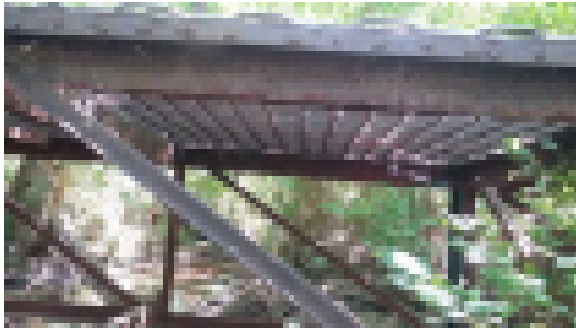
The footbridge appears to have been set directly into the soil at each end which has caused advanced degradation of the steel structure. Significant rusting of the footbridge frame was noted, particularly within the portions of the frame in contact with soil. The steel footbridge has degraded to the point that it is unsafe and unsalvageable. The guardrails for the footbridge do not meet current code requirements. This footbridge is a safety hazard and should be removed. Refer to the Site section for replacement costs.

Steel Bridge Framing

Steel Bridge Frame in Contact with Soil

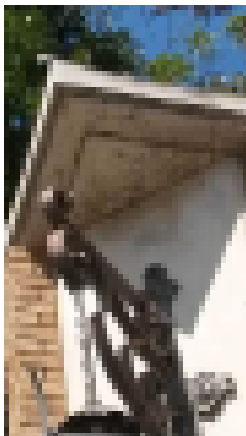
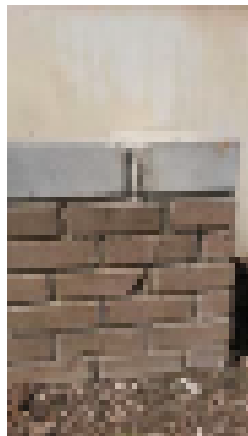
Both precast stone caps at the columns of the Rock Springs Road Garden Entrance, have significant cracks. We recommend that these cracks either be epoxy injected, to extend the useful life of the cap, or replaced. We believe that cap replacement would be more cost effective than injection. There is also isolated cracking located near the north end of the south brick wall (photograph below, right). We recommend that these cracks be re-pointed.

Replace precast stone caps	\$3,500
Repoint brick wall cracks	\$1,000
Sub-Total	\$4,500
Contingency	\$900
Total Cost	\$5,400

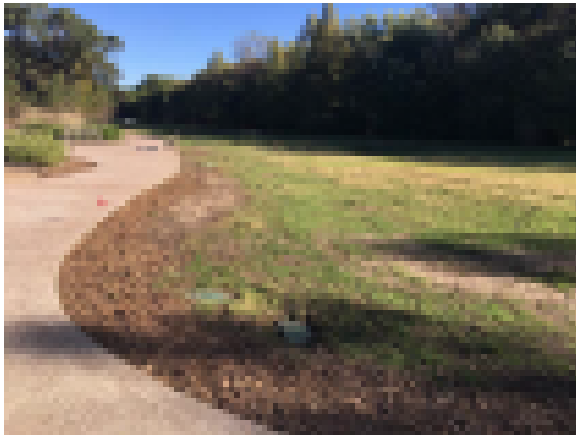
The South Vista lawn is located in one of the lower lying areas of the site between the rose gardens and the lagoons. Due to extensive use and compaction this area does not drain sufficiently and there are visible signs of wear.

South Vista Lawn

The entire lawn and soil beneath it should be excavated and reconstructed using a structural soil that is free draining and more capable of supporting the weight of heavy foot traffic and occasional service vehicle use without creating ruts or other damage. This construction would be similar to an athletic field, and would also include a subsurface drainage system to evacuate water. Additionally, surface runoff upstream of the lawn will need to be collected into area drain inlets and connected to a storm drainage system that outfalls into the creek. Reconstruction would include installing new sod and irrigation system modifications (new heads, etc.).

Excavation & Site Preparation	\$30,000
Subsurface Drainage Allowance	\$75,000
Install Free Drainage Fill Material	\$300,000
Replace Topsoil & Fine Grading	\$12,000
Replace Sod	\$45,000
Irrigation Modifications	\$28,000
Sub-Total	\$490,000
Contingency	\$98,000
Total Cost	\$588,000

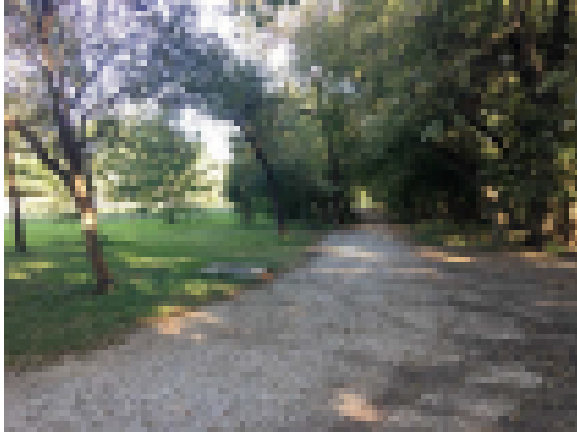
The Service drive just east of the South Vista is utilized by staff on a daily basis but is also used during events for access to the firework launching areas or backstage areas during performances. This drive needs to be resurfaced with a gravel roadway base material and graded smooth.

Gravel Service Drive

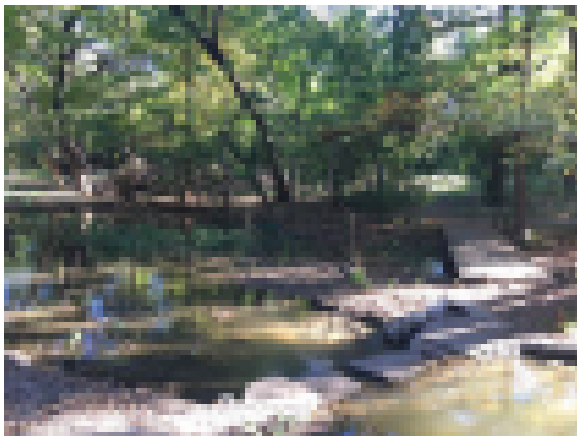
Lagoon Weir Crossing

The Lagoons adjacent to the South Vista flow from South to North through a series of impoundments created by stone weirs. These weirs also provide visitor access across the creek to the nature trails. These lagoons need to be dredged to remove the silt and sediment deposits. This dredging should be performed prior to any drainage improvements in the Perennial Garden or Rose Garden and a French drain installed in the Oval Rose Garden.

Dredge Lagoons	\$25,000
Regrade Soft Trail	\$15,000
Replace 2 Trail Bridges	\$175,000
Sub-Total	\$215,000
Contingency	\$43,000
Total Cost	\$258,000

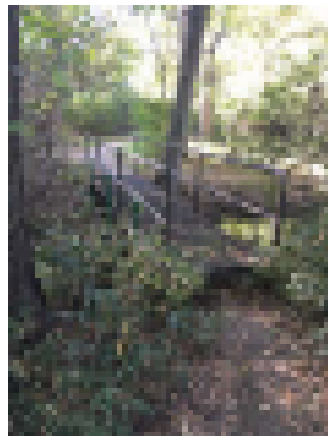
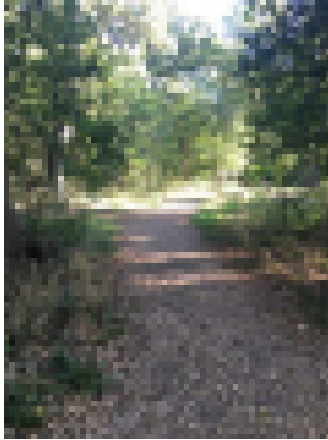
Lagoon Loop Trail Bridge

Lagoon Loop Trails

The Lagoon Loop Trails meander through the woods providing maintenance and visitor access to the heavily wooded area. The trails are primarily soft surface pathways worn by consistent foot traffic. The path crosses the creek over a steel footbridge that has been damaged beyond repair. A second footbridge once located along the eastern creek trail, was previously removed by staff due to damage. Minor grading throughout the trail should be completed to remove ruts and the two footbridges should be replaced with new prefabricated structures.
